ORIGINAL
TIMBER BUNGALOW AT
3 THE RESERVOIR
SURFLEET SPALDING
LINCS PE11 4DJ

DETERMINED
PLAN

-8 OCT 2008
1057/08

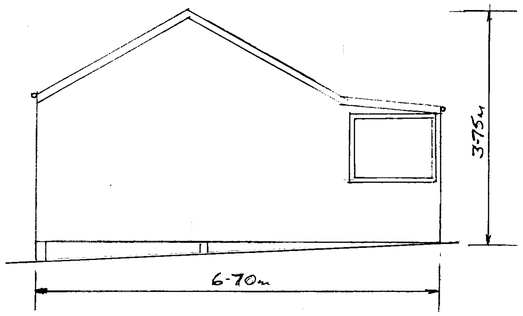
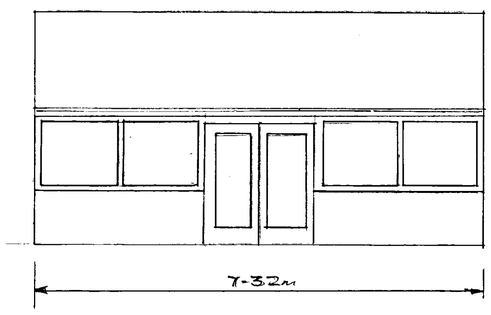
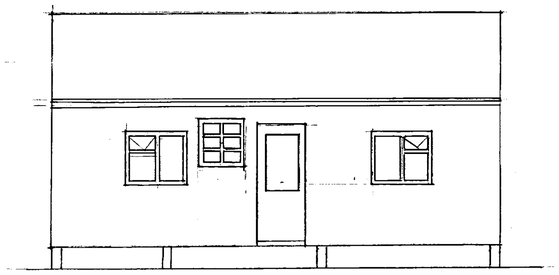
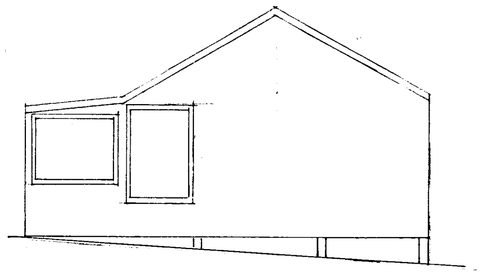
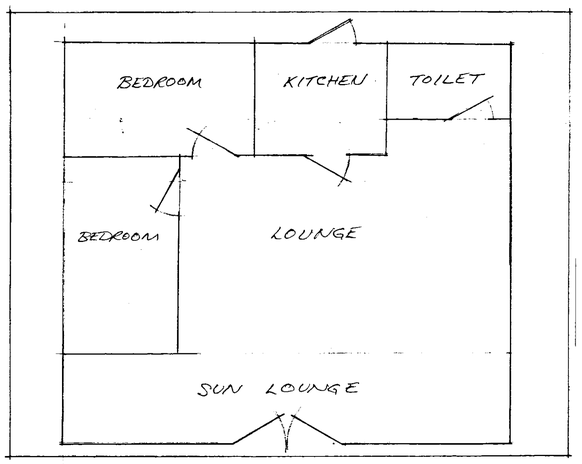
FLOOR ORIGINALLY SUPPORTED ON WOODEN POSTS WHICH HAVE ALL ROTTED OFF AT GROUND LEVEL RANDOM BRICK PIERS WERE ADDED TO HELP SUPPORT THE SAGGING WALLS

NO INSULATION IN WALLS OR CEILING AND ONLY 2 OPENING LIGHTS FOR VENTILATION

ROOF GREEN MINERAL FELT
WALLS HARDBOARD OVER TONGUE & GROVE
