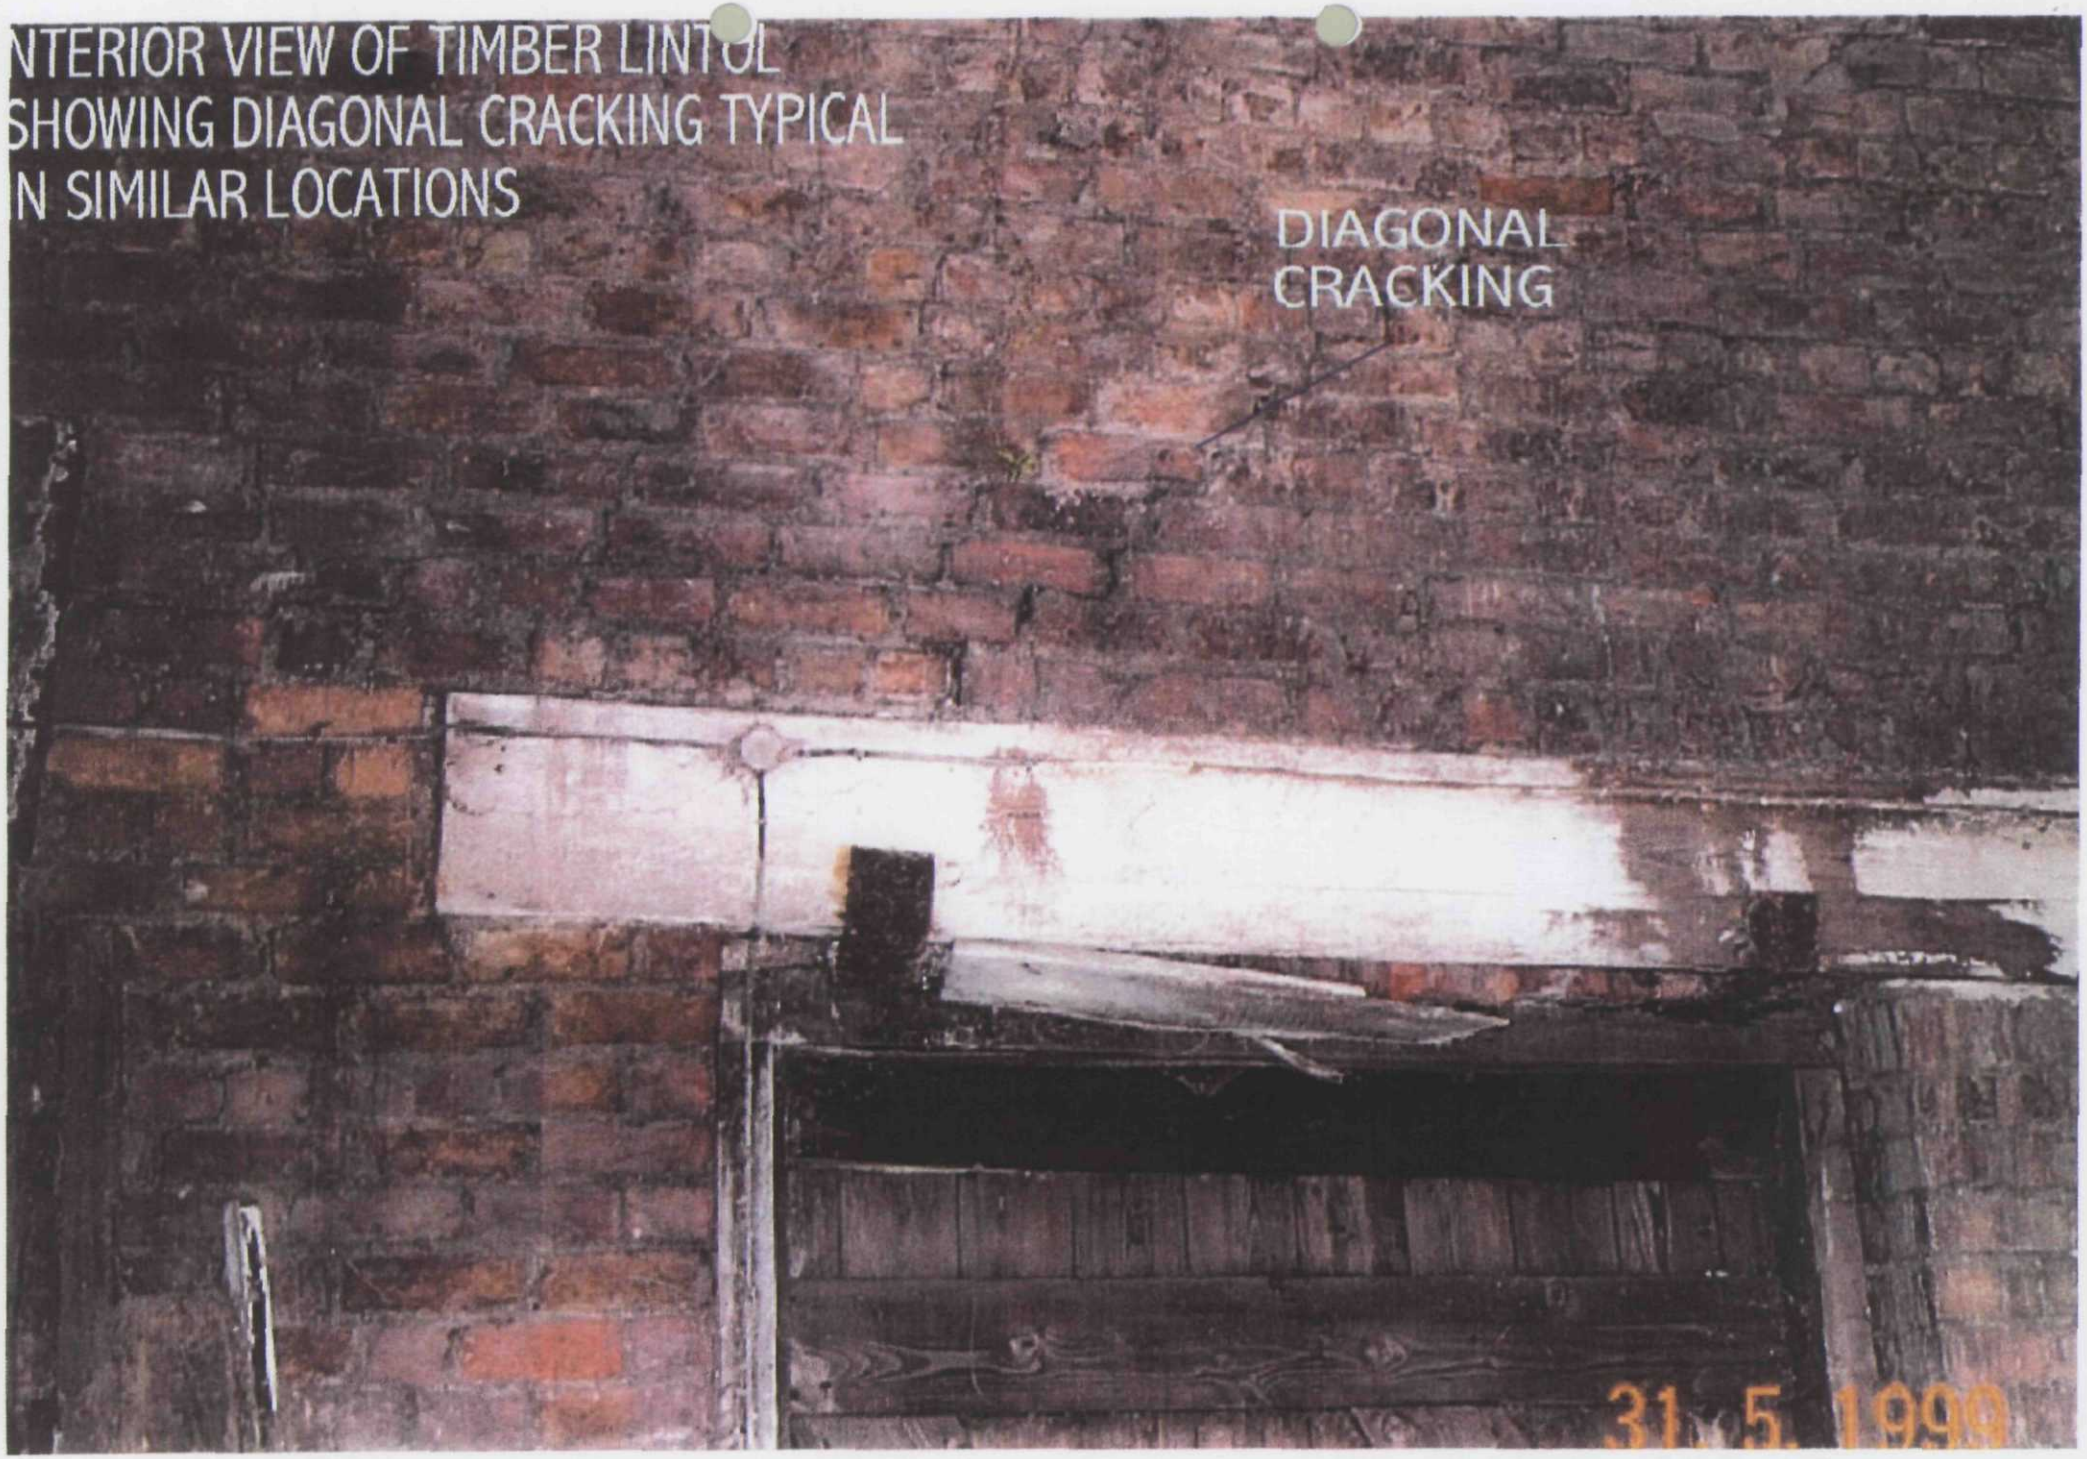
NTERIOR VIEW OF TIMBER LINTOL
SHOWING DIAGONAL CRACKING TYPICAL
N SIMILAR LOCATIONS
DIAGONAL
CRACKING
31.5.1999
