GeoShield Verification Report 19

PROJECT REFERENCE: GEO102862 R019

PROJECT: Persimmon Homes Site

PROJECT ADDRESS: 150-158 High Road

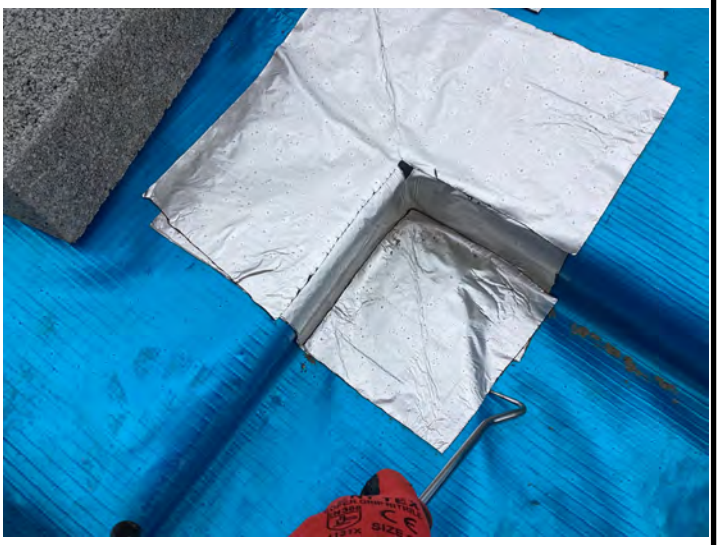
VERIFICATION ITEM ONE

Internal/External Corner Detailing

The various internal and external corners had all been initially formed using sections of Visqueen Gas Barrier. These corners were then reinforced and sealed using strips of Visqueen GRSAM. The initial inspection included checking generally for any loose Visquee Gas Resistant Self Adhesive Membrane where it was

noted that all aspects of installation had been subjected to both heat and pressure so as to activate the bitumen backing improving the bond with the Visqueen Gas Barrier. The bond was confirmed via the Mechanical Point Stress Test as seen in the images.

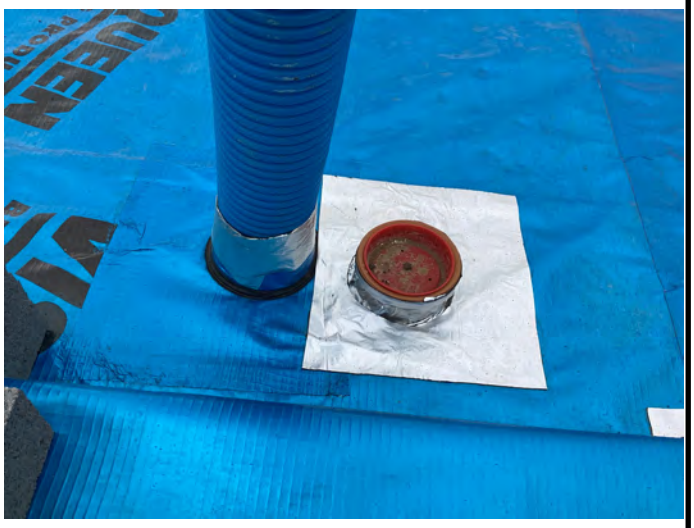
View showing a typical doorway where the reveals have been sealed with strips of Visqueen GRSAM

View showing multiple single pipe penetrations all sealed with the Visqueen Gas Barrier.

View showing twin pipe penetrations sealed with strips of Visqueen Gas Resistant Self Adhesive Membrane

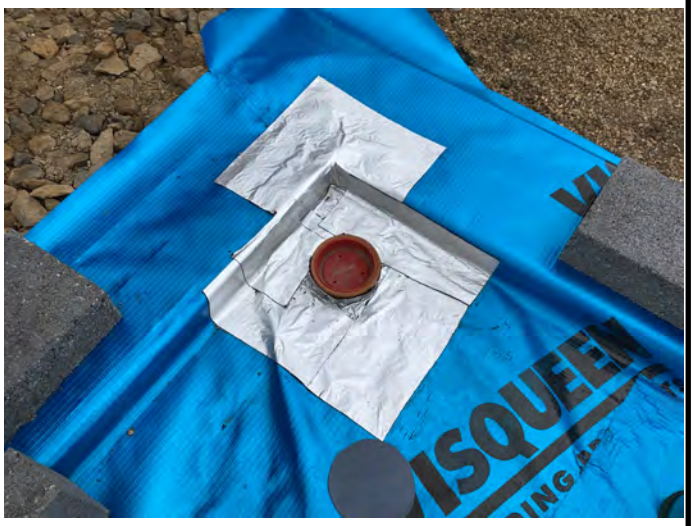
View of multiple internal and external corners sealed with strips of Visqueen Gas Resistant Self Adhesive Membrane

View showing a typical Visqueen Gas Barrier lap joint lapped a minimum of 100mm.

View showing an internal corner with integral pipe penetration sealed with strips of Visqueen GRSAM

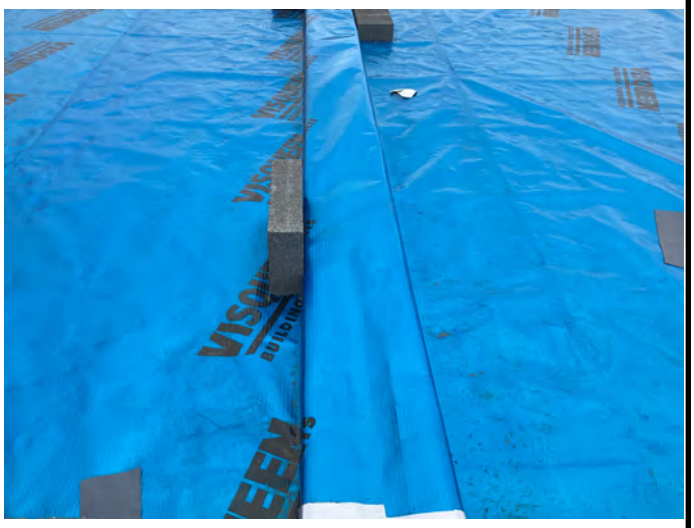
View of multiple internal and external corners sealed with strips of Visqueen Gas Resistant Self Adhesive Membrane

View along the party wall where the Visqueen Gas Barrier has been correctly profiled across.
