GeoShield Verification Report 21

PROJECT REFERENCE:	GEO102862 R021
PROJECT:	Persimmon Homes Site
PROJECT ADDRESS:	150-158 High Road

Weston, Spalding

GeoShield Verification Report

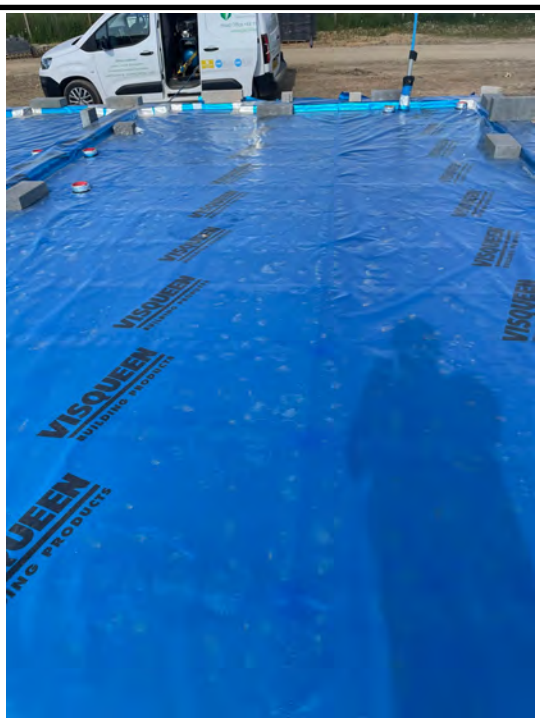
VERIFICATION ITEM ONE

Installation of Visqueen Standard Gas Barrier

A complete line out of the Visqueen Standard Gas Barrier has been installed across the footprint of Plots 119, 120, 121, 122, 123 & 124. The Visqueen Standard Gas Barrier has been lined out across the entirety of the house plots, taken over the internal party walls and external cavities to ensure continuity throughout.

All lap joints between the adjacent sheets of Visqueen Standard Gas Barrier have been overlapped a minimum of 100mm and heat welded using a hot air leister and a silicone roller with adequate pressure applied to ensure a continuous weld is achieved.

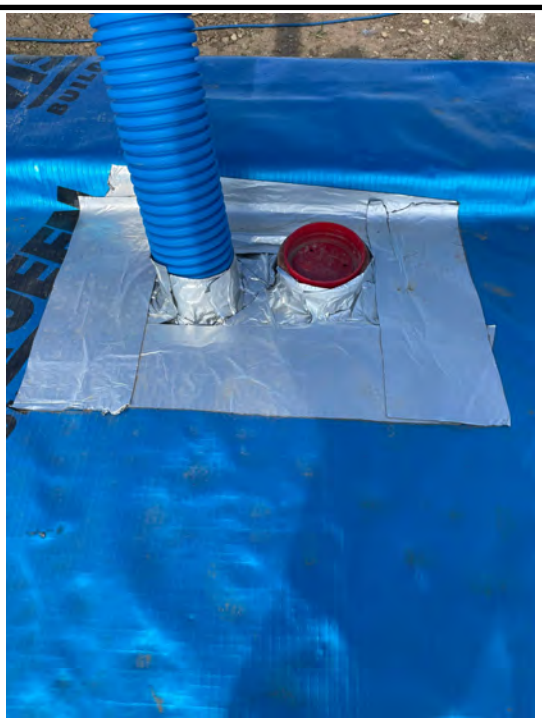
Faults Identified & Remediated

All lap joints of the Visqueen Standard Gas Barrier were subjected to thorough visual inspections, supported by non destructive air lance integrity testing and mechanical point stress testing throughout the installation. A total of three faults and defects were identified at the time of the inspection, which were successfully remediated on site in the presence of GeoShield.

As mentioned, three faults and defects were identified during the testing procedures conducted today. The faults were brought to the attention of the installers and remediated on site in the presence of GeoShield. The installers from Prestige Air opted to

apply patches of Visqueen GRSAM with heat applied to activate the bitumen backing, and firm rolled pressure to ensure a secure bond. No further faults or defects were identified during the testing of the lap joints.

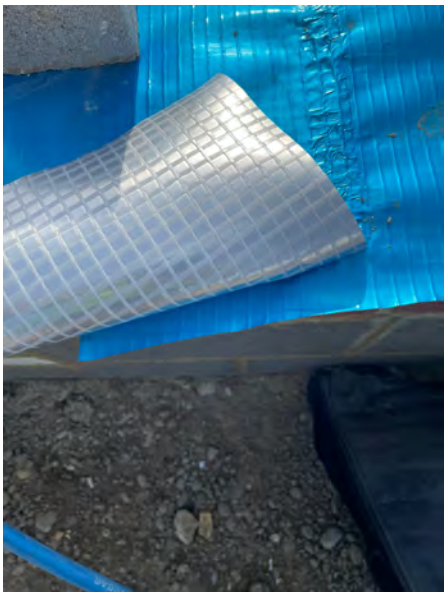
Corner & Threshold Detailing

A number of corners and thresholds throughout the referenced plots have also been sealed correctly using Visqueen GRSAM. Where the Visqueen Standard Gas Barrier has been cut to minimise voided areas and gaps across the footprint of the plot, each corner and threshold junction has been reinforced by heating

strips of Visqueen GRSAM and placed into position around each corner and threshold, onto the Visqueen Standard Gas Barrier. Firm rolled pressure is applied with a silicone roller to aid in the adhesion ensuring the Visqueen GRSAM has fully bonded.

As with the pipe penetrations, a probe was run along all edges of the Visqueen GRSAM within the corner & threshold detailing to validate that a gas tight seal had been achieved throughout. No faults or defects were identified with the corners and thresholds during the testing procedures.
Tested and verified in accordance with CIRIA 735.

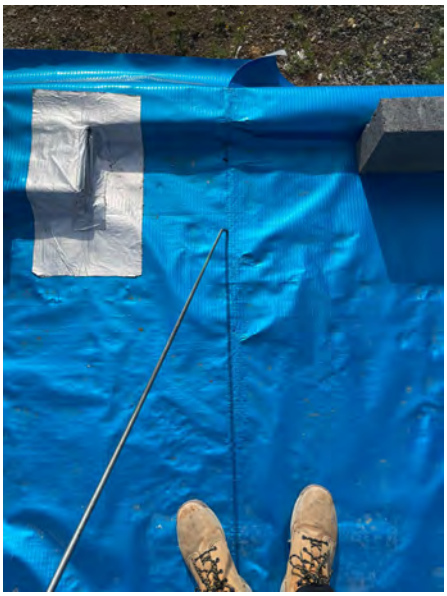
A non destructive air lance integrity test being conducted upon a sealed overlap.

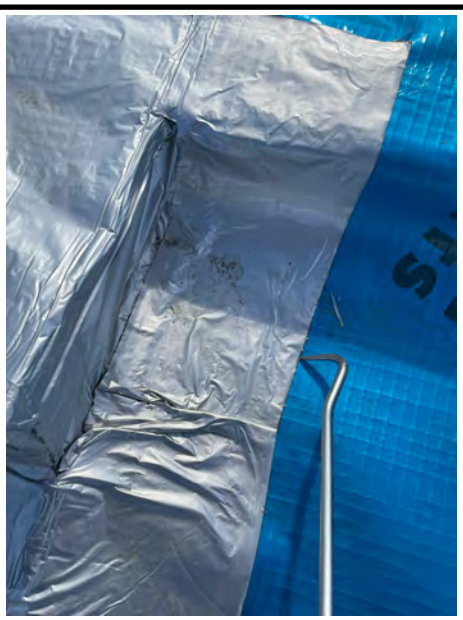
A non destructive air lance integrity test being conducted upon a sealed pipe penetration.

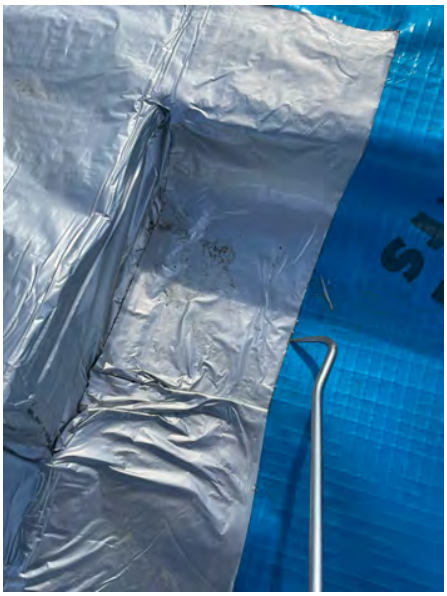
A pick and probe test being conducted upon a sealed corner detail.
