GeoShield Verification Report 24

PROJECT REFERENCE: GEO102862

PROJECT: Persimmon Homes Site

REPORT NUMBER: 024

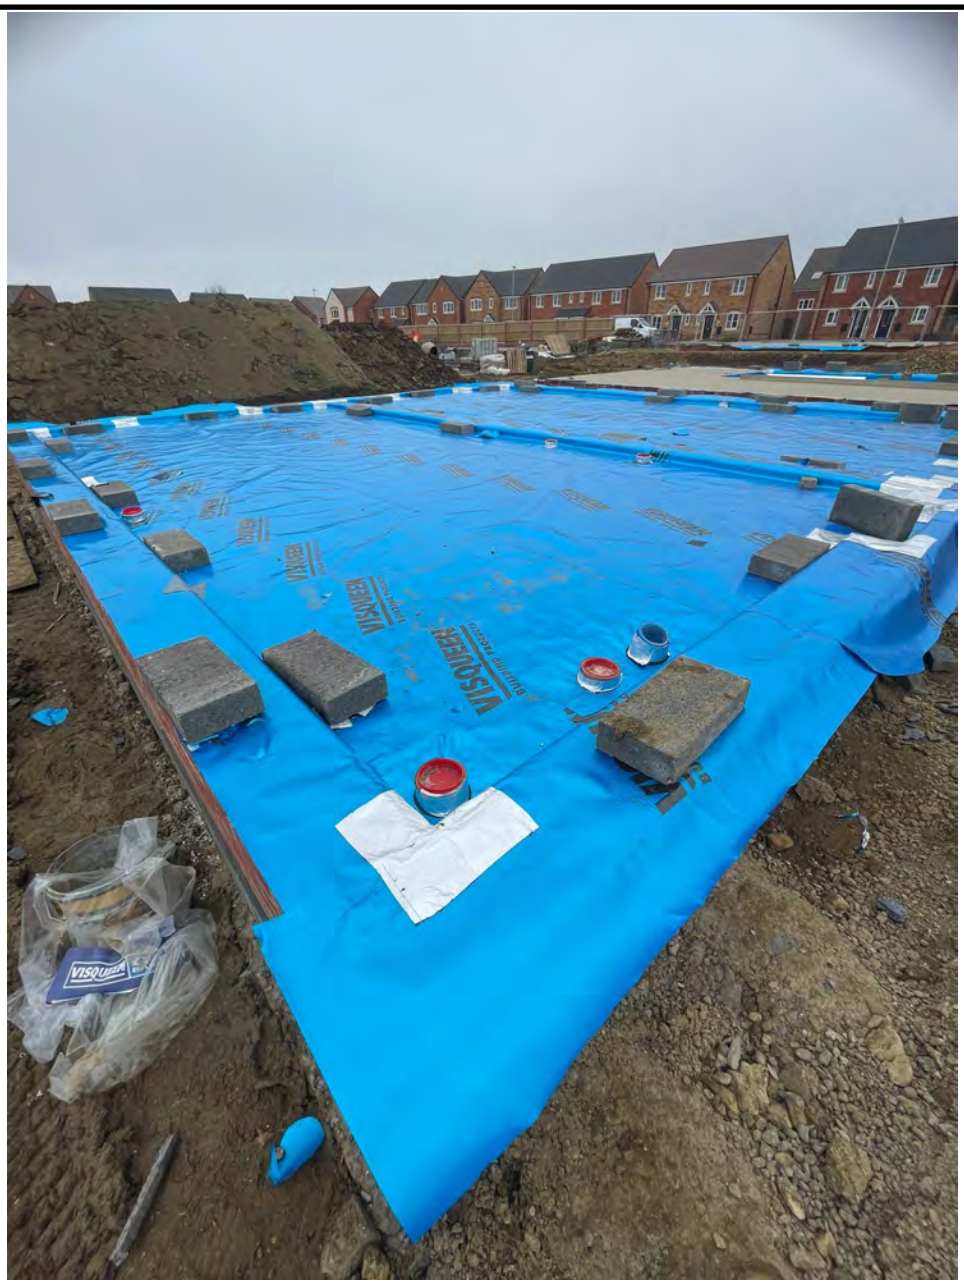
The photograph above displays an overview of plots 78 & 79 where today's verification inspection took place on site.

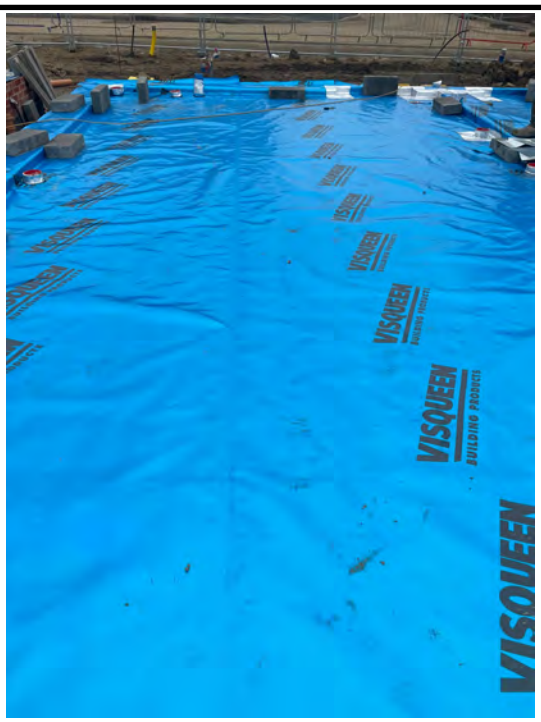
LOCATION/GRID LINE: Plot 80

Within plot 80 there was an outstanding remediation on the garage area which hadn't been sealed on the previous visit. This was due to the builders not having enough insulation for the garage cavity walls.

This has then been sealed and verified during today's visit. No faults or defects were identified during today's testing procedures. Installed in accordance with manufacturer's specifications and design guidelines.

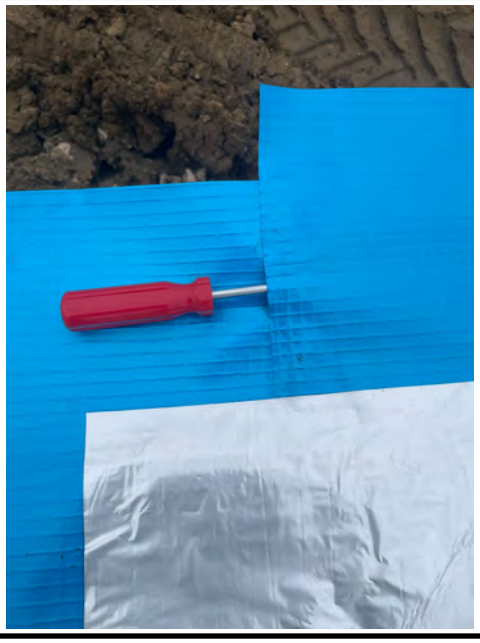
Fault Identified

As mentioned, one miswelded lap joint was identified during the testing procedures conducted today. The fault was brought to the attention of the installers and remediated on site in the presence of GeoShield.

The fault was remediated by applying 150mm patches of Visqueen GR SAM over the affected areas with heat and rolled pressure applied to activate the bitumen backing. No further faults or defects were identified during the testing of the lap joints.
