Geotechnical & Environmental Consultants

Our ref: D41072/MV1/CEH

Re: High Road, Weston (Membrane Validation Works – Plots 1 to 6, 59, 60 and 65 to 68)

Further to your instruction to undertake inspection/verification works following the installation of the ground gas resistant membranes at the above site, we can now make the following comments with regards to Plots 1 to 6, 59, 60 and 65 to 68.

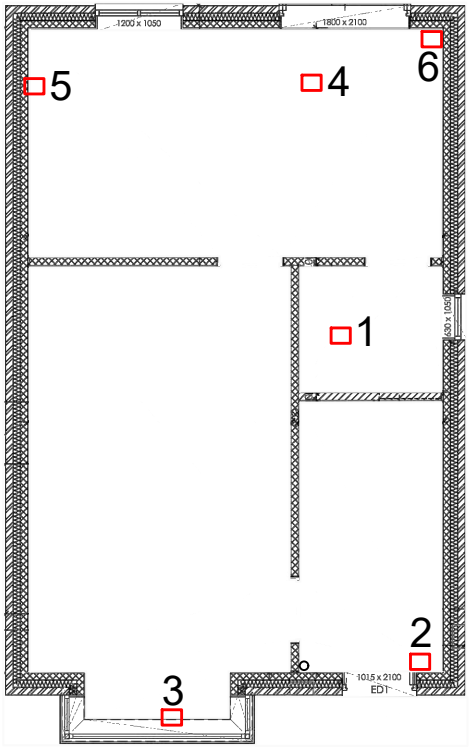
Project No.	D41072
Client	Ashwood Homes
Project	High Road, Weston
Title	Membrane Validation of Plot 1
Drawn By	SJ
Checked By	CEH
Approved By	RS
Scale	NTS
Date Drawn	07/12/2022
Revision	
Figure No.	D41072/MV1/D1

SUMMARY OF DEFECTS				
Defect No.	**Date of Inspection**	**Description**	**Repair**	**Date of Reinspection**
1	05/10/2022	Puncture (2No.)	SAGRM patch (heat sealed)	05/10/2022
2	05/10/2022	Incomplete weld	SAGRM patch (heat sealed)	05/10/2022
3	05/10/2022	Incomplete weld	SAGRM patch (heat sealed)	05/10/2022
4	05/10/2022	Incomplete weld	SAGRM patch (heat sealed)	05/10/2022
5	05/10/2022	Incomplete weld	SAGRM patch (heat sealed)	05/10/2022
6	05/10/2022	Incomplete seal on corner detail	SAGRM patch (heat sealed)	05/10/2022

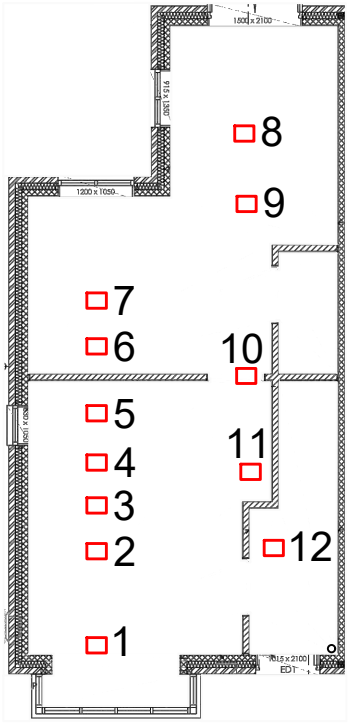
Project No.	D41072
Client	Ashwood Homes
Project	High Road, Weston
Title	Membrane Validation of Plot 2
Drawn By	SJ
Checked By	CEH
Approved By	RS
Scale	NTS
Date Drawn	07/12/2022
Revision	
Figure No.	D41072/MV1/D2

SUMMARY OF DEFECTS				
Defect No.	**Date of Inspection**	**Description**	**Repair**	**Date of Reinspection**
1	05/10/2022	Incomplete weld	SAGRM patch (heat sealed)	05/10/2022
2	05/10/2022	Incomplete weld	SAGRM patch (heat sealed)	05/10/2022
3	05/10/2022	Incomplete weld	SAGRM patch (heat sealed)	05/10/2022
4	05/10/2022	Incomplete weld	SAGRM patch (heat sealed)	05/10/2022

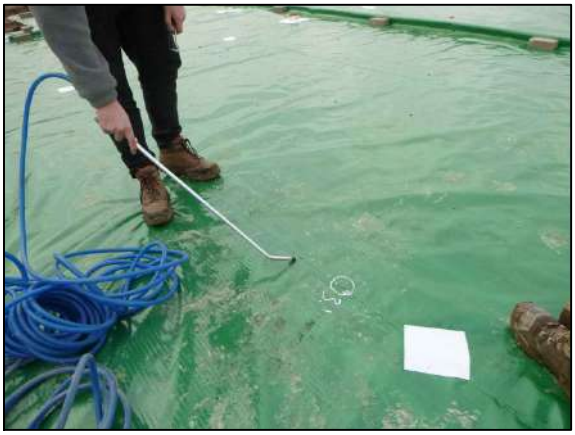
B | SAGRM used to seal corner

C | SAGRM used to seal service penetrations

D | Incomplete weld between membrane panels

E | SAGRM patch to repair defect in Image D

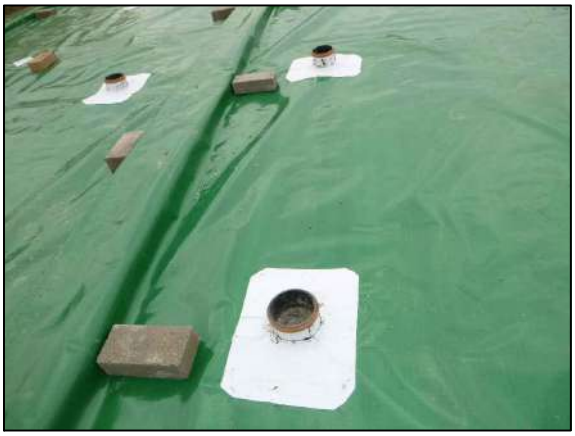
Plot No. 4

A | View of installed membrane

B | Membrane extending across party wall between Plots 3 and 4 and SAGRM used to seal service penetrations

C | SAGRM used to seal corners

D | Damaged block removed from beneath membrane

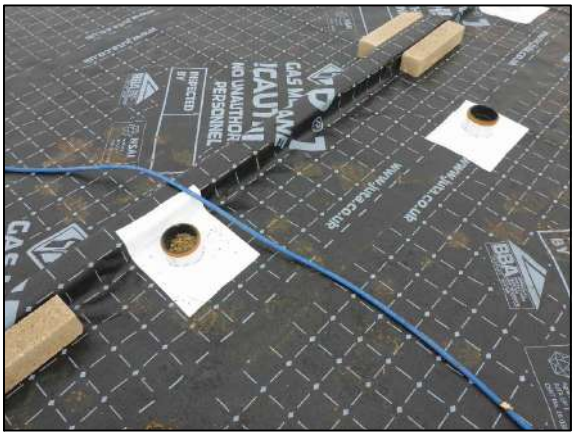
Plot No. 60

A | View of installed membrane

B | SAGRM used to seal service penetrations

C | SAGRM used to seal corners and service penetration

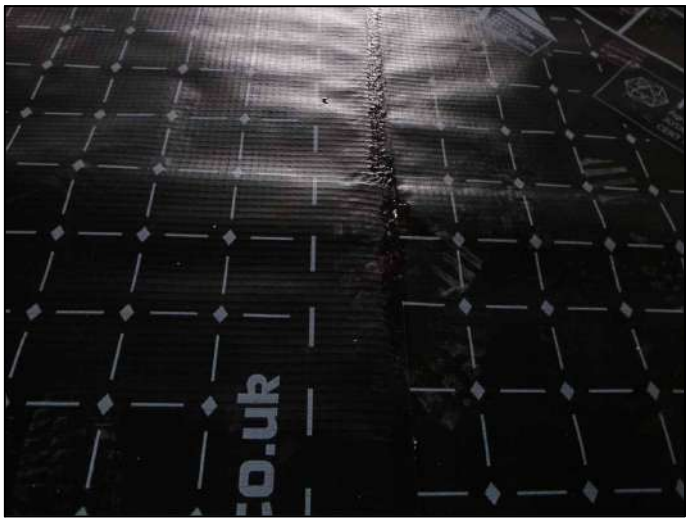
Plot No. 65

A	SAGRM used to seal service penetration

B	Welded joint between membrane panels

C	Damage to membrane exposing aluminium layer

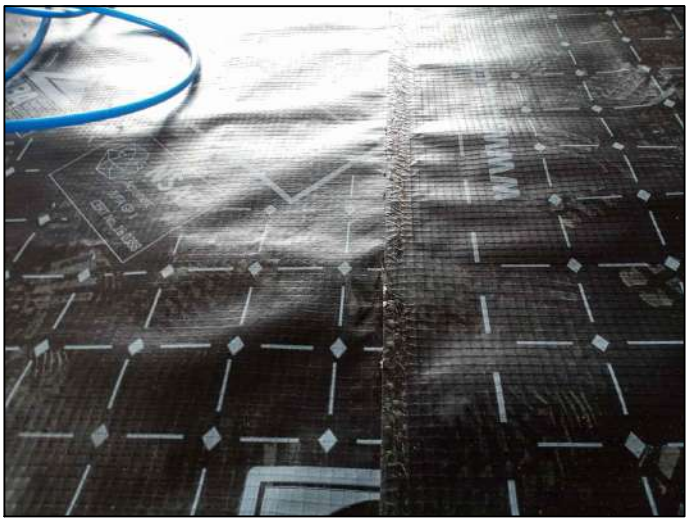
A | SAGRM used to seal service penetration

B | SAGRM used to seal service penetrations

C | Welded joint between membrane panels

D | Damage to membrane exposing aluminium layer

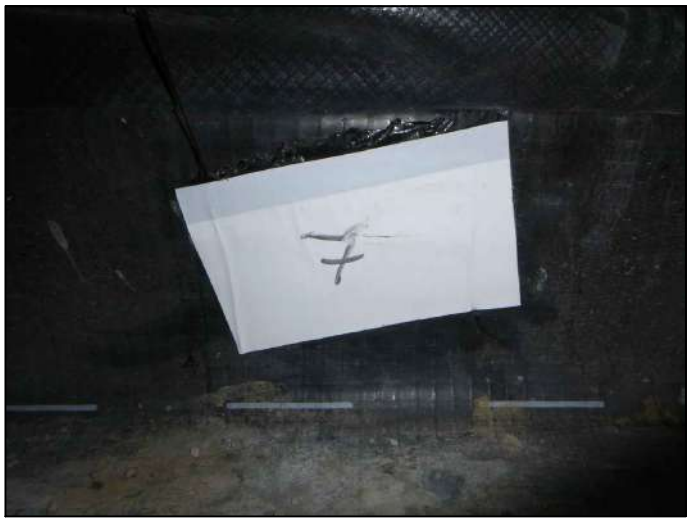
Project No.	D41072	Drawn By	SJ
Client	Ashwood Homes	Checked By	CEH
		Approved By	RS
Project	High Road, Weston	Scale	NTS
		Date Drawn	07/12/2022
Title	Plot 68 - Views during validation works on 28/09/2022	Revision	
		Figure No.	D41072/MV1/P12

B	Welded joint between perimeter and infill membranes

C	Holes in perimeter membrane

D	SAGRM patch to repair damage in Image D
