Our ref: D41072/MV2/CEH

17th March 2023

Re: High Road, Weston (Membrane Validation Works – Plots 7, 47, 50, 58 and 61 to 64)

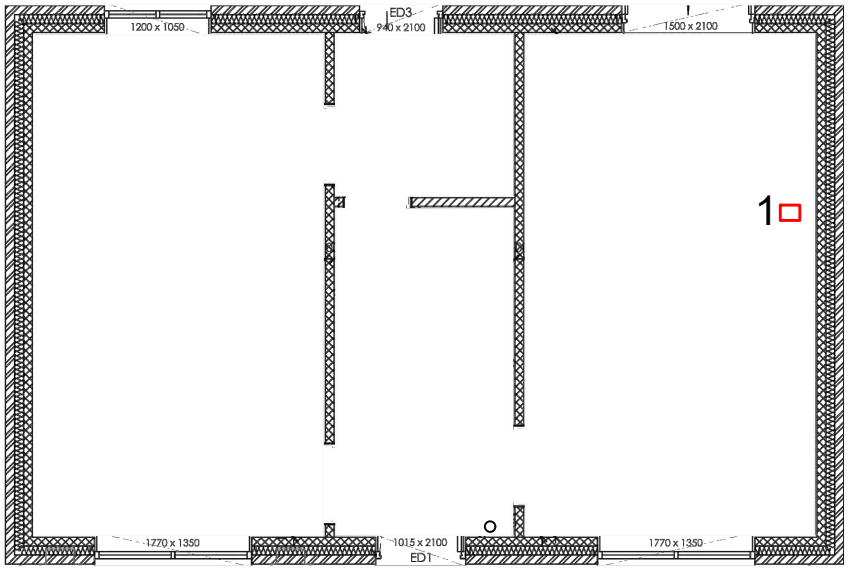
Project No.	D41072
Client	Ashwood Homes
Project	High Road, Weston
Title	Membrane Validation of Plot 7
Drawn By	SJ
Checked By	CEH
Approved By	RS
Scale	NTS
Date Drawn	16/03/2023
Revision	
Figure No.	D41072/MV2/D1

SUMMARY OF DEFECTS				
Defect No.	**Date of Inspection**	**Description**	**Repair**	**Date of Reinspection**
1	27/01/2023	Membrane damaged (aluminium layer exposed)	SAGRM patch (heat sealed)	27/01/2023

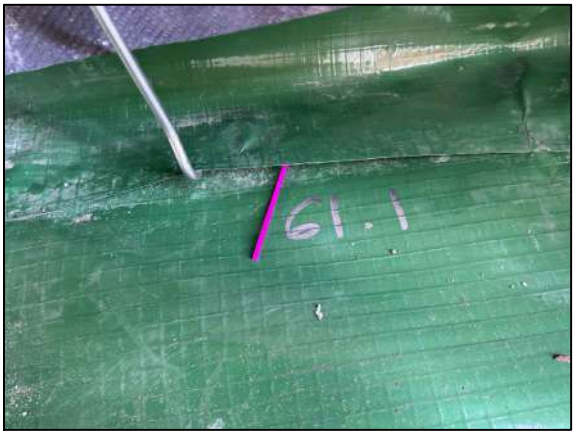
D | Incomplete weld between perimeter and infill membranes

E | Rewelded joint between perimeter and infill membranes in Image D

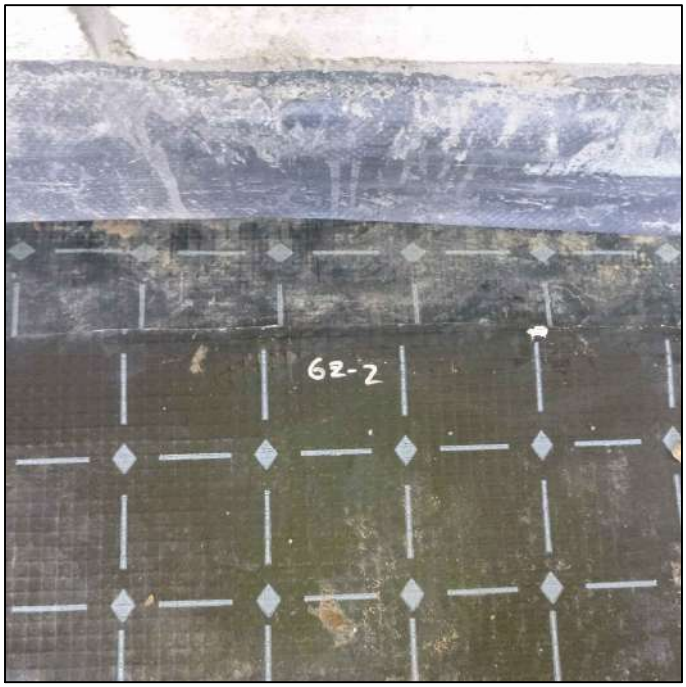
Project No.	D41072	Drawn By	SJ
Client	Ashwood Homes	Checked By	CEH
		Approved By	RS
Project	High Road, Weston	Scale	NTS
		Date Drawn	16/03/2023
Title	Plot 62 - Views during validation works on 20/01/2023	Revision	
		Figure No.	D41072/MV2/P6

A | Incomplete weld between perimeter and infill membranes

B | Rewelded joint between perimeter and infill membranes in Image A

C | Incomplete seals on corners

D | SAGRM patches to repair defects in Image C

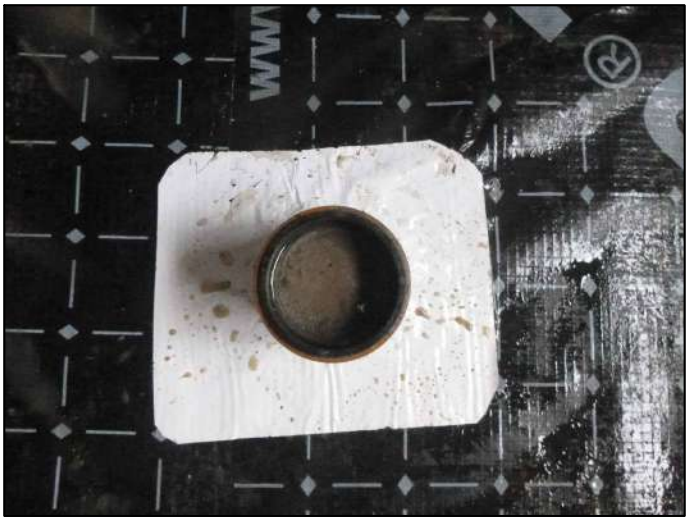
A	SAGRM used to seal service penetrations

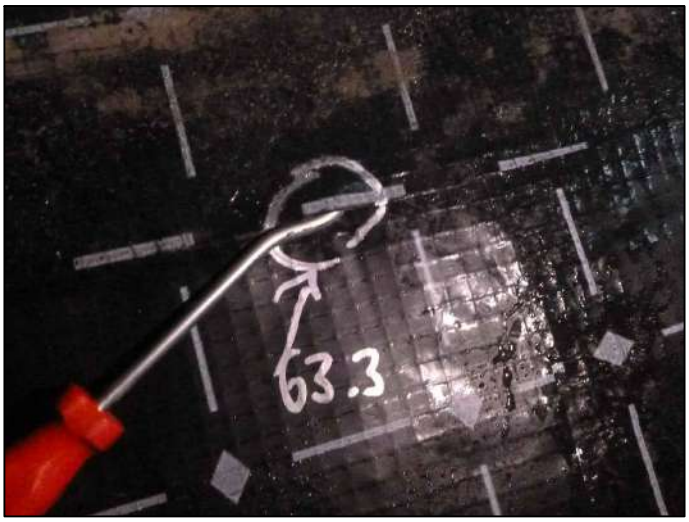
B	SAGRM used to seal corner and punctures

C	Incomplete weld between perimeter and infill membranes

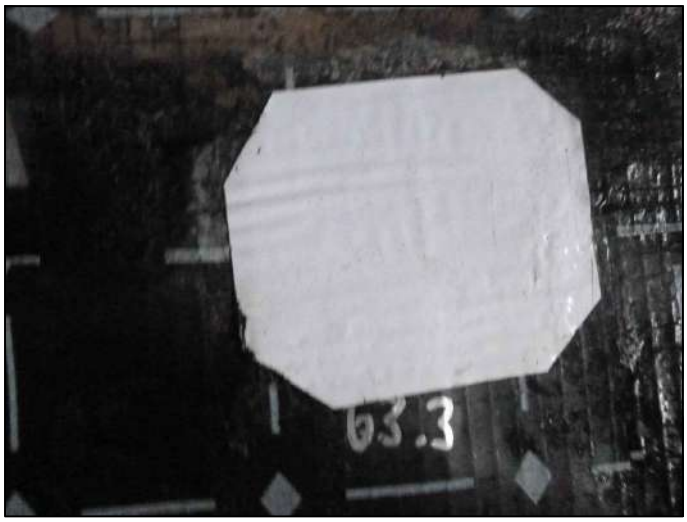
Project No.	D41072	Drawn By	SJ
Client	Ashwood Homes	Checked By	CEH
		Approved By	RS
Project	High Road, Weston	Scale	NTS
		Date Drawn	16/03/2023
Title	Plot 63 - Views during validation works on 10/01/2023	Revision	
		Figure No.	D41072/MV2/P7

D	SAGRM patch to repair defect in Image C
