Our ref: D41072/MV3/CEH

2nd June 2023

Re: High Road, Weston (Membrane Validation Works – Plots 8, 45, 46 and 51 to 55)

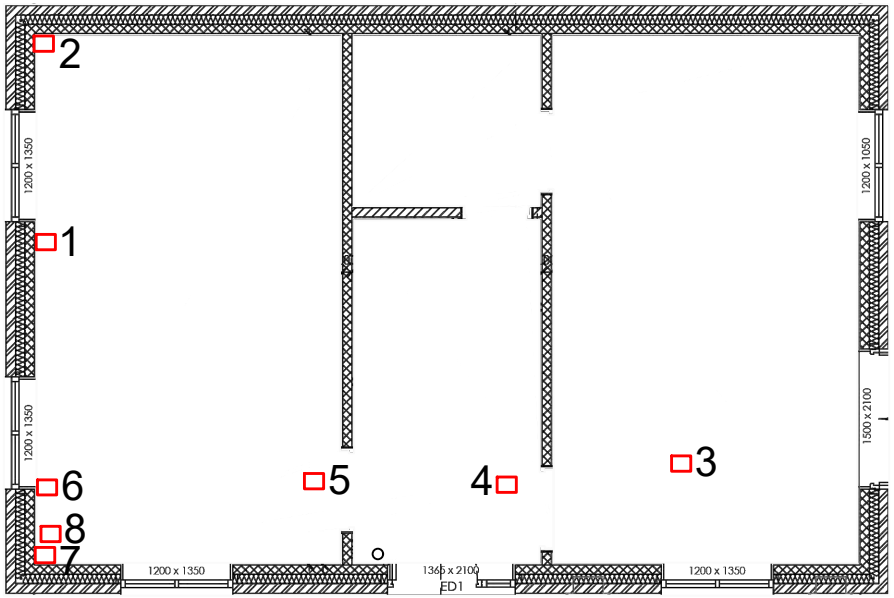
Project No.	D41072
Client	Ashwood Homes
Project	High Road, Weston
Title	Membrane Validation of Plot 8
Drawn By	SJ
Checked By	CEH
Approved By	RS
Scale	NTS
Date Drawn	17/05/2023
Revision	
Figure No.	D41072/MV3/D1

SUMMARY OF DEFECTS				
Defect No.	**Date of Inspection**	**Description**	**Repair**	**Date of Reinspection**
1	16/05/2023	Incomplete weld	SAGRM patch (heat sealed)	16/05/2023
2	16/05/2023	Incomplete weld	SAGRM patch (heat sealed)	16/05/2023
3	16/05/2023	Incomplete weld	SAGRM patch (heat sealed)	16/05/2023
4	16/05/2023	Incomplete weld	SAGRM patch (heat sealed)	16/05/2023
5	16/05/2023	Incomplete weld	SAGRM patch (heat sealed)	16/05/2023
6	16/05/2023	Incomplete weld	SAGRM patch (heat sealed)	16/05/2023
7	16/05/2023	Incomplete weld	SAGRM patch (heat sealed)	16/05/2023
8	16/05/2023	Incomplete weld	SAGRM patch (heat sealed)	16/05/2023

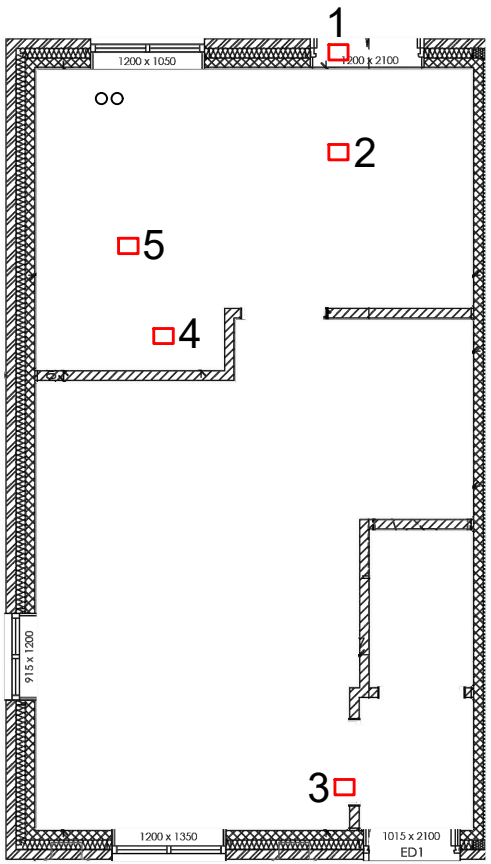
Project No.	D41072
Client	Ashwood Homes
Project	High Road, Weston
Title	Membrane Validation of Plot 45
Drawn By	SJ
Checked By	CEH
Approved By	RS
Scale	NTS
Date Drawn	17/05/2023
Revision	
Figure No.	D41072/MV3/D2

SUMMARY OF DEFECTS				
Defect No.	**Date of Inspection**	**Description**	**Repair**	**Date of Reinspection**
1	03/04/2023	Incomplete weld	SAGRM patch (heat sealed)	03/04/2023
2	03/04/2023	Incomplete weld	SAGRM patch (heat sealed)	03/04/2023
3	03/04/2023	Incomplete weld	SAGRM patch (heat sealed)	03/04/2023
4	03/04/2023	Incomplete weld	SAGRM patch (heat sealed)	03/04/2023
5	03/04/2023	Puncture	SAGRM patch (heat sealed)	03/04/2023

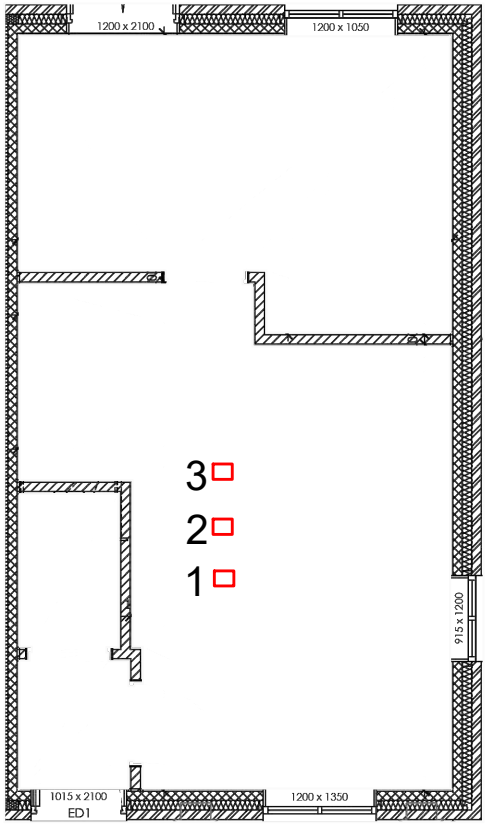
Project No.	D41072
Client	Ashwood Homes
Project	High Road, Weston
Title	Membrane Validation of Plot 46
Drawn By	SJ
Checked By	CEH
Approved By	RS
Scale	NTS
Date Drawn	17/05/2023
Revision	
Figure No.	D41072/MV3/D3

SUMMARY OF DEFECTS				
Defect No.	**Date of Inspection**	**Description**	**Repair**	**Date of Reinspection**
1	03/04/2023	Incomplete weld	SAGRM patch (heat sealed)	03/04/2023
2	03/04/2023	Incomplete weld	SAGRM patch (heat sealed)	03/04/2023
3	03/04/2023	Incomplete weld	SAGRM patch (heat sealed)	03/04/2023

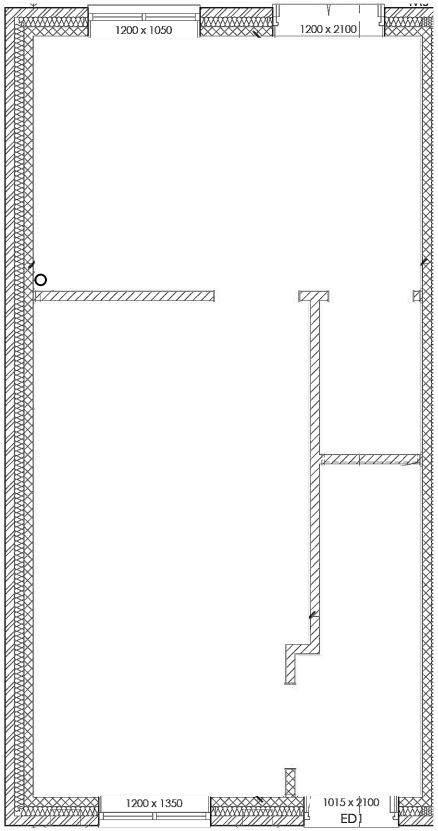
Project No.	D41072
Client	Ashwood Homes
Project	High Road, Weston
Title	Membrane Validation of Plot 51
Drawn By	SJ
Checked By	CEH
Approved By	RS
Scale	NTS
Date Drawn	17/05/2023
Revision	
Figure No.	D41072/MV3/D4

SUMMARY OF DEFECTS				
Defect No.	**Date of Inspection**	**Description**	**Repair**	**Date of Reinspection**
-	03/04/2023	No Defects identified	-	-

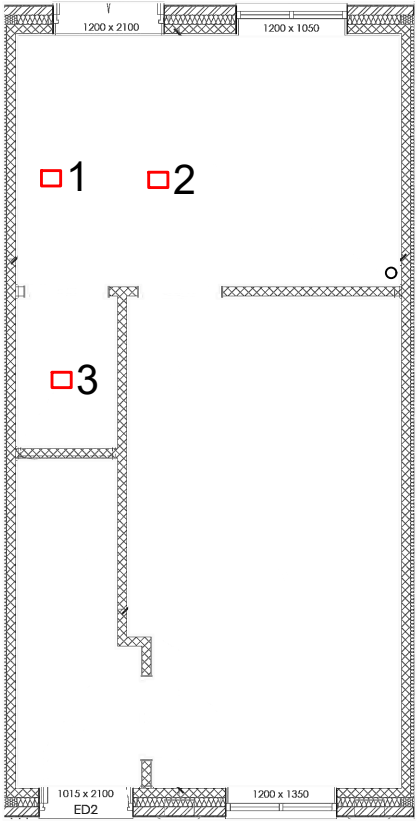
Project No.	D41072
Client	Ashwood Homes
Project	High Road, Weston
Title	Membrane Validation of Plot 52
Drawn By	SJ
Checked By	CEH
Approved By	RS
Scale	NTS
Date Drawn	17/05/2023
Revision	
Figure No.	D41072/MV3/D5

SUMMARY OF DEFECTS				
Defect No.	**Date of Inspection**	**Description**	**Repair**	**Date of Reinspection**
1	03/04/2023	Incomplete weld	SAGRM patch (heat sealed)	03/04/2023
2	03/04/2023	Incomplete weld	SAGRM patch (heat sealed)	03/04/2023
3	03/04/2023	Incomplete weld	SAGRM patch (heat sealed)	03/04/2023

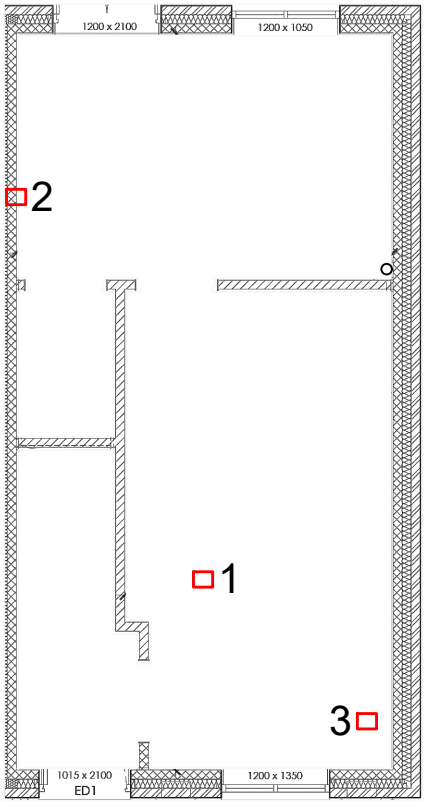
Project No.	D41072
Client	Ashwood Homes
Project	High Road, Weston
Title	Membrane Validation of Plot 53
Drawn By	SJ
Checked By	CEH
Approved By	RS
Scale	NTS
Date Drawn	17/05/2023
Revision	
Figure No.	D41072/MV3/D6

SUMMARY OF DEFECTS				
Defect No.	**Date of Inspection**	**Description**	**Repair**	**Date of Reinspection**
1	03/04/2023	Incomplete weld	SAGRM patch (heat sealed)	03/04/2023
2	03/04/2023	Incomplete weld	SAGRM patch (heat sealed)	03/04/2023
3	03/04/2023	Membrane damaged (aluminium layer exposed)	SAGRM patch (heat sealed)	03/04/2023

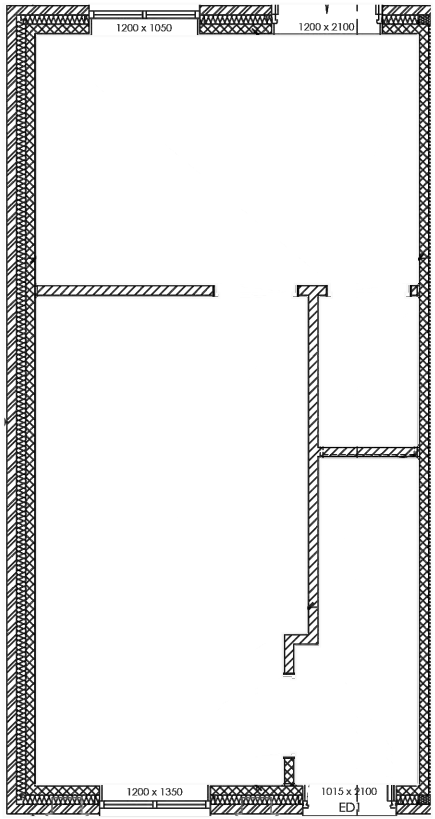
Project No.	D41072
Client	Ashwood Homes
Project	High Road, Weston
Title	Membrane Validation of Plot 54
Drawn By	SJ
Checked By	CEH
Approved By	RS
Scale	NTS
Date Drawn	17/05/2023
Revision	
Figure No.	D41072/MV3/D7

SUMMARY OF DEFECTS				
Defect No.	**Date of Inspection**	**Description**	**Repair**	**Date of Reinspection**
-	03/04/2023	No Defects identified	-	-

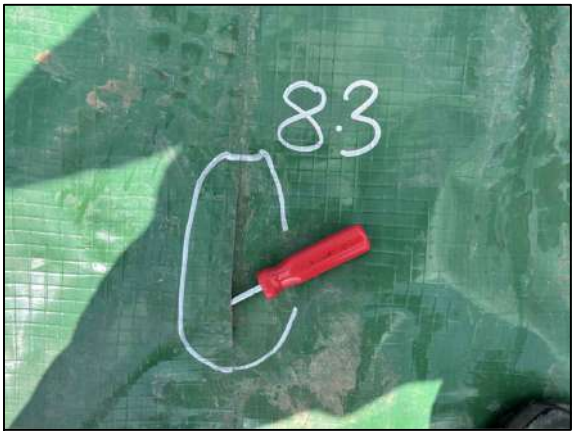
D | Incomplete weld between membrane panels

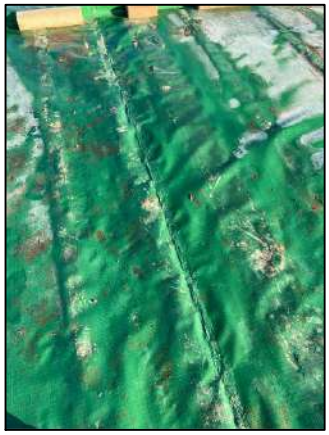
Project No.	D41072	Drawn By	SJ
Client	Ashwood Homes	Checked By	CEH
		Approved By	RS
Project	High Road, Weston	Scale	NTS
		Date Drawn	17/05/2023
Title	Plot 52 - Views during validation works on 03/04/2023	Revision	
		Figure No.	D41072/MV3/P5

D | Failure of joint during air lancing

E | Rewelded joint between membrane panels in Image D

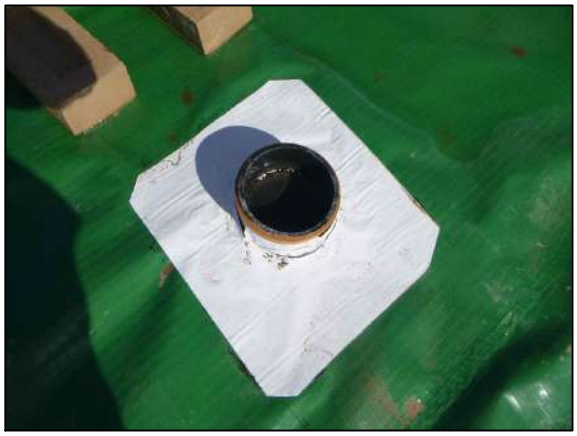
A | View of installed membrane

B | SAGRM used to seal corner

C | SAGRM used to seal service penetration

D | SAGRM used to seal corners

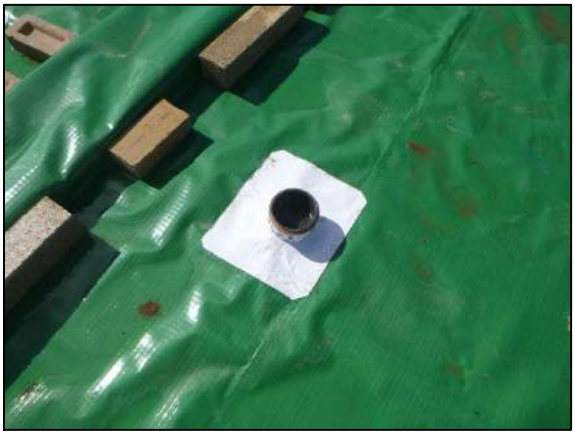
B | View of installed airbrick

C | SAGRM used to seal corner

D | SAGRM used to seal service penetration

E | Membrane extending across party wall between Plots 54 and 55
