Our ref: D41072/MV4/CEH

Re: High Road, Weston (Membrane Validation Works – Plots 24, 25 and 31 to 38)

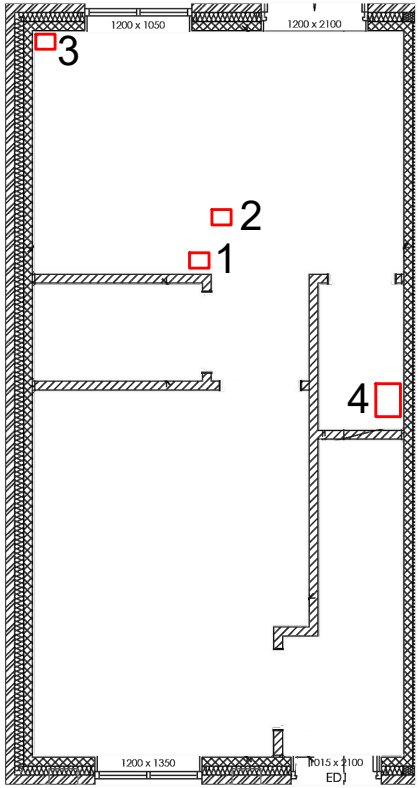
Project No.	D41072
Client	Ashwood Homes
Project	High Road, Weston
Title	Membrane Validation of Plot 24
Drawn By	SJ
Checked By	CEH
Approved By	RS
Scale	NTS
Date Drawn	30/06/2023
Revision	
Figure No.	D41072/MV4/D1

SUMMARY OF DEFECTS				
Defect No.	**Date of Inspection**	**Description**	**Repair**	**Date of Reinspection**
1	26/06/2023	Puncture	SAGRM patch (heat sealed)	26/06/2023
2	26/06/2023	Puncture	SAGRM patch (heat sealed)	26/06/2023
3	26/06/2023	Incomplete weld on corner detail	SAGRM patch (heat sealed)	26/06/2023
4	26/06/2023	Thermal block sunken through beams	Membrane cut to enable replacement of block and SAGRM patch (heat sealed)	26/06/2023

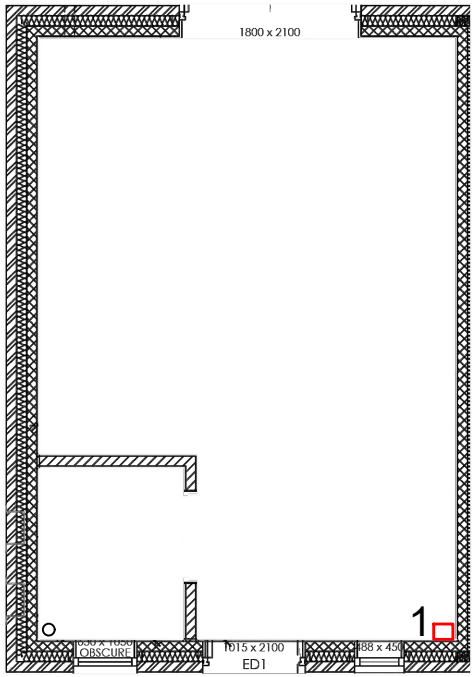
Project No.	D41072
Client	Ashwood Homes
Project	High Road, Weston
Title	Membrane Validation of Plot 31
Drawn By	SJ
Checked By	CEH
Approved By	RS
Scale	NTS
Date Drawn	30/06/2023
Revision	
Figure No.	D41072/MV4/D3

SUMMARY OF DEFECTS				
Defect No.	**Date of Inspection**	**Description**	**Repair**	**Date of Reinspection**
1	26/06/2023	Incomplete weld on corner detail	SAGRM patch (heat sealed)	26/05/2023

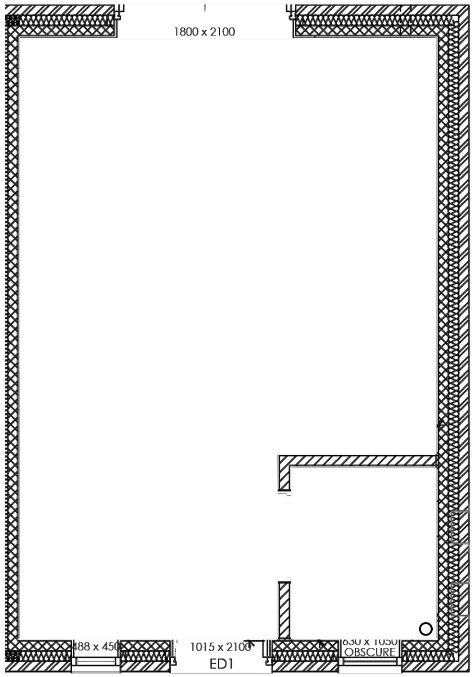
SUMMARY OF DEFECTS				
Defect No.	**Date of Inspection**	**Description**	**Repair**	**Date of Reinspection**
-	26/06/2023	No Defects identified	-	-

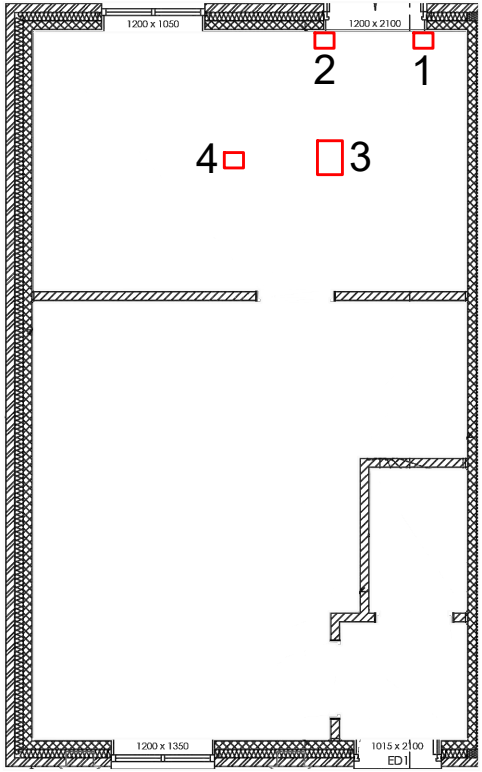
Project No.	D41072
Client	Ashwood Homes
Project	High Road, Weston
Title	Membrane Validation of Plot 33
Drawn By	SJ
Checked By	CEH
Approved By	RS
Scale	NTS
Date Drawn	30/06/2023
Revision	
Figure No.	D41072/MV4/D5

SUMMARY OF DEFECTS				
Defect No.	**Date of Inspection**	**Description**	**Repair**	**Date of Reinspection**
1	26/06/2023	Incomplete weld on corner detail	SAGRM patch (heat sealed)	26/06/2023
2	26/06/2023	Incomplete weld on corner detail	SAGRM patch (heat sealed)	26/06/2023
3	26/06/2023	Thermal block sunken through beams	Membrane cut to enable replacement of block and reseealed with SAGRM patch (heat sealed)	26/06/2023
4	26/06/2023	Puncture	SAGRM patch (heat sealed)	26/06/2023

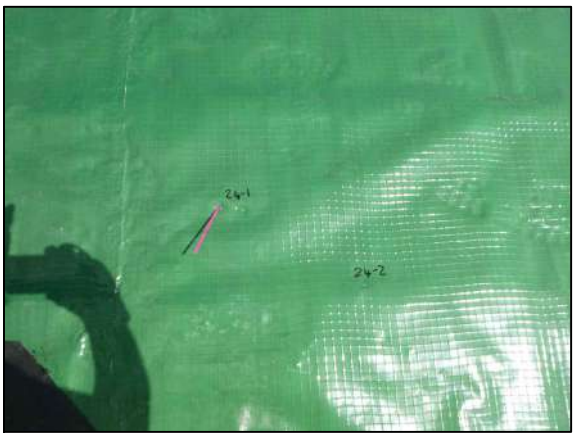
D | Punctures

E | SAGRM patches to repair defects in Image D

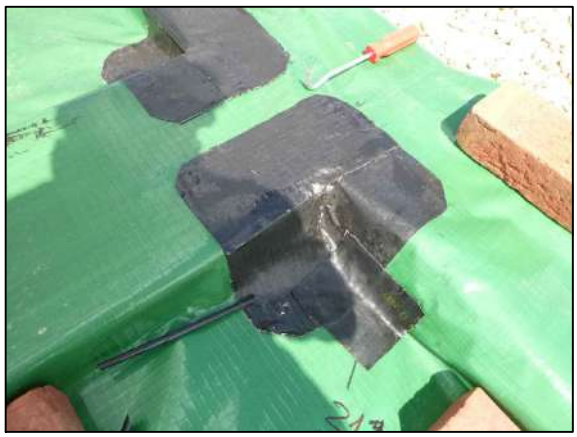
Project No.	D41072	Drawn By	SJ
Client	Ashwood Homes	Checked By	CEH
		Approved By	RS
Project	High Road, Weston	Scale	NTS
		Date Drawn	30/06/2023
Title	Plot 31 - Views during validation works on 26/06/2023	Revision	
		Figure No.	D41072/MV4/P3

D | Incomplete seal on corner detail

E | SAGRM patch to repair defect in Image D

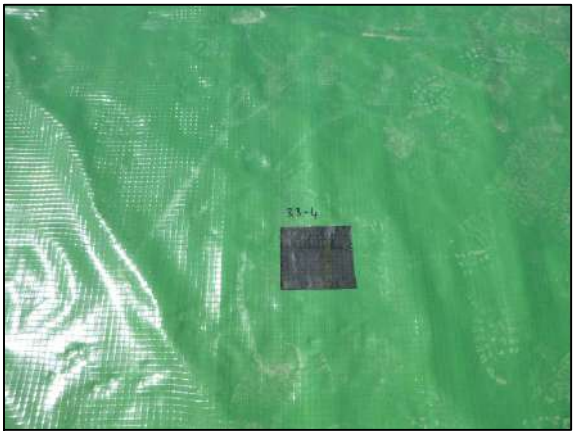
D | SAGRM patch to repair puncture

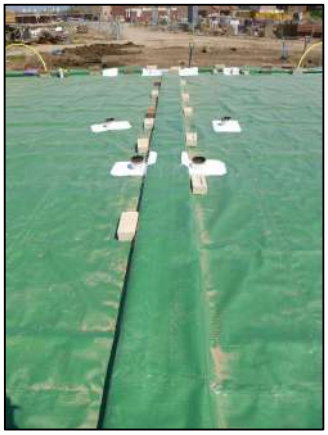
Plot No. 37

A | View of installed membrane

B | Membrane extending over party wall between Plots 37 and 38

C | SAGRM used to seal corner
