Geotechnical & Environmental Consultants

Our ref: D41072/MV6/CEH

Re: High Road, Weston (Membrane Validation Works – Plots 9, 18 to 21 and 39 to 42)

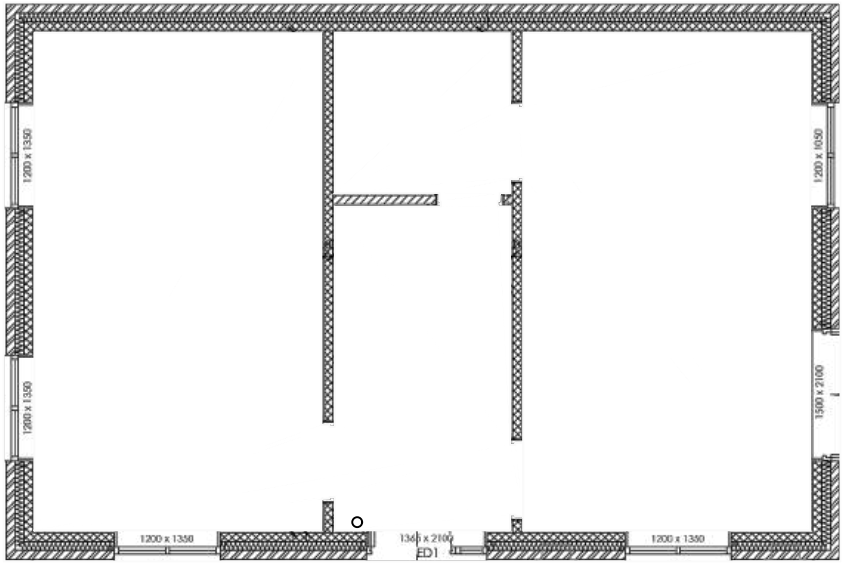
Project No.	D41072
Client	Ashwood Homes
Project	High Road, Weston
Title	Membrane Validation of Plot 9
Drawn By	SJ
Checked By	CEH
Approved By	RS
Scale	NTS
Date Drawn	12/03/2024
Revision	
Figure No.	D41072/MV6/D1

SUMMARY OF DEFECTS				
Defect No.	**Date of Inspection**	**Description**	**Repair**	**Date of Reinspection**
-	11/03/2024	No Defects identified	-	-

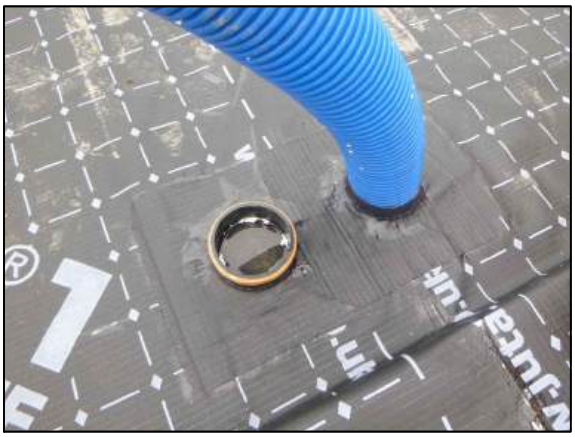
Plot No. 9

A | View of installed membrane

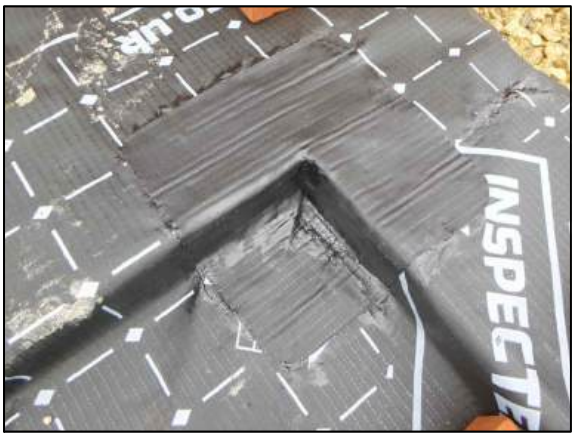
B | SAGRM used to seal service penetrations

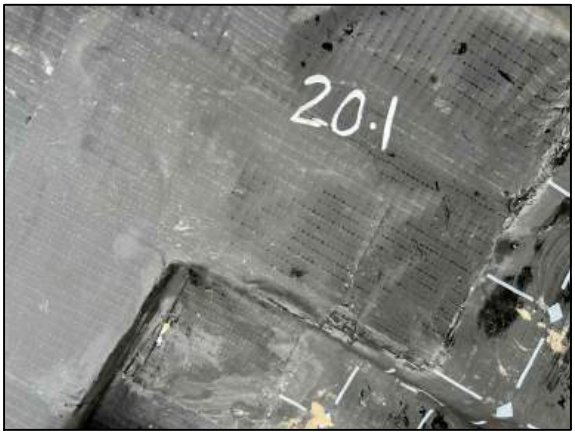
Plot No. 20

A View of installed membrane

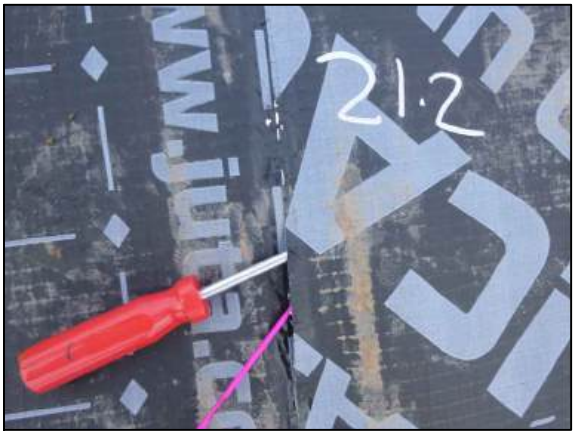
D	Incomplete weld between membrane panels

E	SAGRM patch to repair defect in Image D

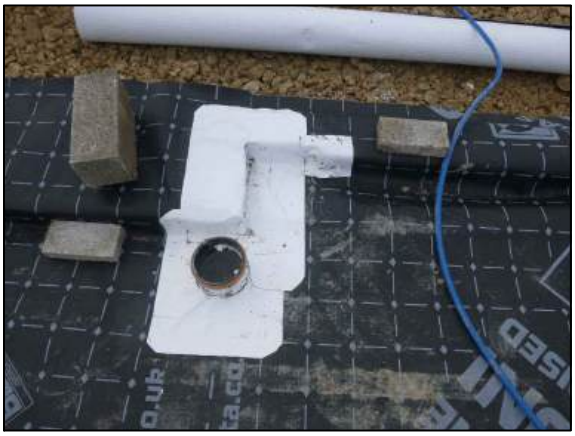
Plot No. 40

A | View of installed membrane

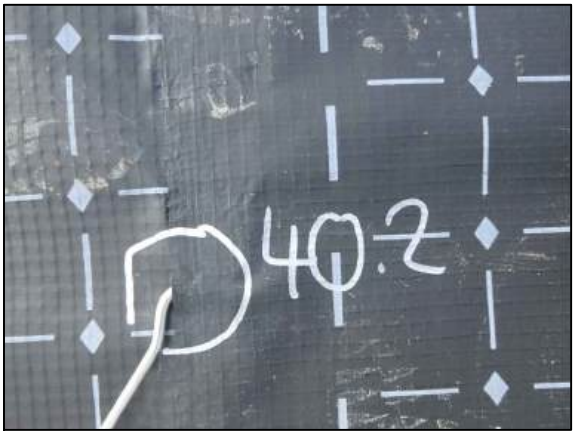
D | Incomplete weld between membrane panels

E | SAGRM patch to repair defect in Image D

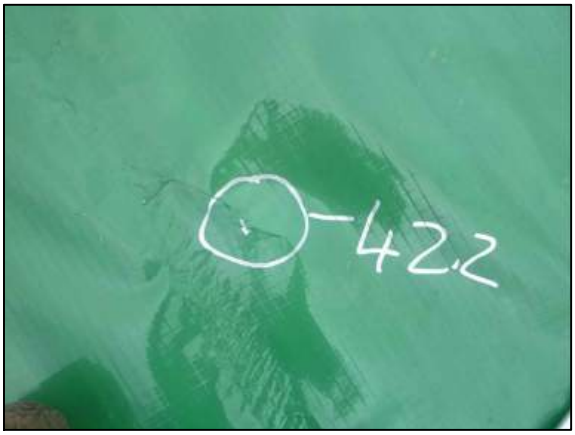
D | Damage to membrane exposing aluminium layer

E | SAGRM patch to repair damage in Image D
