Geotechnical & Environmental Consultants

Our ref: D41072/MV7/CEH

Re: High Road, Weston (Membrane Validation Works – Plots 10 to 17, 56 and 57)

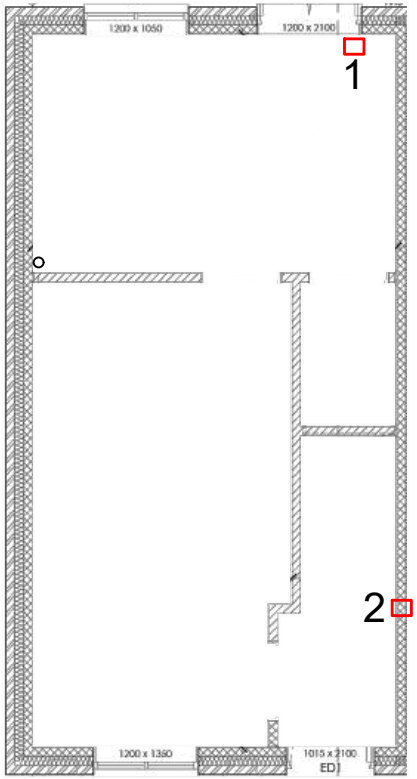
Project No.	D41072
Client	Ashwood Homes
Project	High Road, Weston
Title	Membrane Validation of Plot 10
Drawn By	SJ
Checked By	CEH
Approved By	RS
Scale	NTS
Date Drawn	28/06/2024
Revision	
Figure No.	D41072/MV7/D1

SUMMARY OF DEFECTS				
Defect No.	**Date of Inspection**	**Description**	**Repair**	**Date of Reinspection**
1	22/04/2024	Incomplete weld on corner detail	SAGRM patch (heat welded)	22/04/2024
2	22/04/2024	Membrane damaged (aluminium layer exposed)	SAGRM patch (heat welded)	22/04/2024

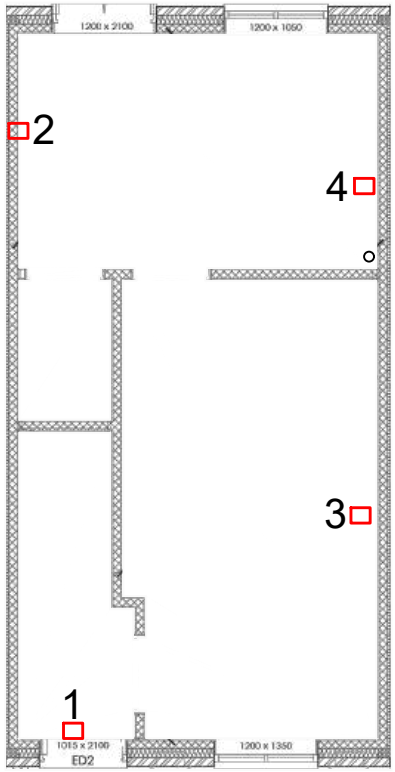
Project No.	D41072
Client	Ashwood Homes
Project	High Road, Weston
Title	Membrane Validation of Plot 11
Drawn By	SJ
Checked By	CEH
Approved By	RS
Scale	NTS
Date Drawn	28/06/2024
Revision	
Figure No.	D41072/MV7/D2

SUMMARY OF DEFECTS				
Defect No.	**Date of Inspection**	**Description**	**Repair**	**Date of Reinspection**
1	22/04/2024	Incomplete weld on corner detail	SAGRM patch (heat sealed)	22/04/2024
2	22/04/2024	Tear in weld between membrane panels	SAGRM patch (heat sealed)	22/04/2024
3	22/04/2024	Membrane damaged (aluminium layer exposed)	SAGRM patch (heat sealed)	22/04/2024
4	22/04/2024	Tear in weld between membrane panels	SAGRM patch (heat sealed)	22/04/2024

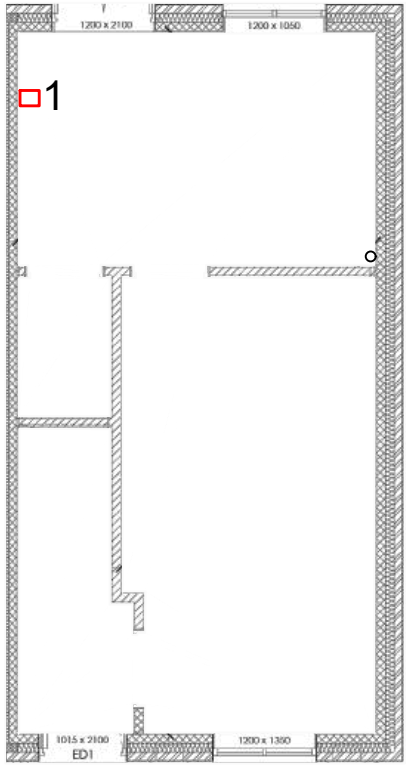
Project No.	D41072
Client	Ashwood Homes
Project	High Road, Weston
Title	Membrane Validation of Plot 12
Drawn By	SJ
Checked By	CEH
Approved By	RS
Scale	NTS
Date Drawn	28/06/2024
Revision	
Figure No.	D41072/MV7/D3

SUMMARY OF DEFECTS				
Defect No.	**Date of Inspection**	**Description**	**Repair**	**Date of Reinspection**
1	22/04/2024	Tear in weld between membrane panels	SAGRM patch (heat sealed)	22/04/2024

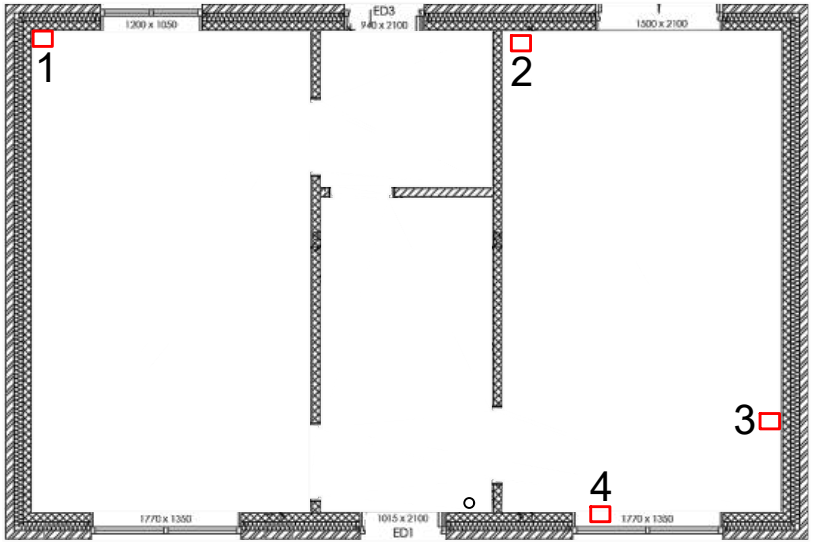
Project No.	D41072
Client	Ashwood Homes
Project	High Road, Weston
Title	Membrane Validation of Plot 13
Drawn By	SJ
Checked By	CEH
Approved By	RS
Scale	NTS
Date Drawn	28/06/2024
Revision	
Figure No.	D41072/MV7/D4

SUMMARY OF DEFECTS				
Defect No.	**Date of Inspection**	**Description**	**Repair**	**Date of Reinspection**
1	22/04/2024	Incomplete weld on corner detail	SAGRM patch (heat sealed)	22/04/2024
2	22/04/2024	Tear in weld between membrane panels	SAGRM patch (heat sealed)	22/04/2024
3	22/04/2024	Tear in weld between membrane panels	SAGRM patch (heat sealed)	22/04/2024
4	22/04/2024	Tear in weld between membrane panels	SAGRM patch (heat sealed)	22/04/2024

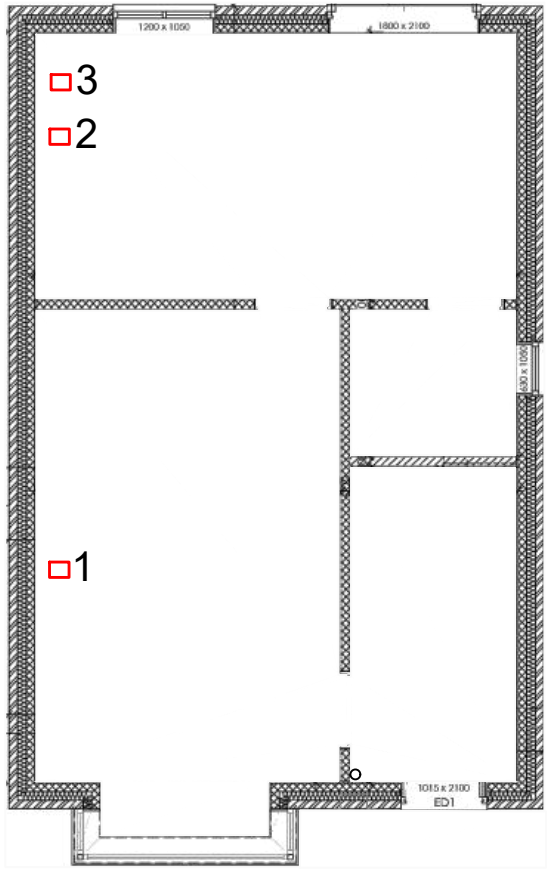
Project No.	D41072
Client	Ashwood Homes
Project	High Road, Weston
Title	Membrane Validation of Plot 15
Drawn By	SJ
Checked By	CEH
Approved By	RS
Scale	NTS
Date Drawn	28/06/2024
Revision	
Figure No.	D41072/MV7/D6

SUMMARY OF DEFECTS				
Defect No.	**Date of Inspection**	**Description**	**Repair**	**Date of Reinspection**
1	03/06/2024	Membrane damaged (aluminium layer exposed)	SAGRM patch (heat sealed)	03/06/2024
2	03/06/2024	Membrane damaged (aluminium layer exposed)	SAGRM patch (heat sealed)	03/06/2024
3	03/06/2024	Puncture	SAGRM patch (heat sealed)	03/06/2024

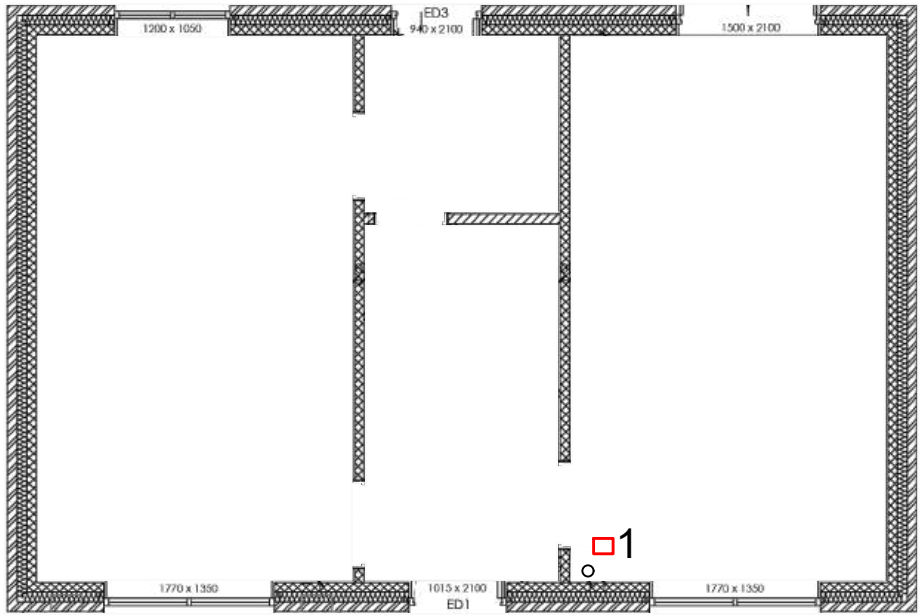
Project No.	D41072
Client	Ashwood Homes
Project	High Road, Weston
Title	Membrane Validation of Plot 16
Drawn By	SJ
Checked By	CEH
Approved By	RS
Scale	NTS
Date Drawn	28/06/2024
Revision	
Figure No.	D41072/MV7/D7

SUMMARY OF DEFECTS				
Defect No.	**Date of Inspection**	**Description**	**Repair**	**Date of Reinspection**
1	03/06/2024	Membrane damaged (aluminium layer exposed)	SAGRM patch (heat sealed)	03/06/2024

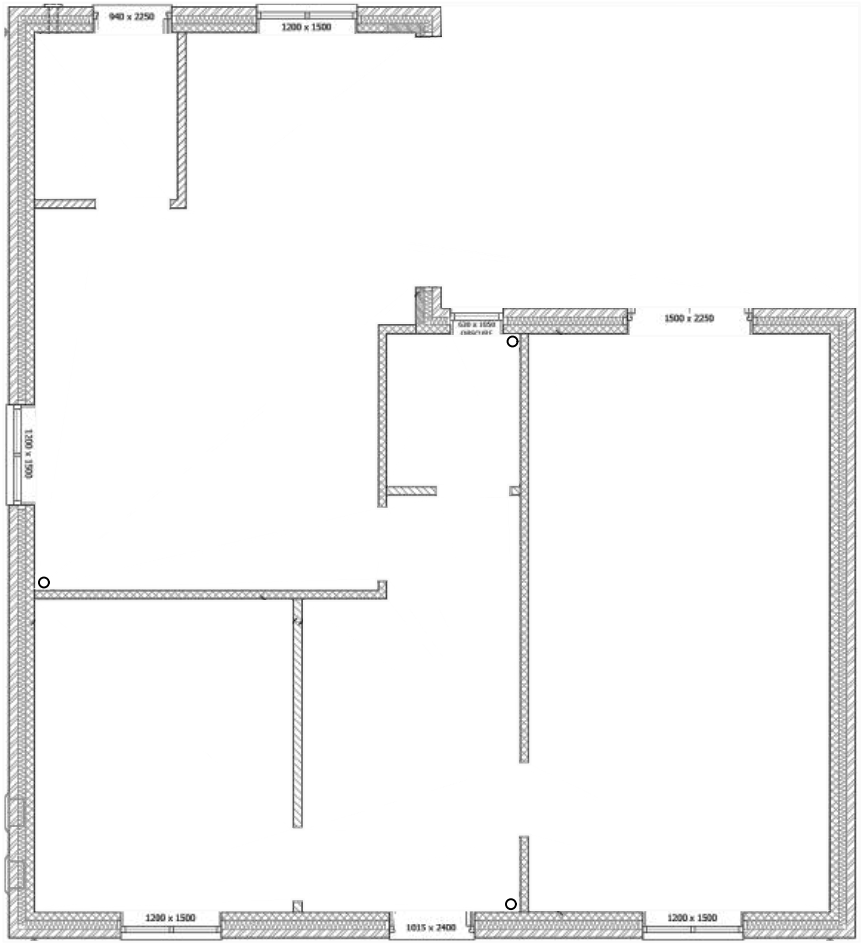
Project No.	D41072
Client	Ashwood Homes
Project	High Road, Weston
Title	Membrane Validation of Plot 17
Drawn By	SJ
Checked By	CEH
Approved By	RS
Scale	NTS
Date Drawn	28/06/2024
Revision	
Figure No.	D41072/MV7/D8

SUMMARY OF DEFECTS				
Defect No.	**Date of Inspection**	**Description**	**Repair**	**Date of Reinspection**
-	03/06/2024	No Defects identified	-	-

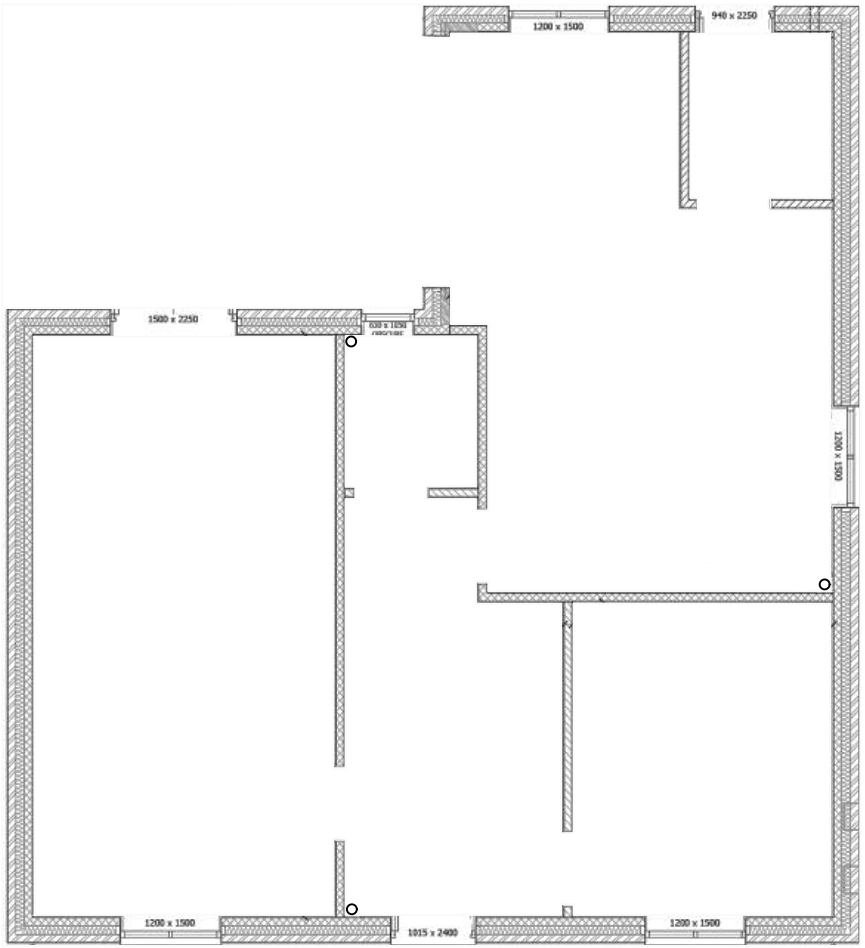
Project No.	D41072
Client	Ashwood Homes
Project	High Road, Weston
Title	Membrane Validation of Plot 56
Drawn By	SJ
Checked By	CEH
Approved By	RS
Scale	NTS
Date Drawn	28/06/2024
Revision	
Figure No.	D41072/MV7/D9

SUMMARY OF DEFECTS				
Defect No.	**Date of Inspection**	**Description**	**Repair**	**Date of Reinspection**
-	28/06/2024	No Defects identified	-	-

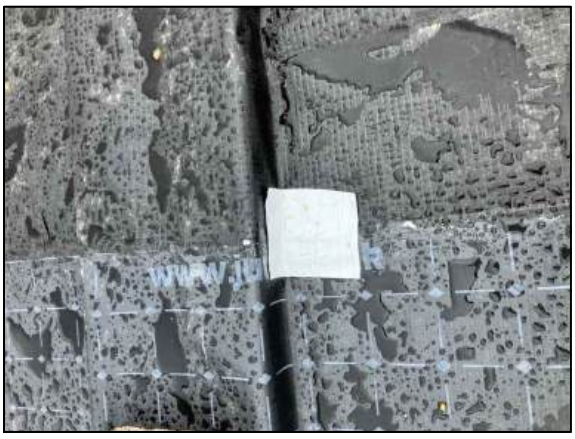
Project No.	D41072	Drawn By	SJ
Client	Ashwood Homes	Checked By	CEH
		Approved By	RS
Project	High Road, Weston	Scale	NTS
		Date Drawn	28/06/2024
Title	Plot 12 - Views during validation works on 22/04/2024	Revision	
		Figure No.	D41072/MV7/P3

D | Tear in weld between membrane panels

E | SAGRM patch to repair damage in Image D

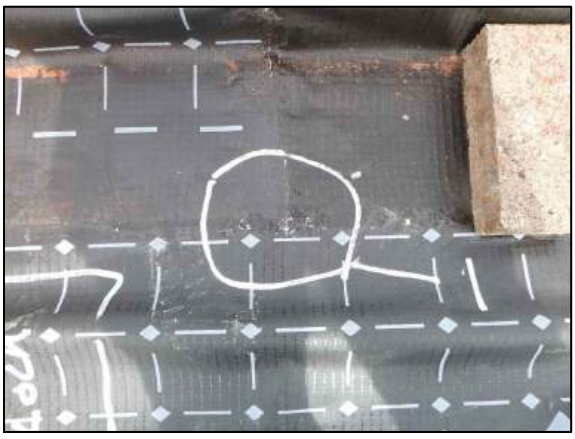
D | Damage to membrane exposing aluminium layer

E | SAGRM patch to repair damage in Image D
