# **Ground Gas Mitigation: Verification Inspection Report**

Pearsons Close  
(Prev. 128 Barrier Bank),  
Cowbit, Spalding, PE12 6AL

Issue 2

March 2026

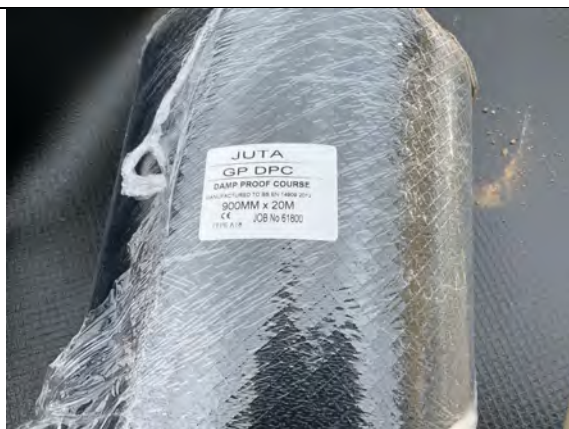
Evidence of Juta GP DPC used for perimeter & internals.

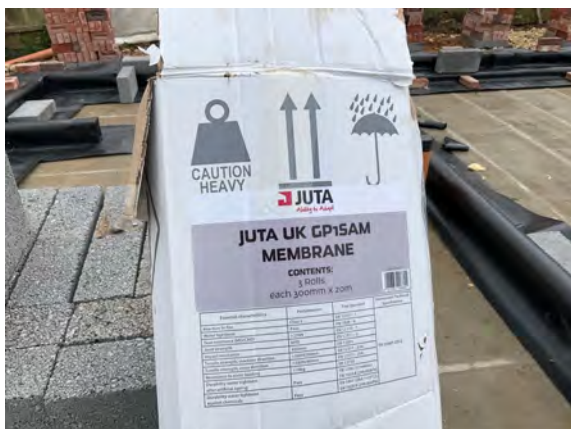
Evidence of Juta GP1 SAM used for detailing works.

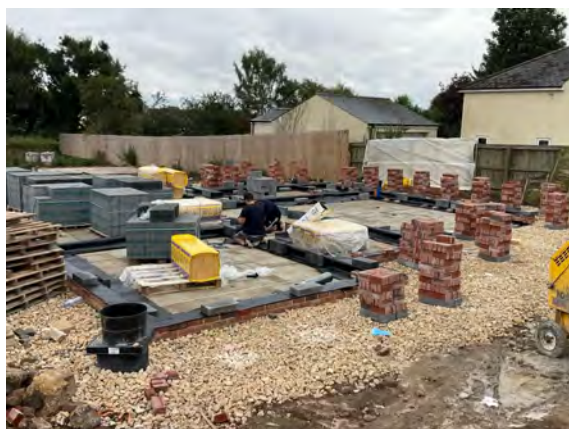
Overview of the perimeter and internal wall installation to Plot 2.

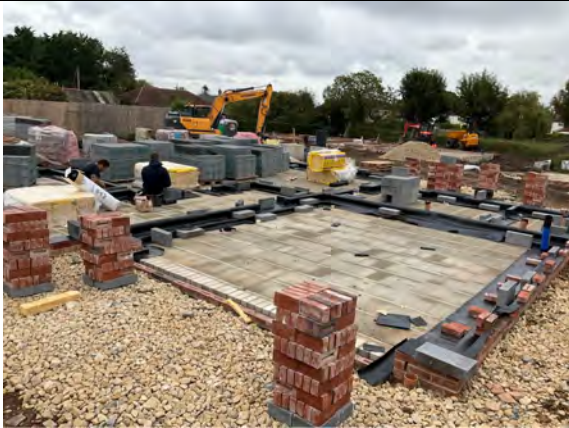
An alternative overview of the perimeter and internal wall installation to Plot 2.

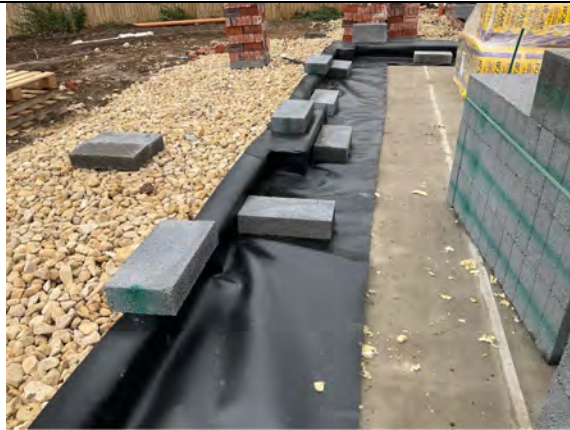
Overview of perimeter installation along external cavity wall.

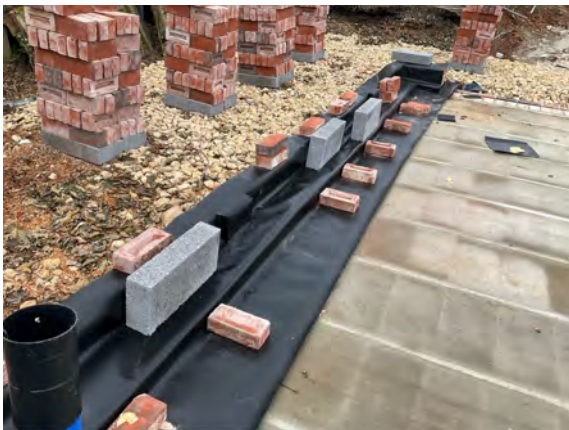
Perimeter installation using Juta GP DPC.

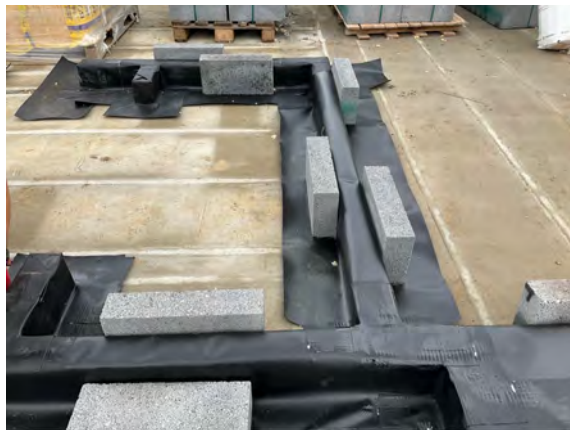
Overview of internal masonry wall installation using Juta GP DPC.

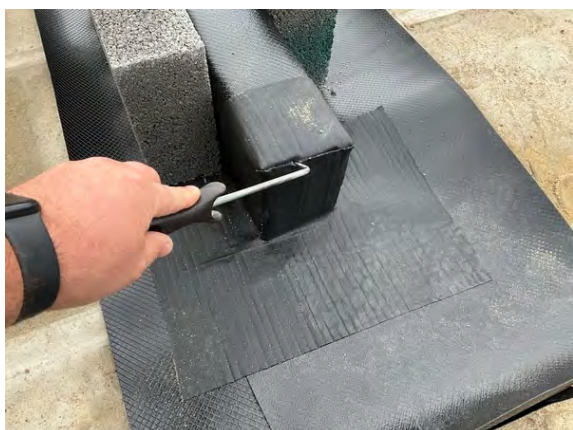
Probe testing to internal wall corner detailing.

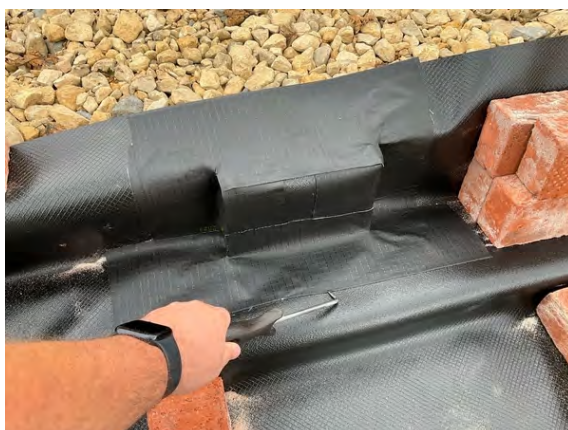
Probe testing to cavity vent detailing.

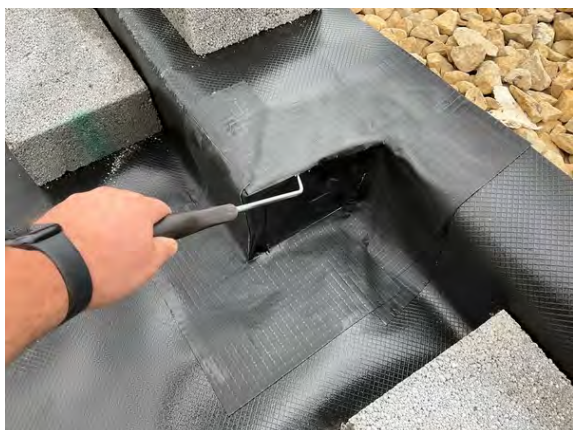
Probe testing to door threshold detailing.

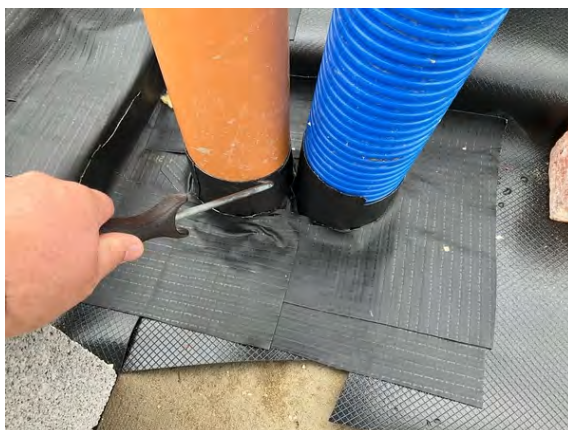
Probe testing to pipe penetration detailing.

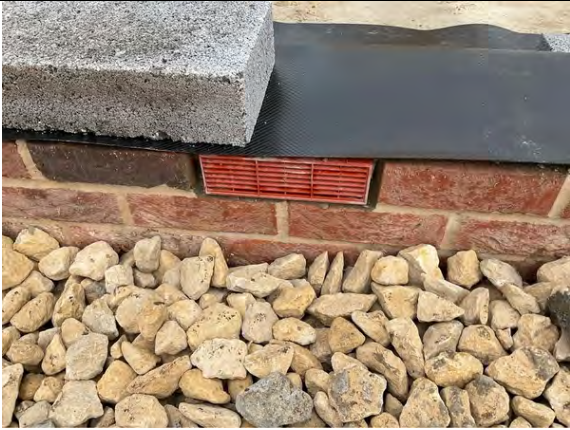
Cavity vents in place below Juta GP DPC installation  
at time of inspection.

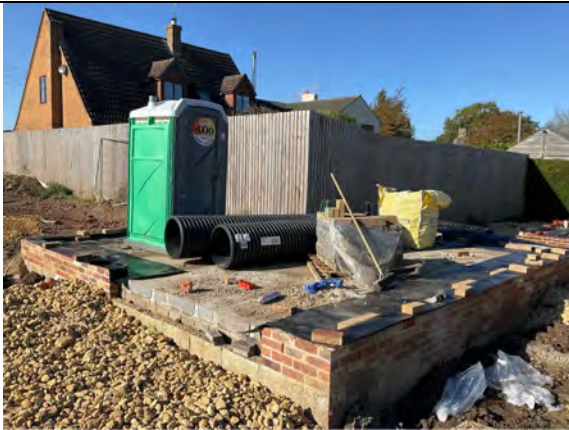
Overview of the perimeter installation to Plot 1  
Garage.

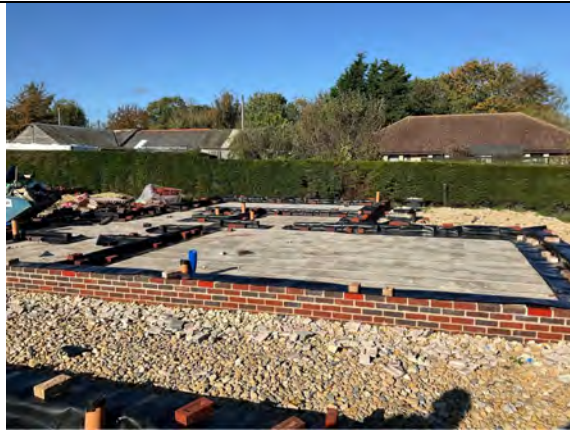
Overview of the perimeter installation to Plot 3.

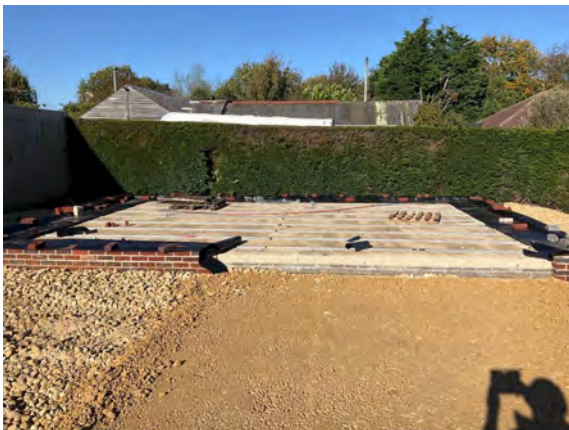
Overview of the perimeter installation to Plot 3  
Garage.

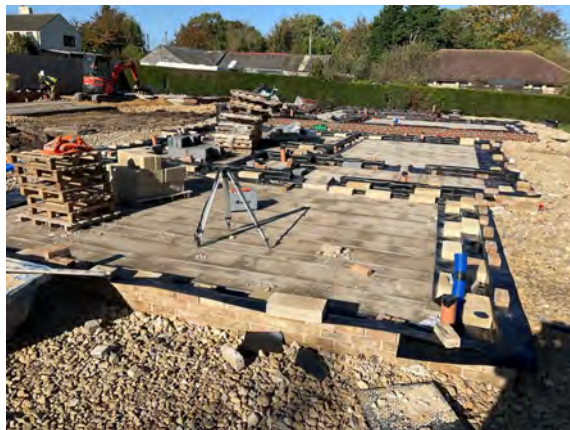
Overview of the perimeter installation to Plot 4.

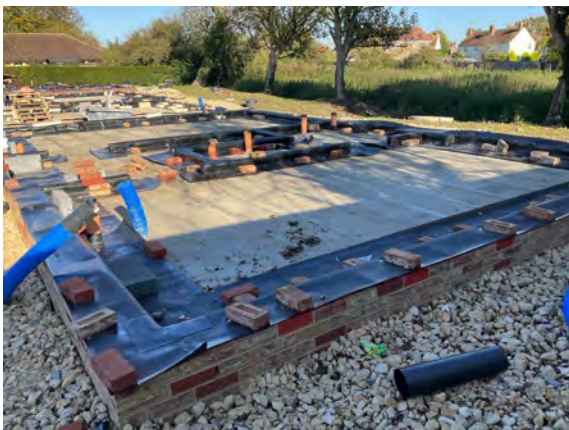
Overview of the perimeter installation to Plot 5.

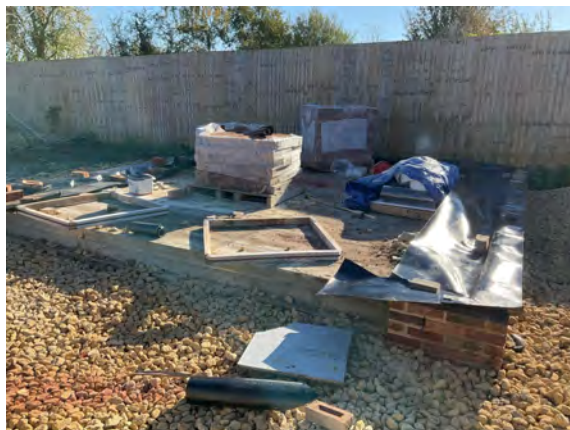
Overview of the perimeter installation to Plot 5  
Garage.

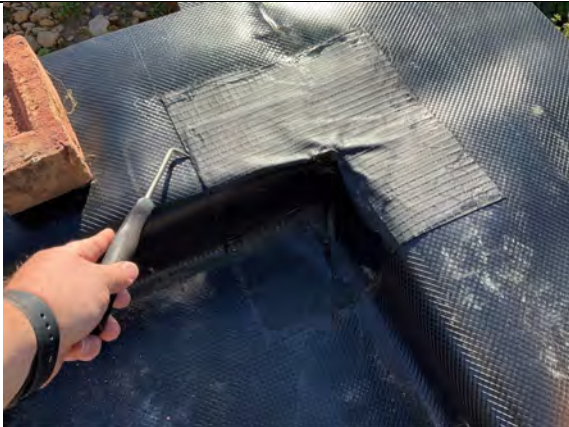
Plot 1. Probe testing to corner detailing.

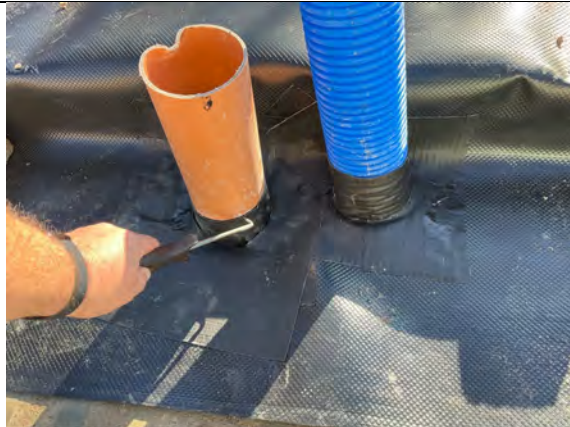
Plot 1. Probe testing to pipe penetration detailing.

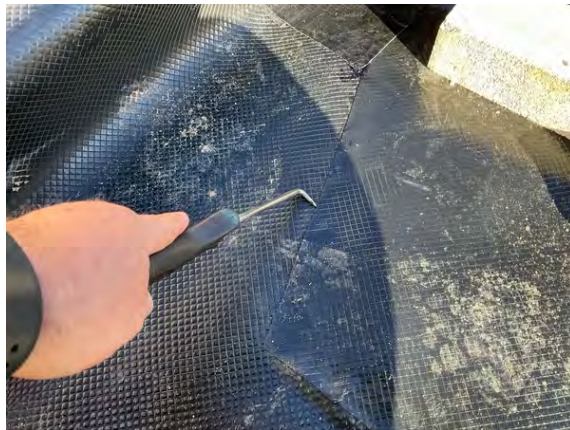
Plot 1. Probe testing along hand welded membrane lap joint.

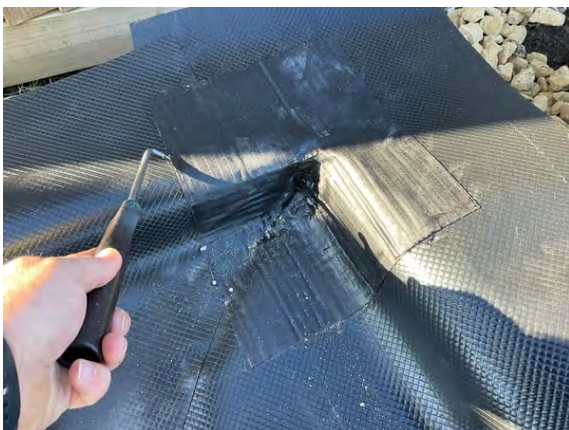
Plot 1 Garage. Probe testing to corner detailing.

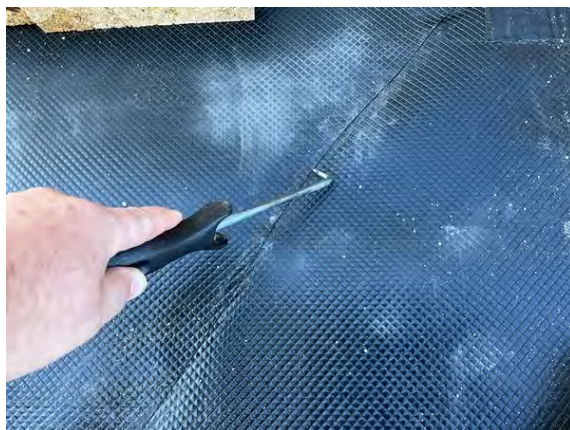
Plot 1 Garage. Probe testing along hand welded membrane lap joint.

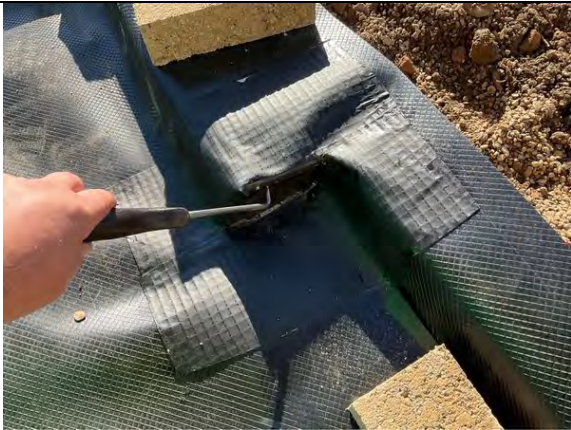
Plot 1 Garage. Probe testing to door threshold detailing.

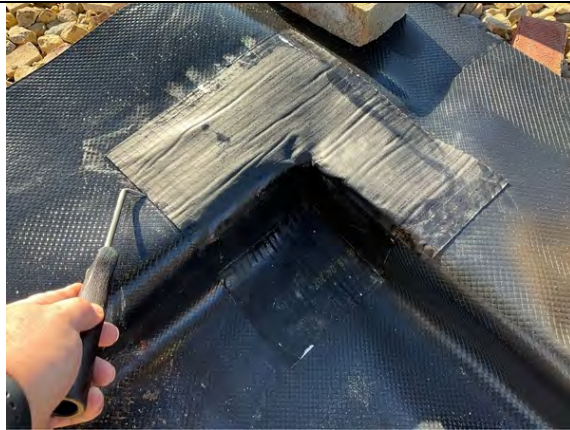
Plot 3. Probe testing to corner detailing.

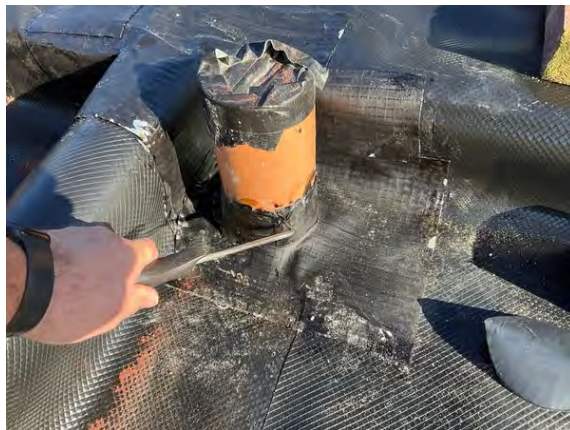
Plot 3. Probe testing to pipe penetration detailing.

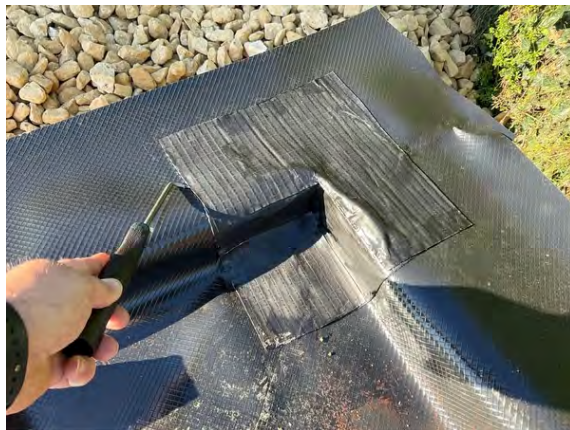
Plot 3 Garage. Probe testing to corner detailing.

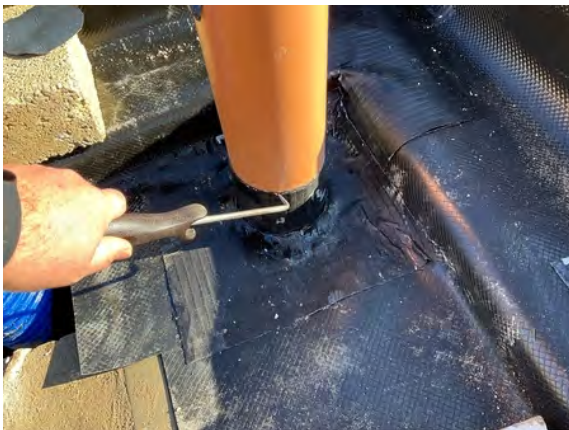
Plot 4. Probe testing to pipe penetration detailing.

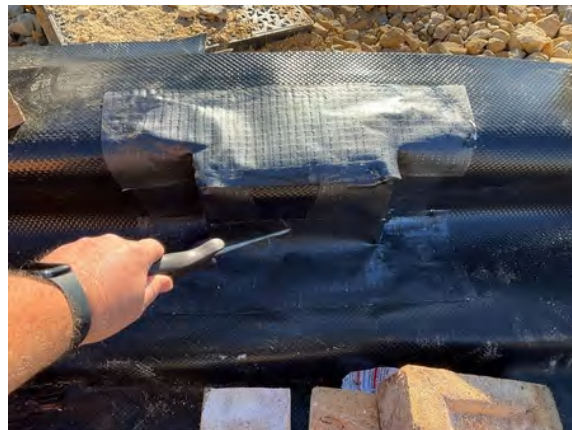
Plot 4. Probe testing to cavity vent detailing.

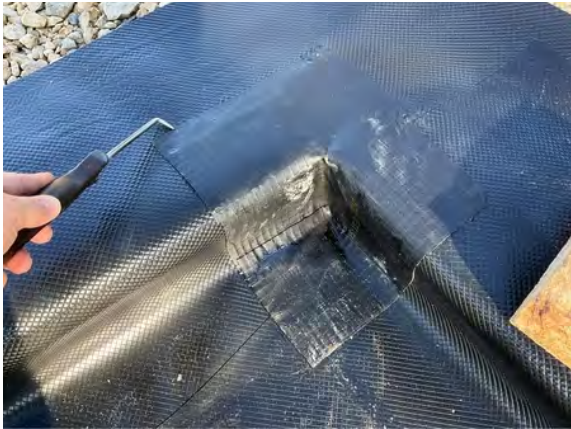
Plot 5. Probe testing to door threshold detailing.

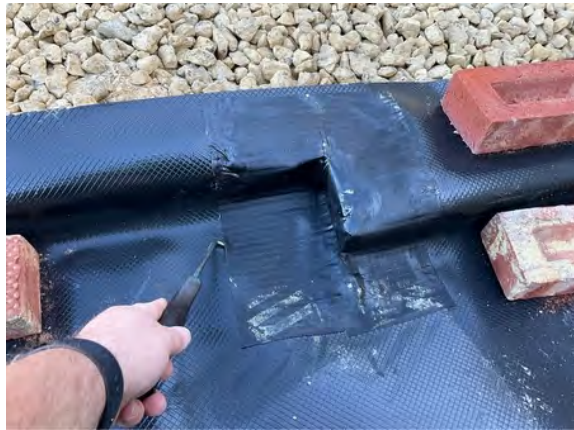
Plot 5. Probe testing along hand welded membrane lap joint.

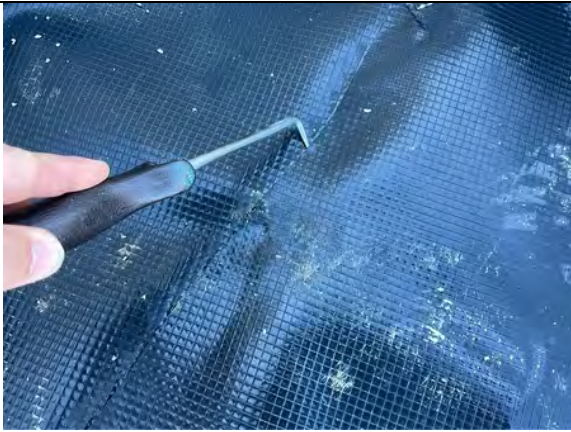
Plot 5 Garage. Probe testing to door threshold detailing.

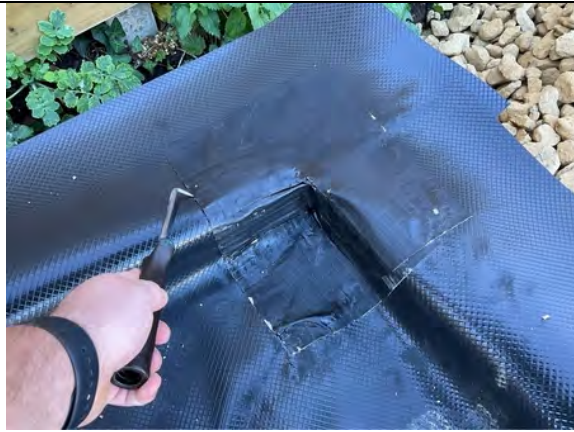
Plot 5 Garage. Probe testing along hand welded membrane lap joint.

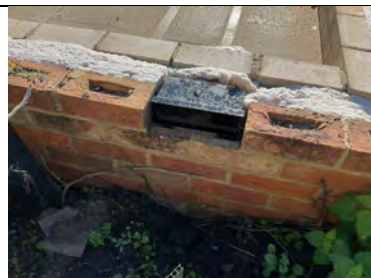
| (Section 1, Materials and Method of Seal) | |
|---|---|
| Plot 1: Advisory, air bricks were not in place at time of MEC inspection. | No defects recorded and therefore no action required. |

Plot 1. Telescopic vents in place.  
*Note: Air bricks were not installed at the time of inspection.*

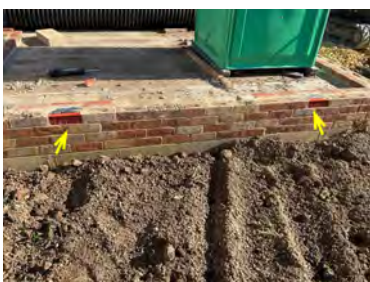
Plot 1 Garage. Telescopic vents in place.

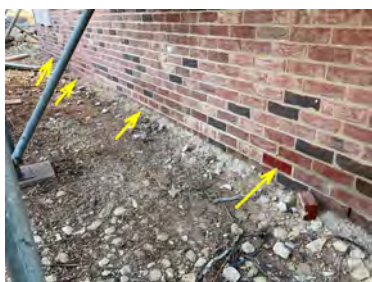
| (Section 1, Materials and Method of Seal) | |
|---|---|
| Plot 2: Advisory, 2x telescopic vents missing due to coordination issues on site. | |

Plot 2. Telescopic vents in place.

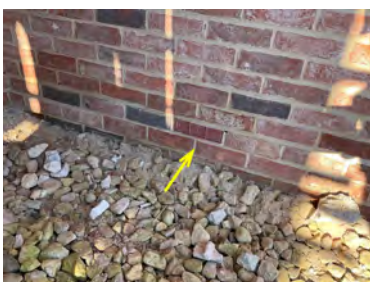
Plot 2. Telescopic vents in place.

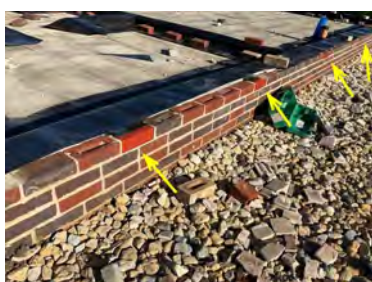
Plot 3. Telescopic vents in place.

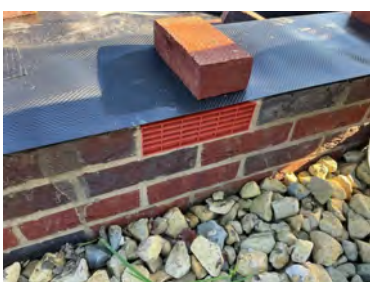
Plot 3. Telescopic vents in place.

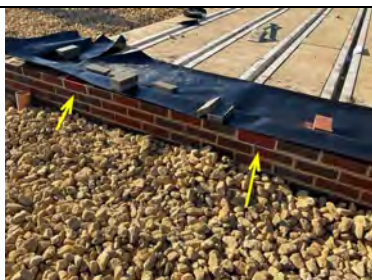
Plot 3 Garage. Telescopic vents in place.

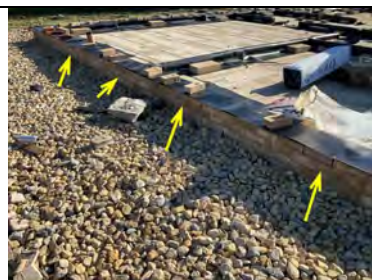
| (Section 1, Materials and Method of Seal) | |
|---|---|
| Plot 4: Advisory, 1x telescopic vent missing. | |

Plot 4. Telescopic vents in place.

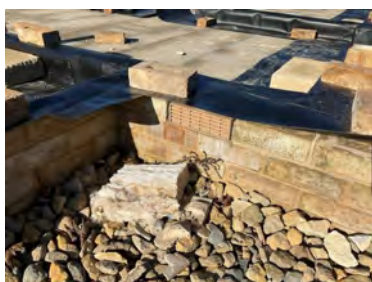
Plot 4. Telescopic vents in place.

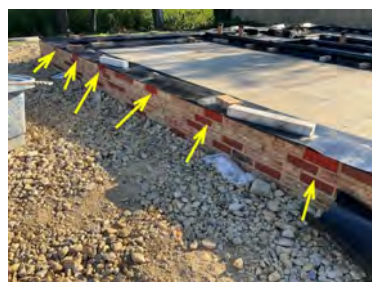
Plot 5. Telescopic vents in place.

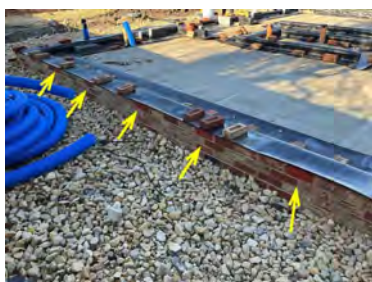
Plot 5. Telescopic vents in place.

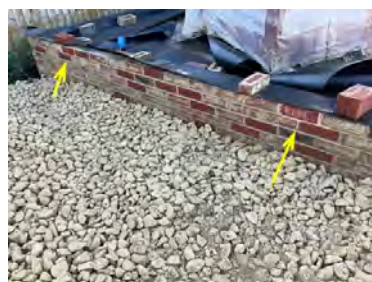
Plot 5 Garage. Telescopic vents in place.

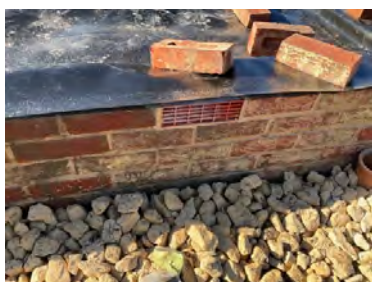
Plot 5 Garage. Telescopic vents in place.

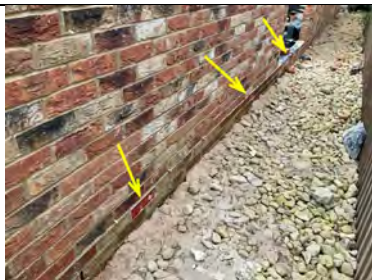
| Plot 1. Air Bricks in place along the North Elevation, but are still be completed on South Elevation (albeit telescopic vents are constructed, ready for completion). | | N/A |

Plot 1. North Elevation with Air Bricks in place at the time of inspection.

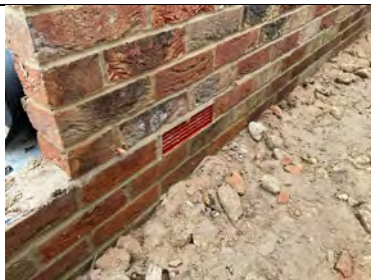
Plot 1. North Elevation Air Bricks in place.

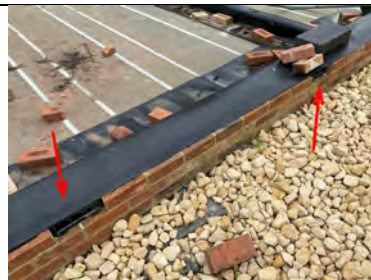
Plot 1. Air Brick still outstanding along the South Elevation, telescopic locations in position ready to receive air brick.

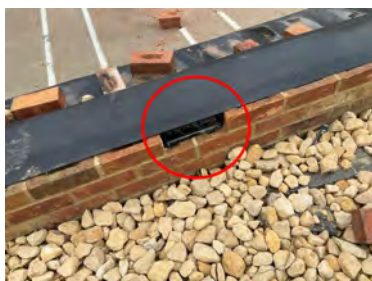
Plot 1. South Elevation Air Bricks still outstanding, telescopic locations in position ready to receive air brick.

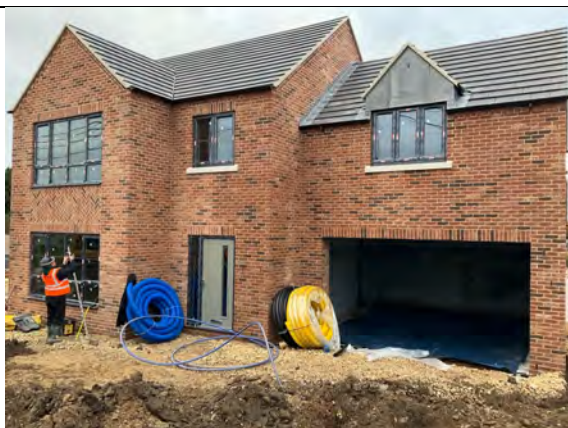
General overview of where today's inspection took place.

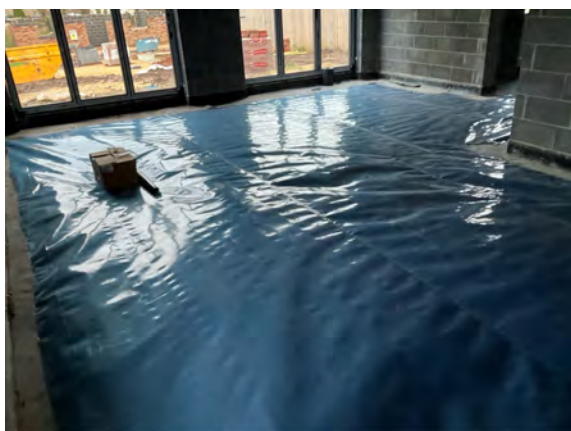
Overview of the infill installation to Kitchen/Diner.

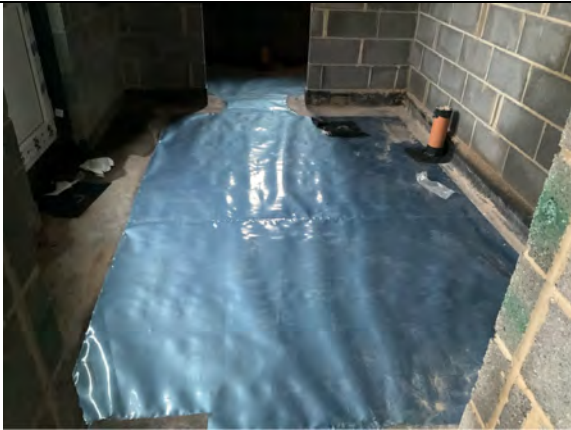
Overview of the infill installation to Utility Area.

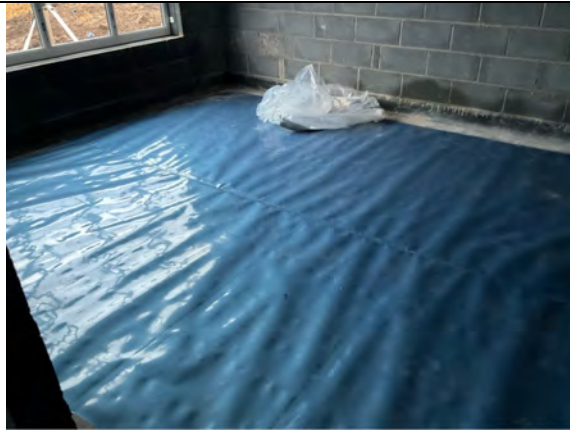
Overview of the infill installation to Lounge.

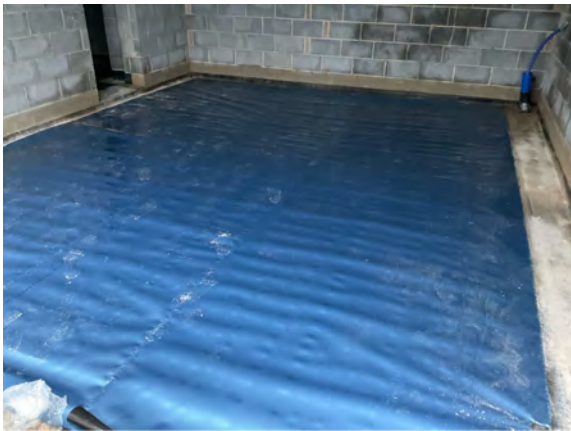
Overview of the infill installation to Garage Area.

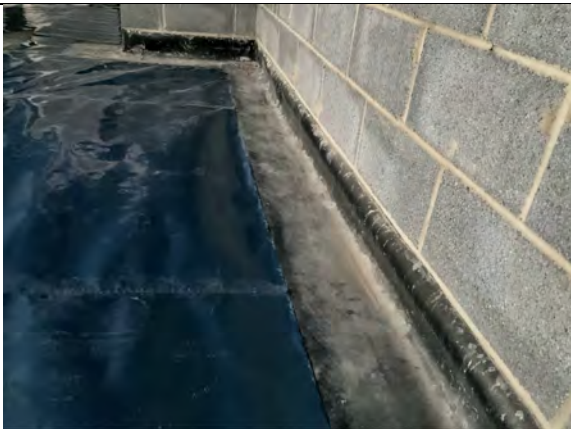
Infill Juta GP5 gas barrier hand welded to the existing perimeter membrane.

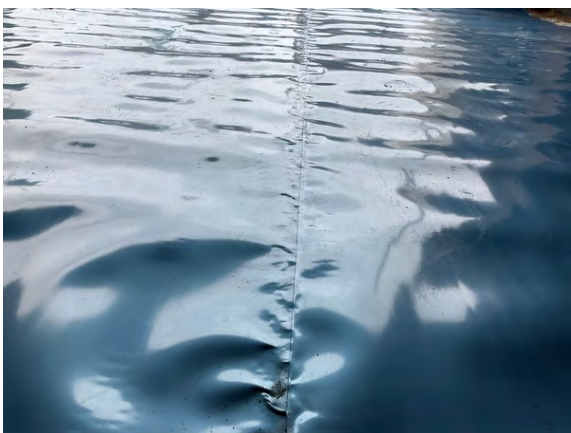
Overview of a hand welded membrane lap joint.

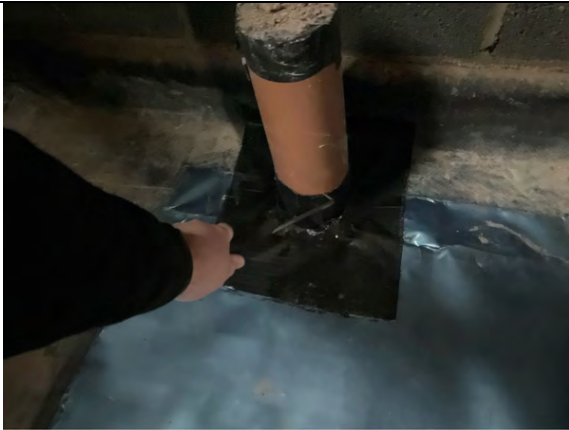
Probe testing to pipe penetration detailing.

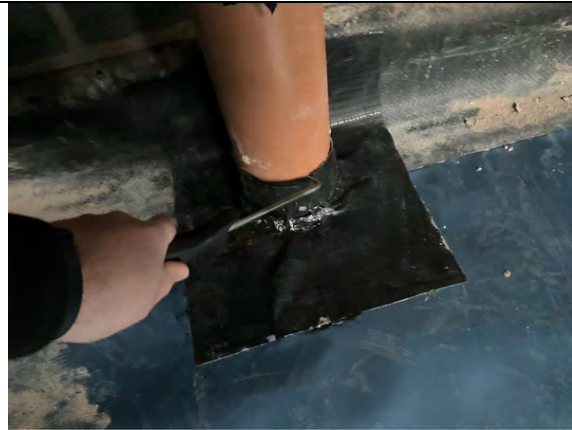
Probe testing to pipe penetration detailing.

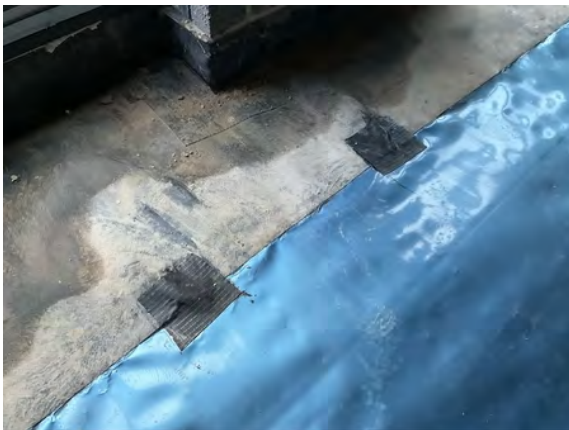
CQA patch repairs carried out by Installer using Juta GP1 SAM.

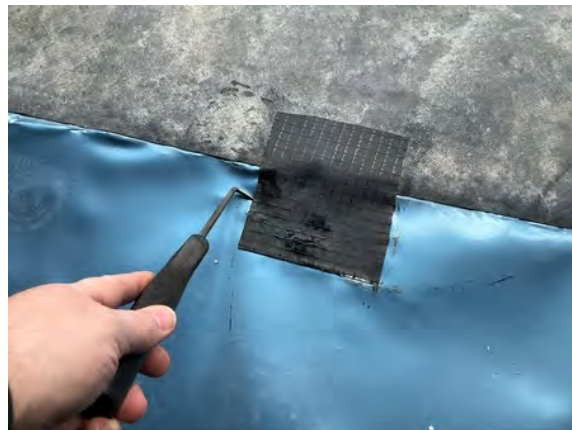
Probe testing to Installer CQA patch repairs.

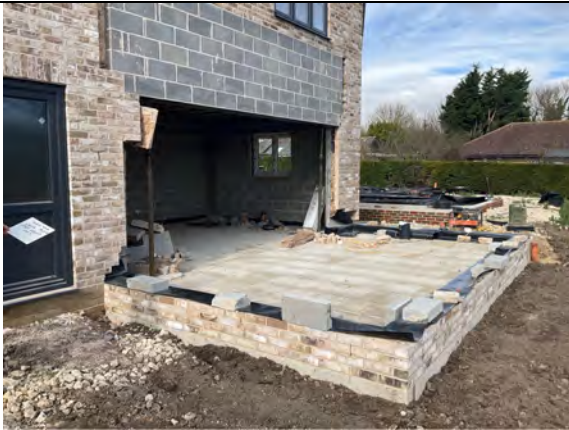
Overview of the perimeter installation to the extension.

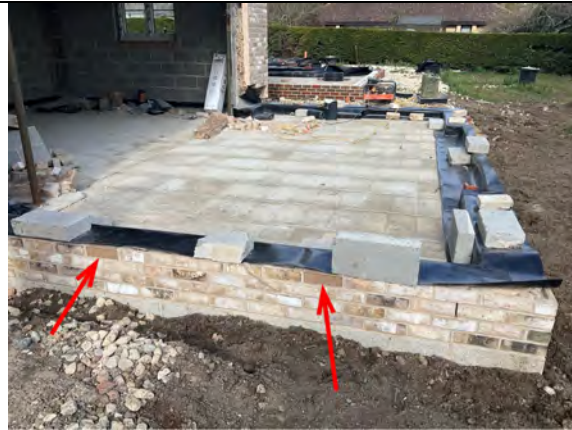
Overview of the perimeter installation to the extension and cavity vents in place below gas barrier terminated

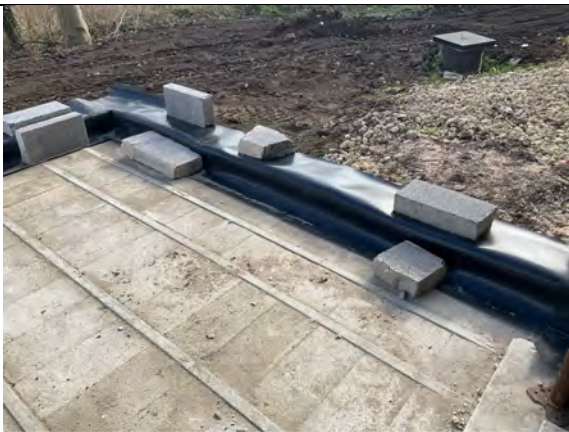
Juta GP TitanTech DPC lined along perimeter walls of extension.

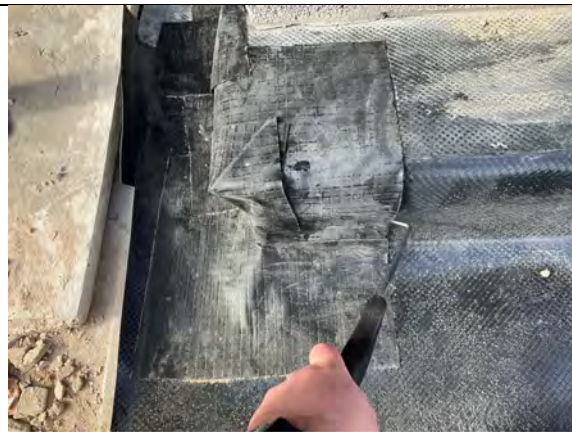
Probe testing to corner details.

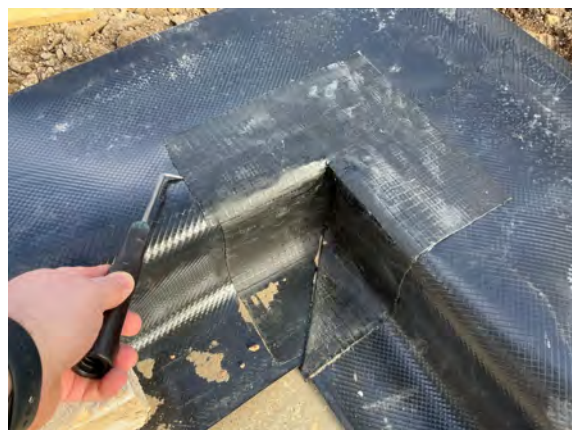
Probe testing to corner details.

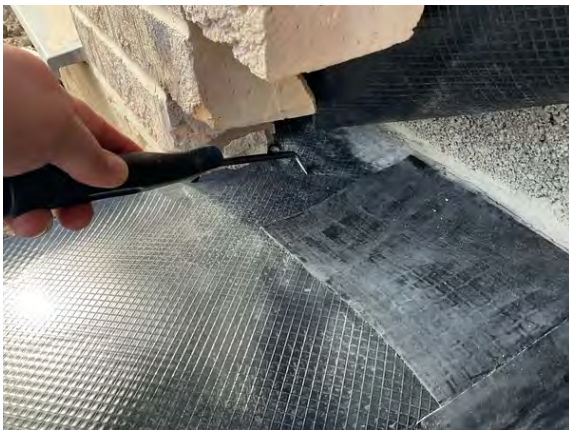
Probe testing to hand welded laps to existing perimeter membrane.

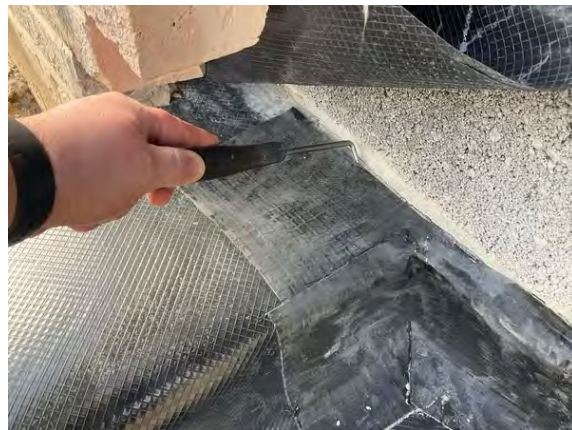
Probe testing termination of corner detail to existing perimeter membrane.

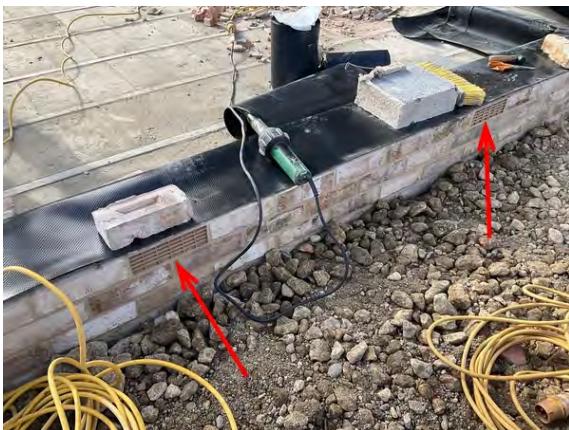
Cavity vents in place below gas barrier at time of inspection.

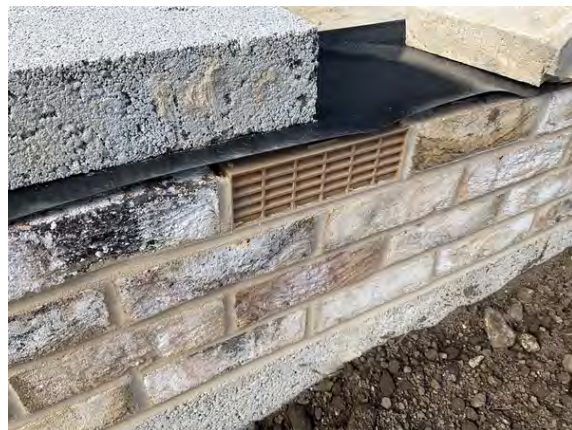
6no of cavity vents in place below gas barrier within extension perimeter.

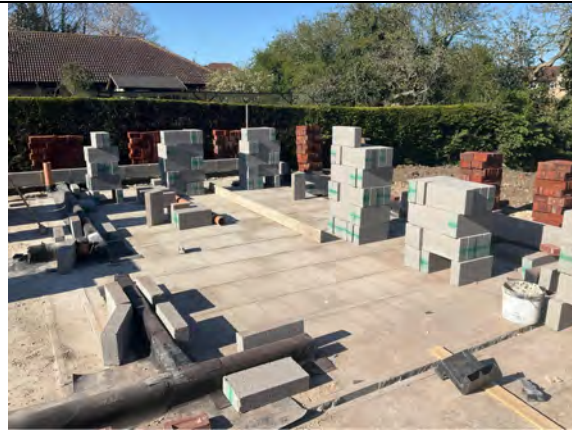
General overview of Plot 3 Extension perimeter works.

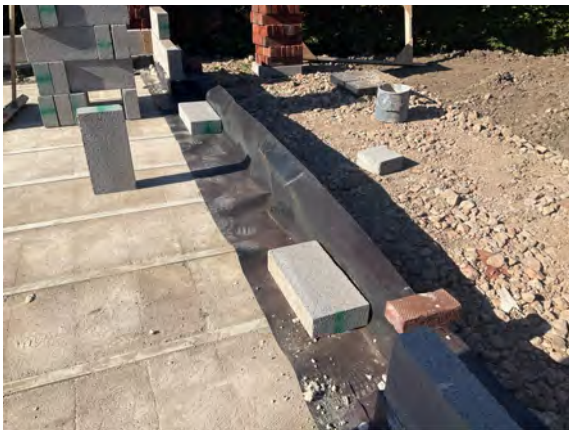
Plot 3 extension. Overview of the perimeter installation using Juta GP TitanTech DPC.

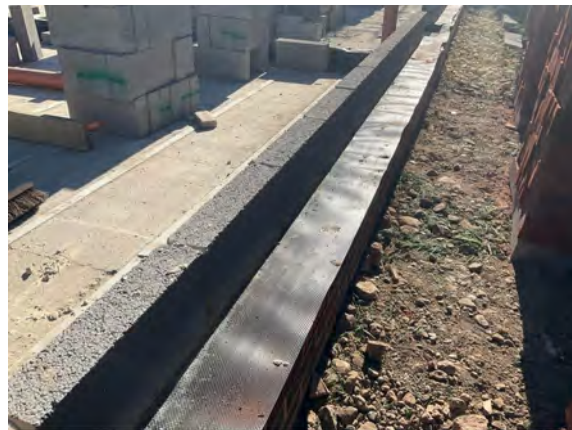
Plot 3 extension. Overview of the perimeter installation using Juta GP TitanTech DPC with cavity closure.

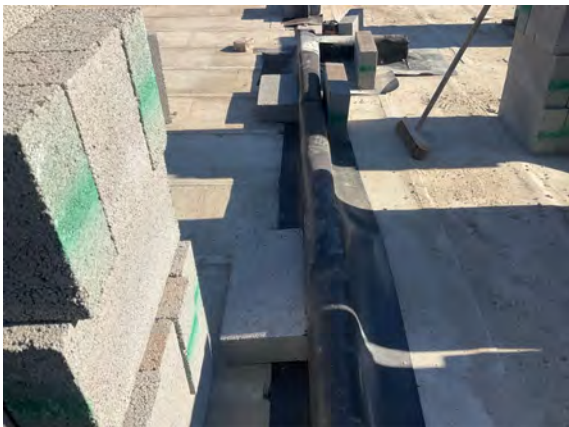
Plot 3 extension. Overview of the internal perimeter wall installation using Juta GP TitanTech DPC.

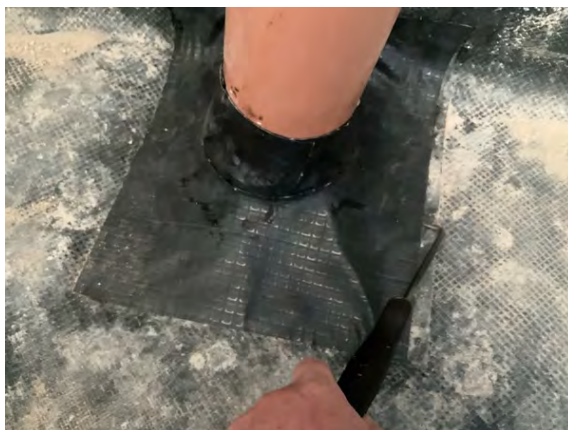
Plot 1. Probe testing to pipe penetration details.

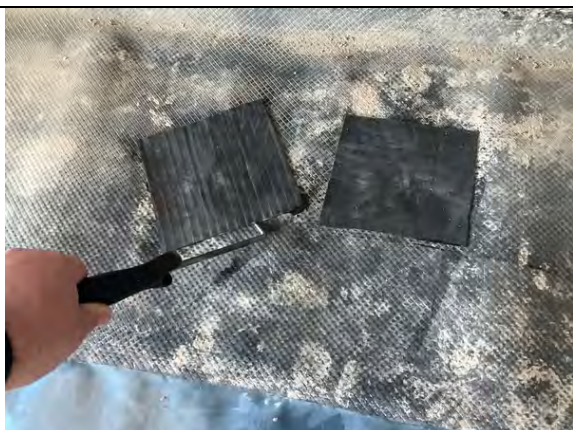
Plot 1. Probe testing to installer CQA patch repairs.

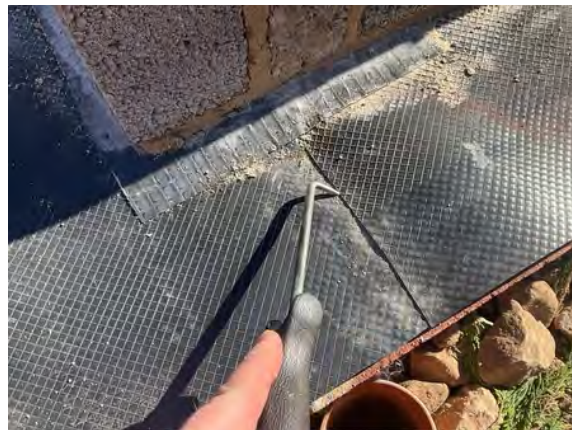
Plot 3 Extension. Probe testing along hand welded membrane lap joints.

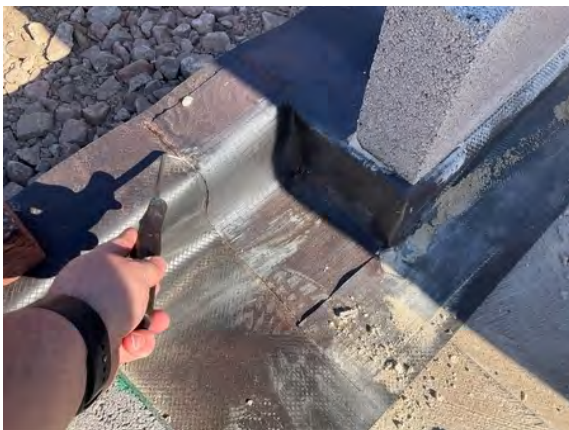
Plot 3 Extension. Probe testing to door threshold details.

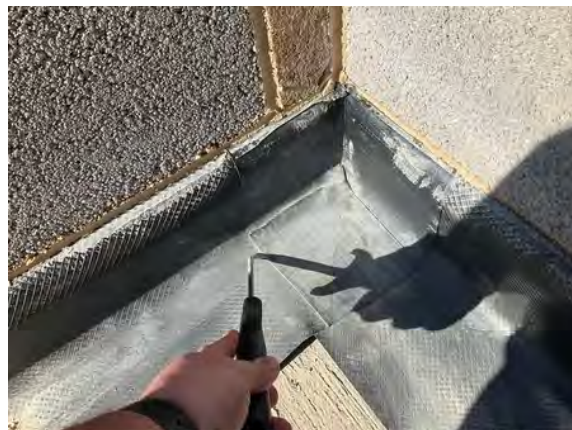
Plot 3 Extension. Probe testing to corner details.

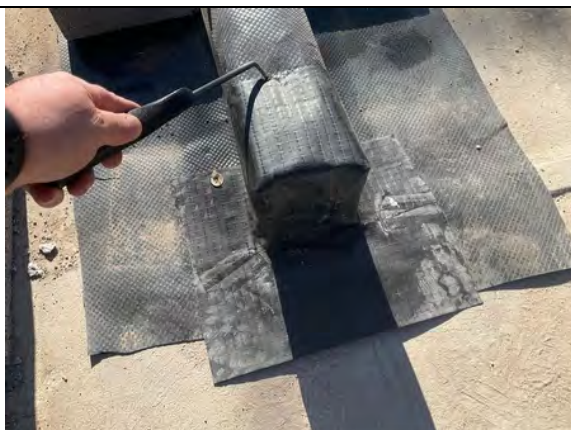
Plot 3 Extension. Probe testing to internal wall corner details.

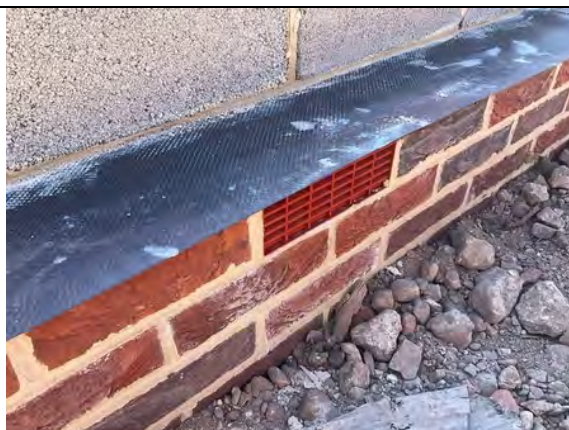
Plot 3 Extension. Cavity vents in place below gas barrier at time of inspection.

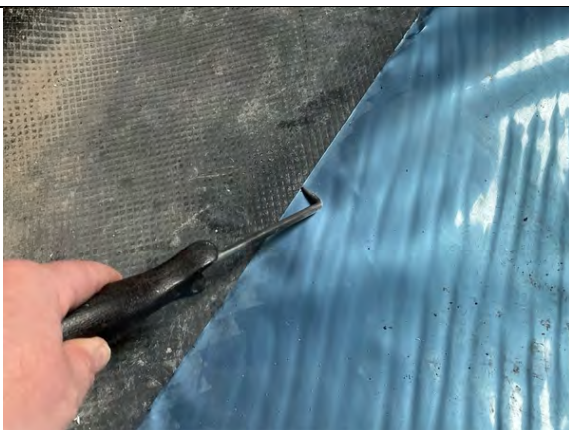
Plot 4. Probe testing to hand welded lap joints along existing perimeter edge membrane.

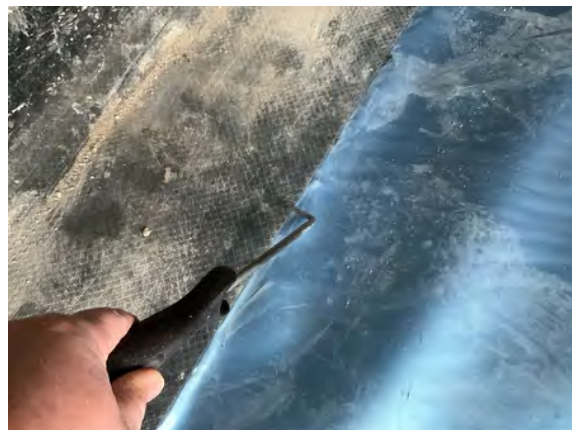
Plot 5. Probe testing to hand welded lap joints along existing perimeter edge membrane.

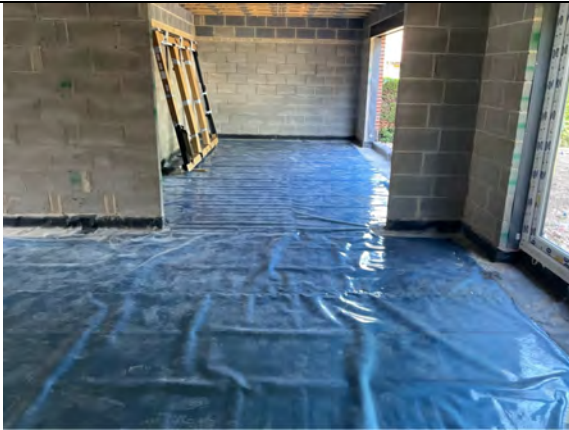
Overview of the infill installation.

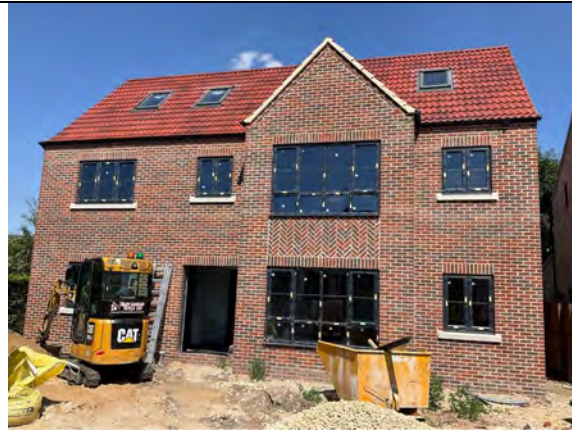
General overview of Plot 3 where today's inspection took place.

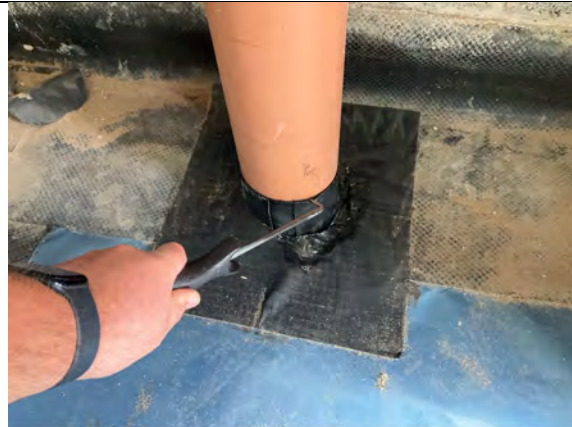
Probe testing to pipe penetration details.

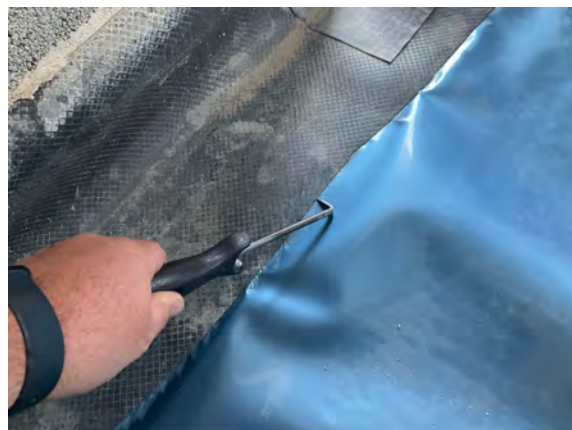
Probe testing to hand welded membrane lap joints along perimeter edge Juta DPC.

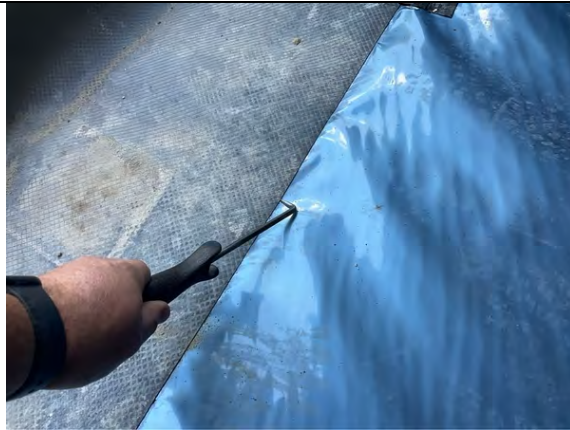
Probe testing to hand welded membrane lap joints along perimeter edge Jute DPC.

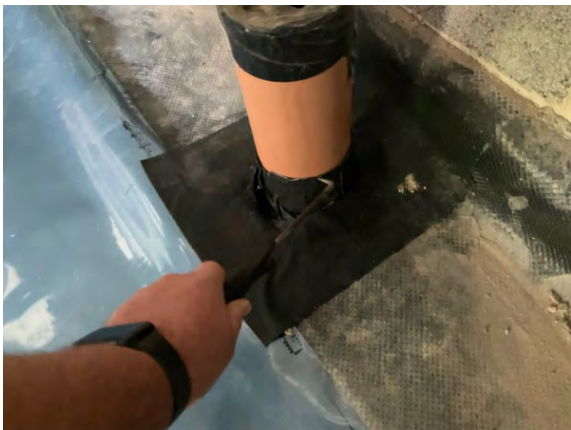
Probe testing to pipe penetration details.

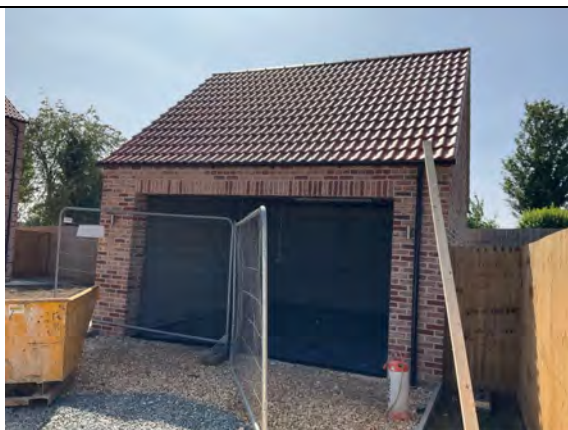
General overview of Plot 5 Garage.

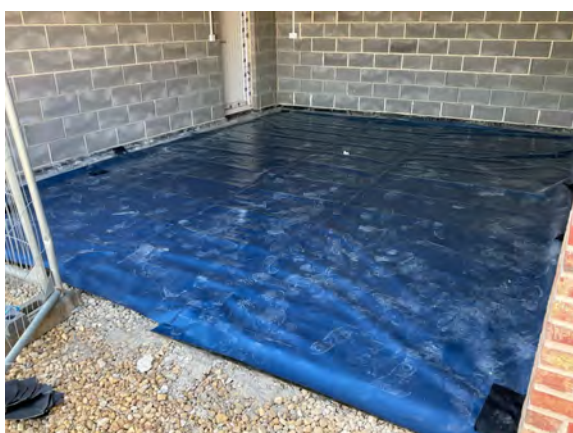
Overview of the infill installation to Plot 5 Garage.

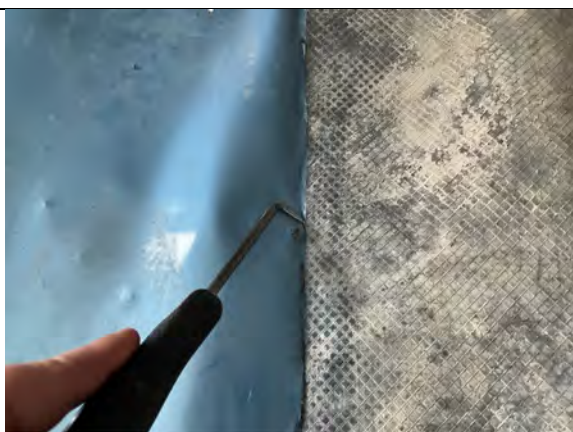
Plot 1 Garage. Probe testing along hand welded membrane laps joints to existing perimeter Jute DPC.

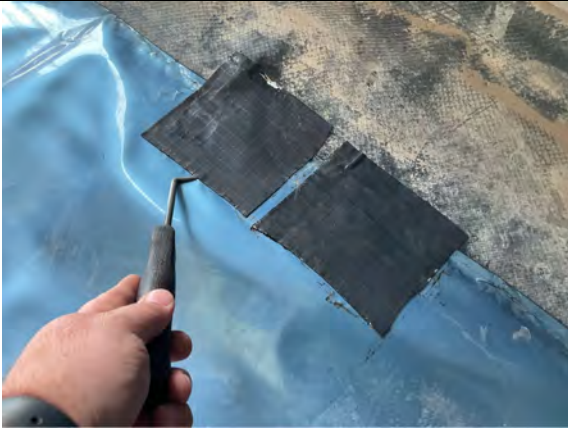
Plot 1 Garage. Probe testing to installers own CQA patch repairs using Juta GP1 SAM.

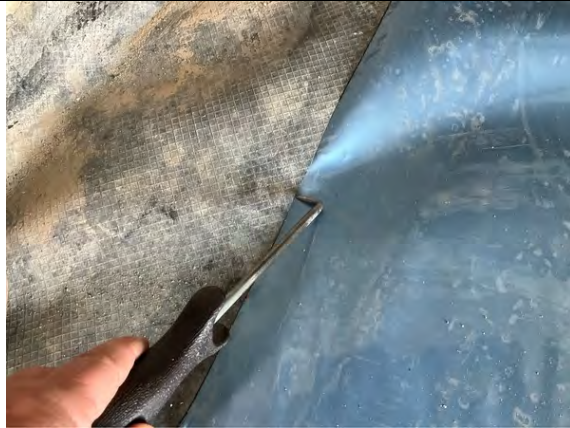
Plot 3 Garage. Probe testing along hand welded membrane laps joints to existing perimeter Juta DPC.

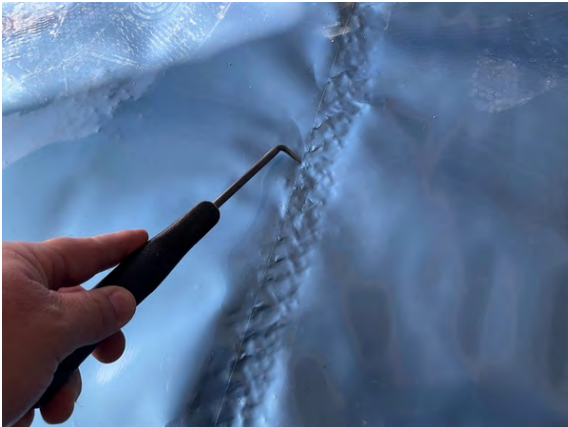
Plot 3 Garage. Probe testing along hand welded membrane laps joints.

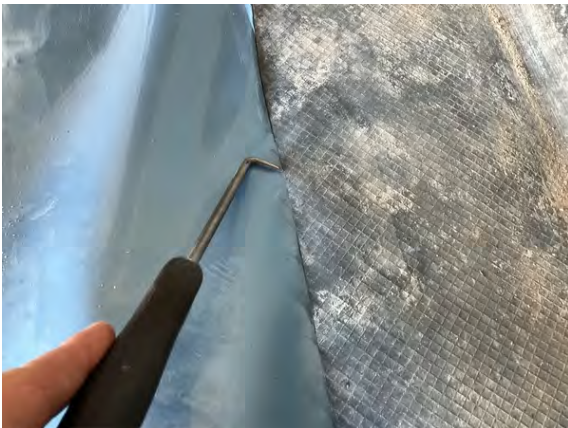
Plot 5 Garage. Probe testing along hand welded membrane laps joints to existing perimeter Juta DPC.

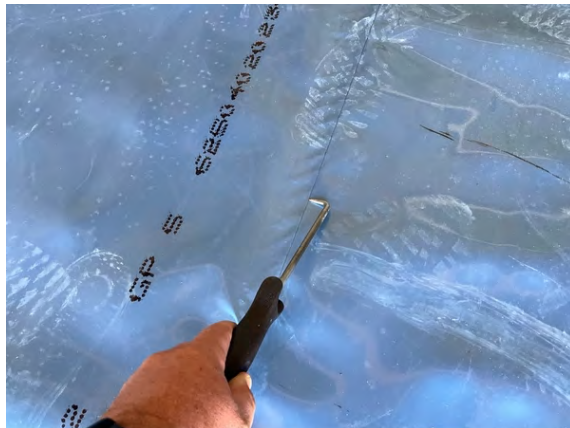
Plot 5 Garage. Probe testing along hand welded membrane laps joints.
