# **Ground Gas Mitigation: Verification Inspection Report**

Pearsons Close  
(Prev. 128 Barrier Bank),  
Cowbit, Spalding, PE12 6AL

Issue 2

March 2026

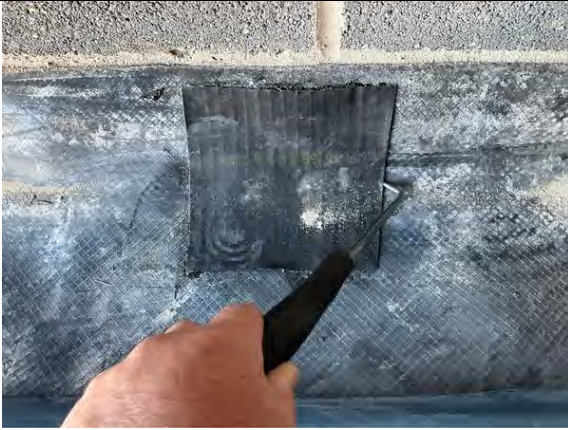
Plot 5 Garage. Probe testing to installers own CQA patch repairs using Jura GP1 SAM.

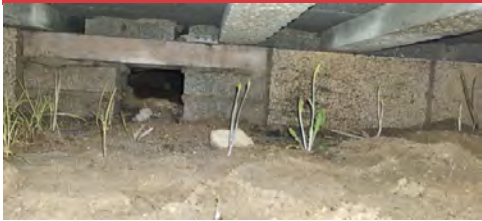
**PLOT 1 - MISSED BLOCKWORK TO SLEEPER WALLS**

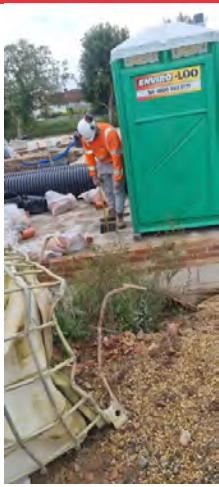
**PLOT 1 GARAGE - CONFIRMATION OF VOID DEPTH**

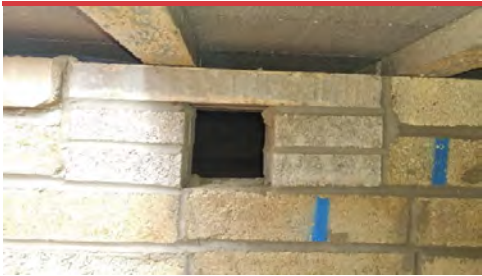
**PLOT 2 - MISSED BLOCKWORK TO SLEEPER WALLS**

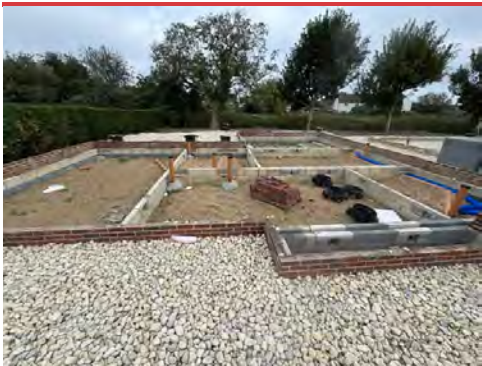
**PLOT 3 - VOID DEPTH ~500MM, MISSED  
BLOCKWORK TO SLEEPER WALLS**

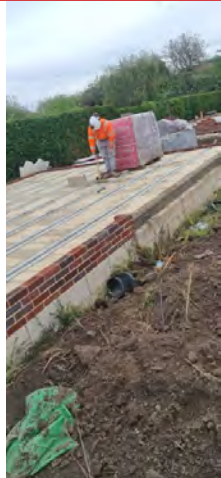
**PLOT 3 GARAGE - CONFIRMATION OF VOID DEPTH**

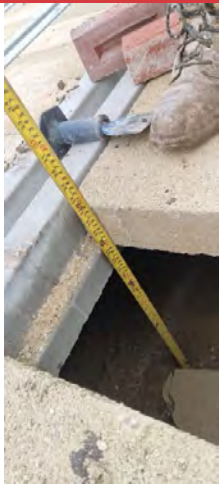
**PLOT 3 GARAGE - OPEN VOID**

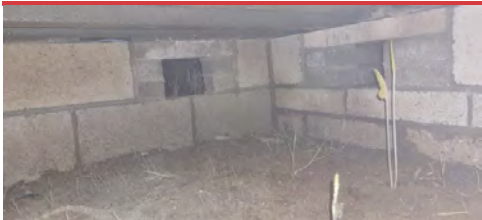
**PLOT 4 - CONFIRMATION OF VOID DEPTH**

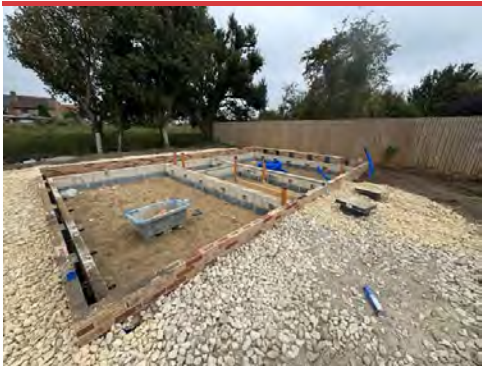
**PLOT 4 - VOID DEPTH 470MM**

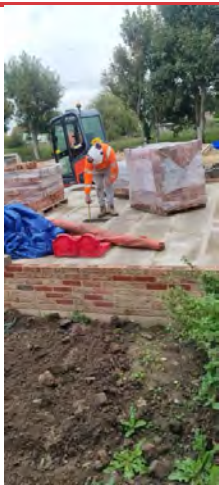
**PLOT 5 - VOID DEPTH ~500MM, MISSED  
BLOCKWORK TO SLEEPER WALLS**
