## **Structural Appraisal**

**Wykes Manor  
Wykes Lane  
Donington  
Spalding  
PE11 4SD**

**Ref: 9267**

**Date: November 2021**

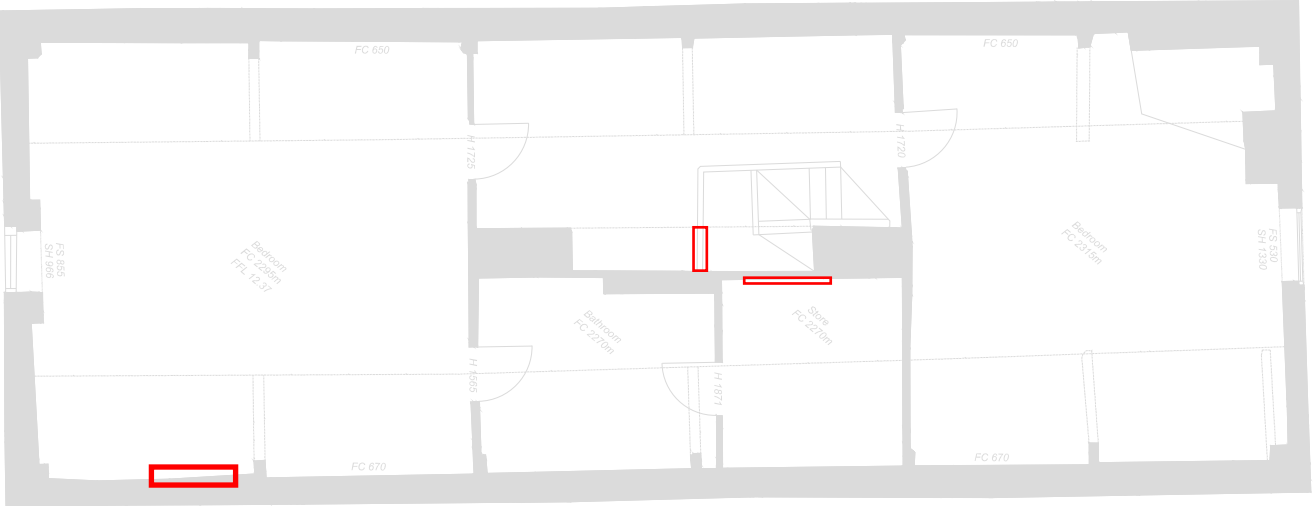
Localised crack.  
Monitor

Hairline crack to arch apex.  
Photo 2. Monitor

Minor localised cracking.  
Photo 1. Monitor

Diagonal racking cracks  
Photo 3. Monitor

Significant racking cracking.  
Photo 5. Monitor

Significant lateral displacement  
between external wall and stud wall.  
Photo 4. Provide Helifix Bowtie to tie  
wall to floor plate.

Potential extent of Helifix Bowtie
