**ARCHAEOLOGICAL MONITORING AND RECORDING AND HISTORIC BUILDING SURVEY AT FORMER RED  
COW HOTEL, 8 HIGH STREET, DONINGTON, LINCOLNSHIRE**

Planning Reference: H04-1190-17  
NGR: TF 20915 35710  
AAL Site Code: DOHS 20  
Museum Accession Number: 2020.178  
OASIS Reference Number: allenarc1-416605

By  
Allen Archaeology Ltd  
Report Number AAL 2021045

April 2021

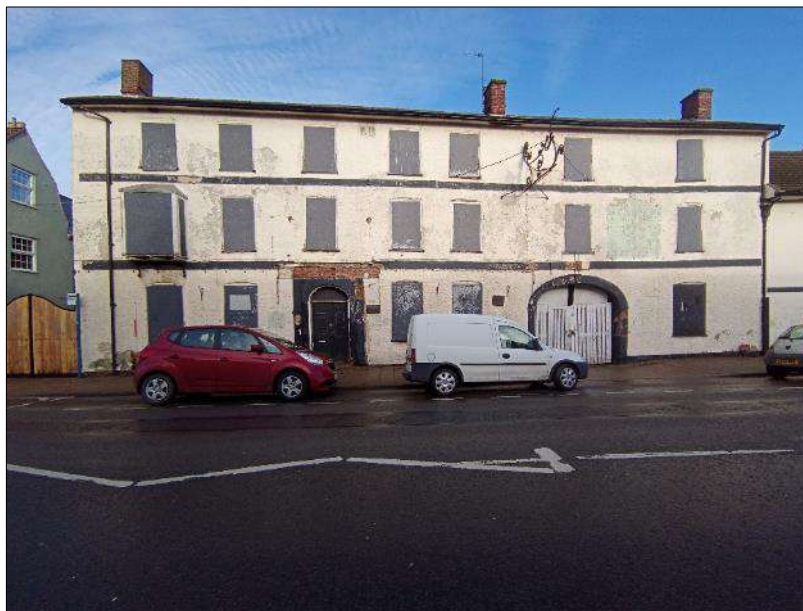
- 6.2 The main hotel structure is a three-storey high rendered brick building, with cellar, measuring c.22m x 6m (Plate 1 and Plate 2). It is east-west orientated and flanks the High Street situated to the south. It was once attached to the building to the west, but the eastern part of that structure, once incorporating an archway, has been removed (<https://www.heritagesouthholland.co.uk/article/the-red-cow-hotel-donington/> accessed: 12/02/2021).
- 6.3 It has a gabled roof covered with later Welsh slates. It has three brick stacks, one at each gable and one towards the centre, protruding through the apex of the roof. The Georgian front is, according to the listing and heritage statement, a later alteration and refronting dating to the 1800s, associated with increasing the height of the structure.

*Plate 1 (shot 171): General view of the hotel from the High Street. Looking north*

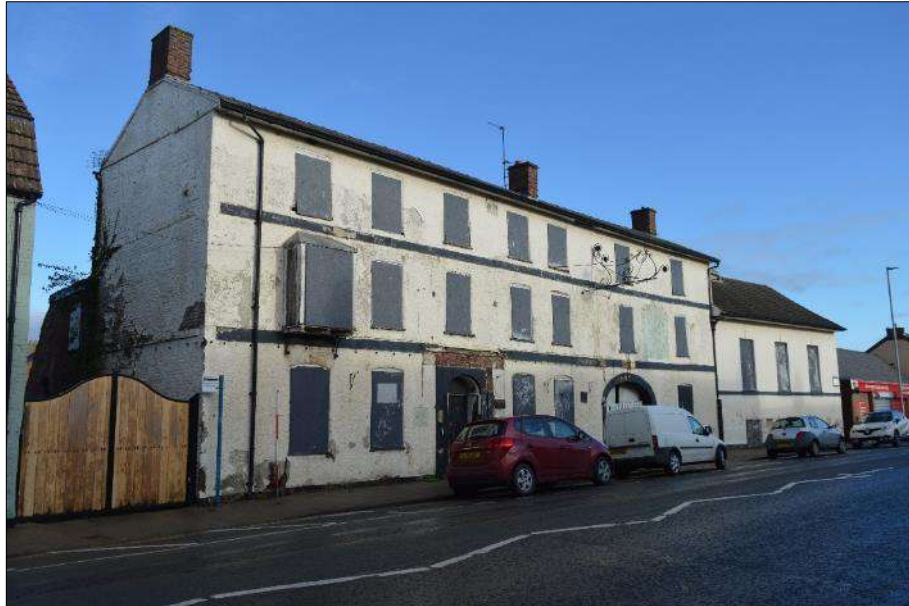
*Plate 2 (shot 11): View of the hotel from the High Street, also showing the west elevation. Looking northeast, scale 2m*

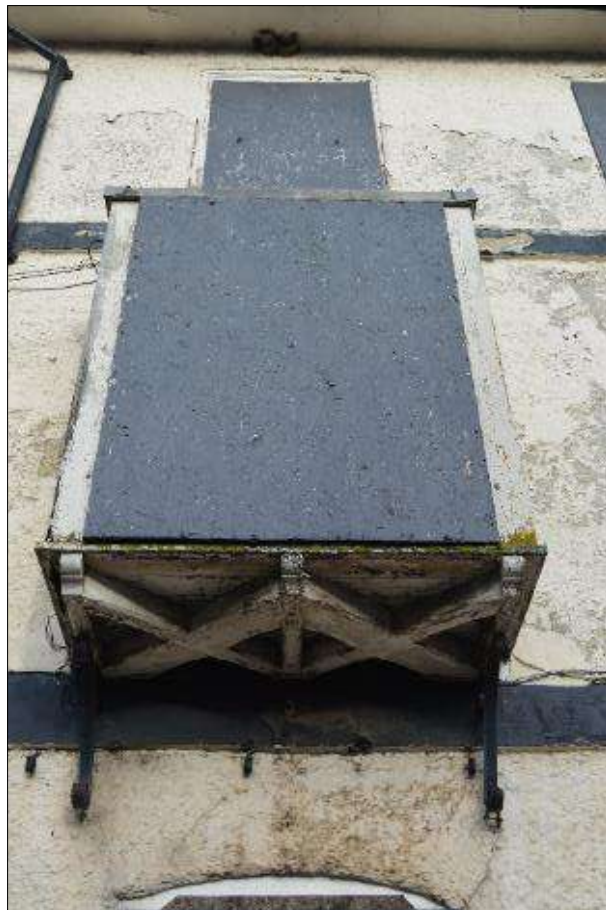
- 6.4 Two string courses run around the building below the first and second floor windows. At the time of the survey all windows on the front were boarded up and only visible from the inside of the building. Image 5 in the heritage assessment (Swann Edwards 2017) show Georgian nine-light sash windows to the first and second floors, fitted flush with the wall. At the west end of the range on the first floor is an oriel window with a four-light Victorian sash window with side lights. The window is supported by consoles, and the later iron brackets have been added as a decorative feature (Plate 3).

*Plate 3 (shot 13): Oriel window on brackets. Looking north*

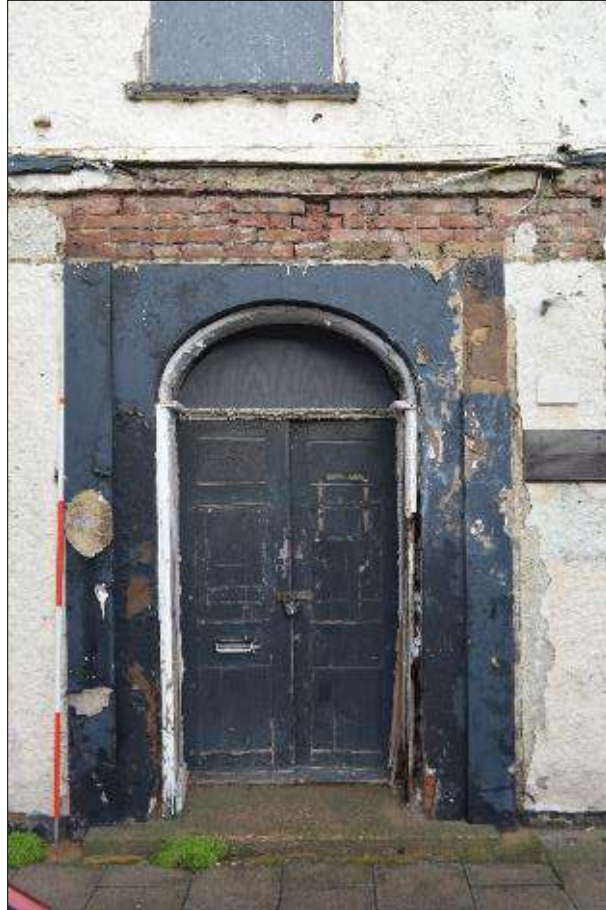
- 6.5 The main entrance is through a plain moulded timber architrave with double doors. The Georgian door is of a six panelled and beaded design with the typical smaller panels at the top, large in the middle and slightly smaller to the bottom. Above the opening is a board replacing a

semi-circular fanlight (Plate 4). The exposed brickwork above the opening is a result of the removal of an overhanging canopy, a feature added during the first half of the 20<sup>th</sup> century, and still there in the 1950s (as seen in Swann Edwards 2017). There was no trace of the foot scraper once located to the right of the door and also seen on historic images. This part of the wall has now been rendered (<https://www.heritagesouthholland.co.uk/article/the-red-cow-hotel-donington/> accessed: 12/02/2021)

*Plate 4 (shot 17): Main entrance. Looking north, 2m scale*

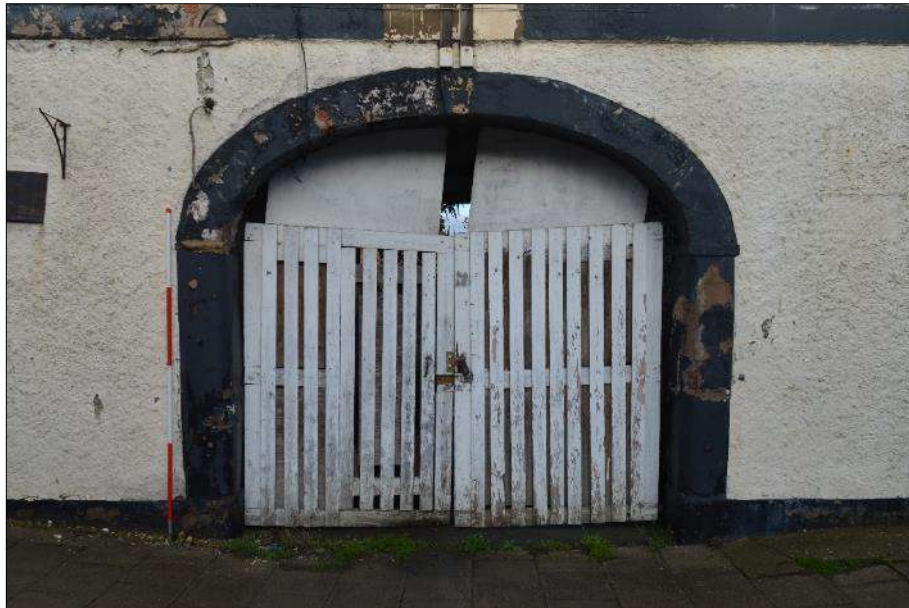
- 6.6 Another large semi-circular opening in the south elevation (Plate 5) has a wide segmental arch with a projecting keystone at the apex and a modern timber lath gate. The opening is wide enough to have allowed coaches to pass through to the yard at the rear and to access the stables.

*Plate 5 (shot 20): Wide opening for coaches leading to the rear of the building and the stables.  
Looking north*

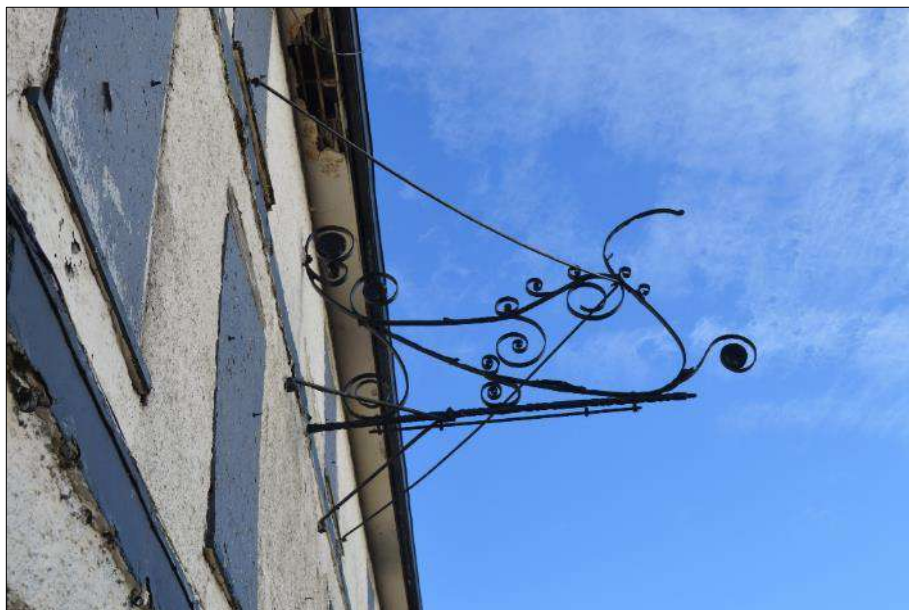
- 6.7 An iron bracket, to hold a sign, resides between the first and second floor. Although these features were common on Georgian buildings, the date on this is uncertain (Plate 6). It is seen on a photograph from the 1900s (<https://sites.google.com/view/doningtonillustrated/pubs-inns/red-cow-hotel> accessed: 13/02/2020)

*Plate 6 (shot 19): Sign bracket on the south elevation, looking east*

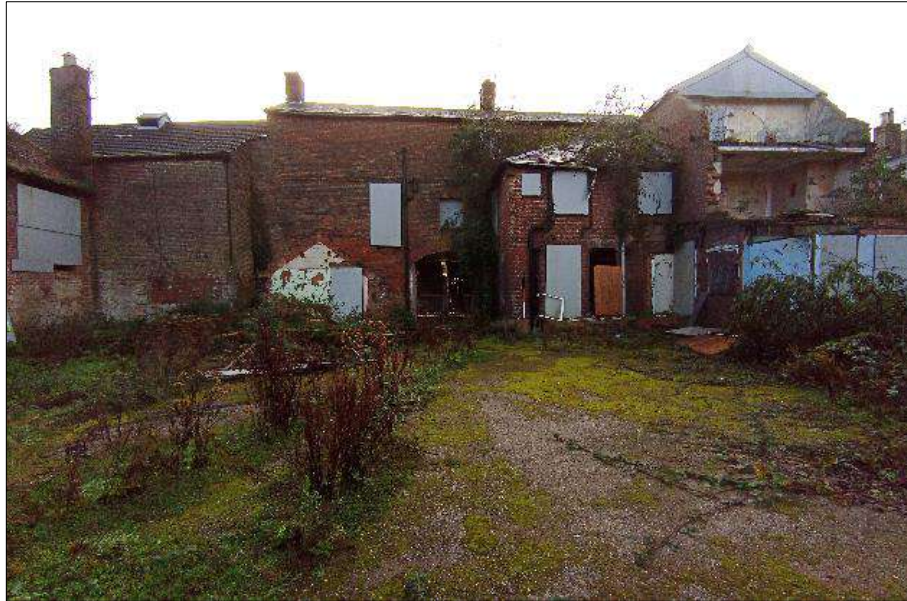
- 6.8 The rear of the structure is largely disguised by the attached north projecting wings comprising Structure D and a smaller extension to the east. Part of the extensions have either collapsed or been removed at the time of the survey (Plate 7).

*Plate 7 (shot 175): General view of the rear of the hotel also showing Structures B, C and D.  
Looking south, 2m scale*

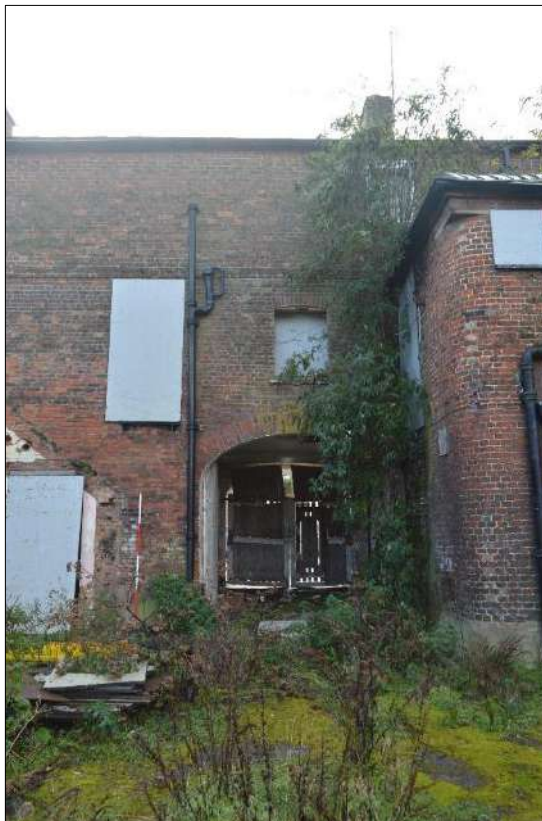
*Plate 9 (shot 66): View of archway, boarded door and window on first floor. Looking south, 2m scale*

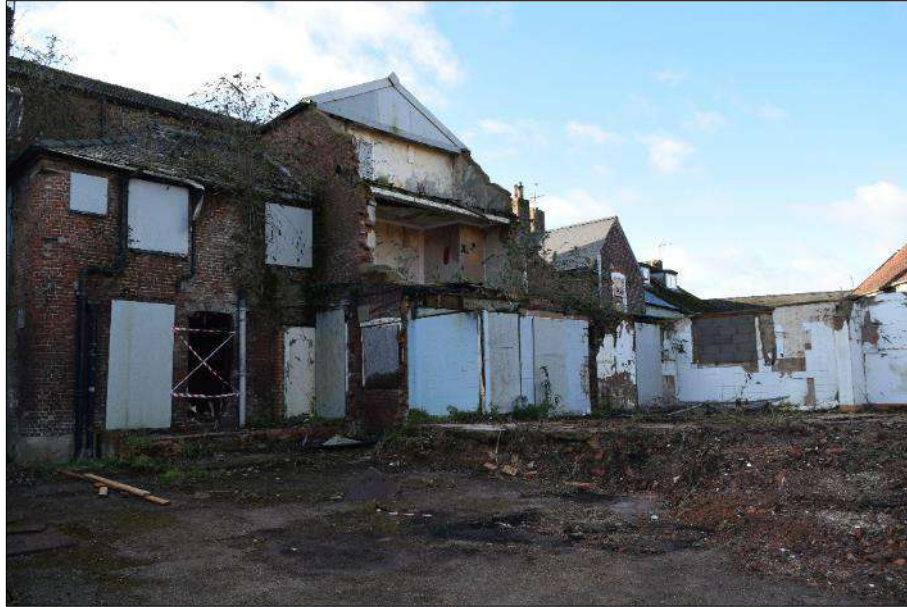
- 6.12 A small two storey extension is built on the north elevation, abutting Structure D to the west. It has a rounded northeast corner and a hipped roof covered in later Welsh slate, with three boarded windows on the first floor, and one or two boarded doors on the ground floor. The third opening in centre of the ground floor is a demolished window opening. All openings display segmental brick arches. This structure also has a door on the first floor of the east elevation to allow for loading and offloading carts.

*Plate 10 (shot 207): General view of extensions on north elevation. Looking southwest*

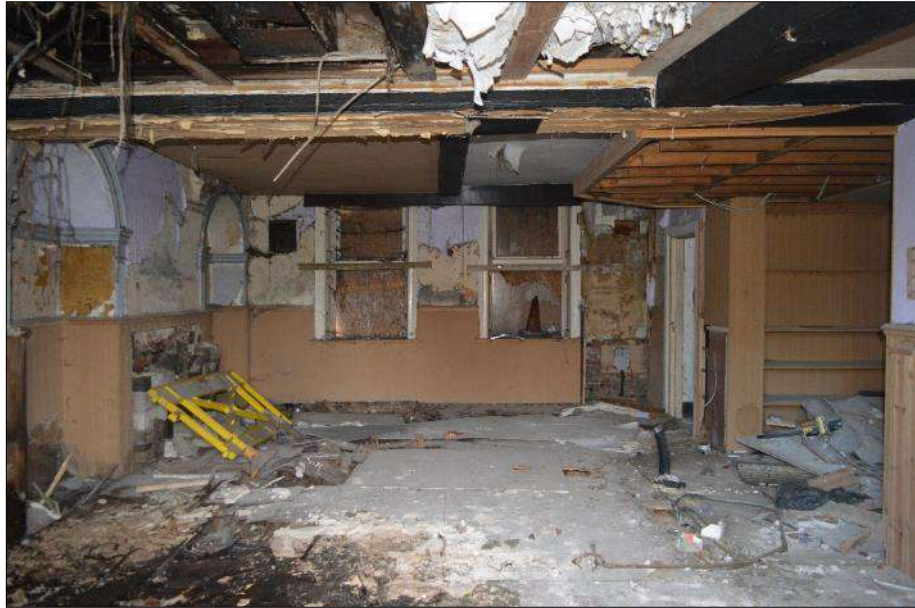
*Plate 11 (shot 164): General view of eastern bar/reception area. Looking south*

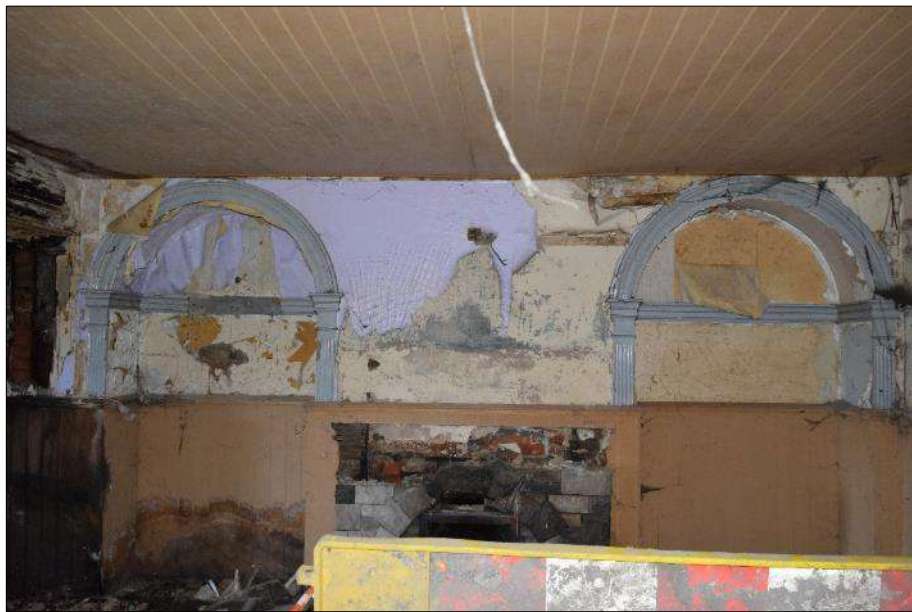
*Plate 12 (shot 185): Western bar area with shallow Doric inspired alcoves. Looking east*

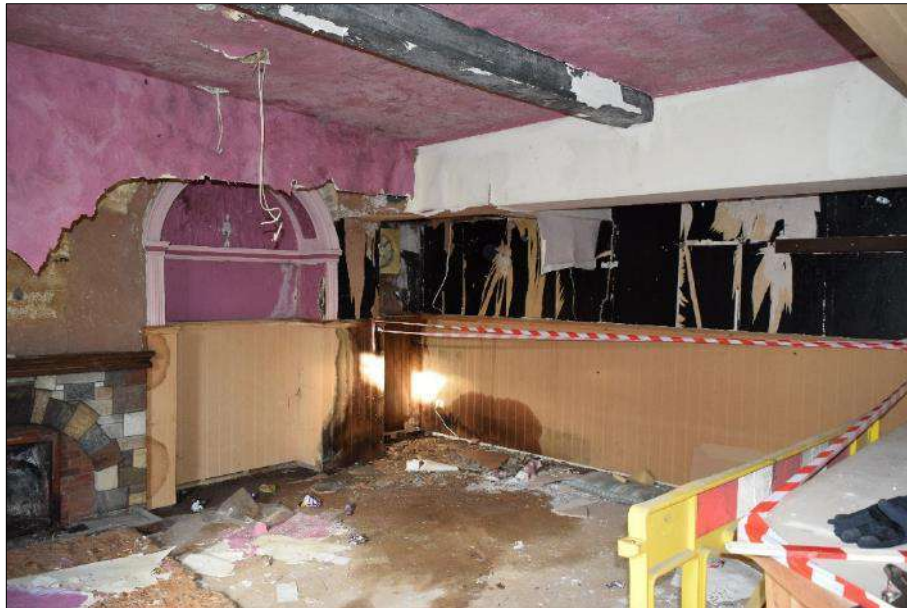
*Plate 13 (shot 196): General view of bar/reception area to the west. Looking northwest*

- 6.16 Some of the main beams in the ceiling displayed axe/adze hewn edges on the timbers as seen on Plate 13, and could be of early date, whereas others were hidden by modern cladding. The ceiling towards the northeast end of the pub had partially collapsed or had been demolished, and showed a mix of new and old timbers, the latter ones hewn with axe or adze.
- 6.17 The doorway leading to the Assembly Room in Structure B, and to a small bedroom/office on the ground floor in Structure A, has been blocked with breeze blocks. The six-fielded door has been removed and placed adjacent to the late Georgian doorway. The architrave shows a Doric inspired style with fluted sides but with concentric circles/paterae on the corner squares.

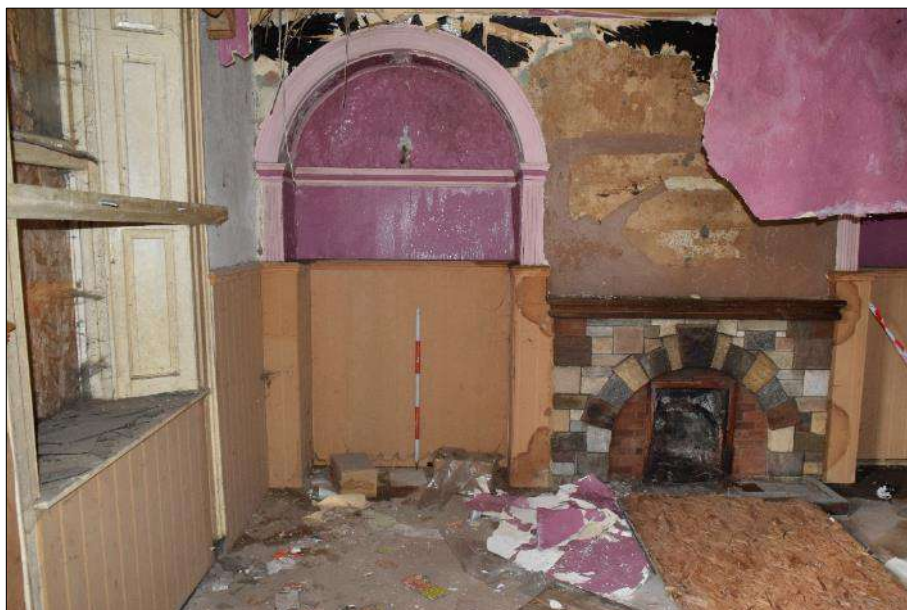
*Plate 14 (shot 194): General view of western bar area showing alcove and modern fireplace.  
Looking west, 1m scale*

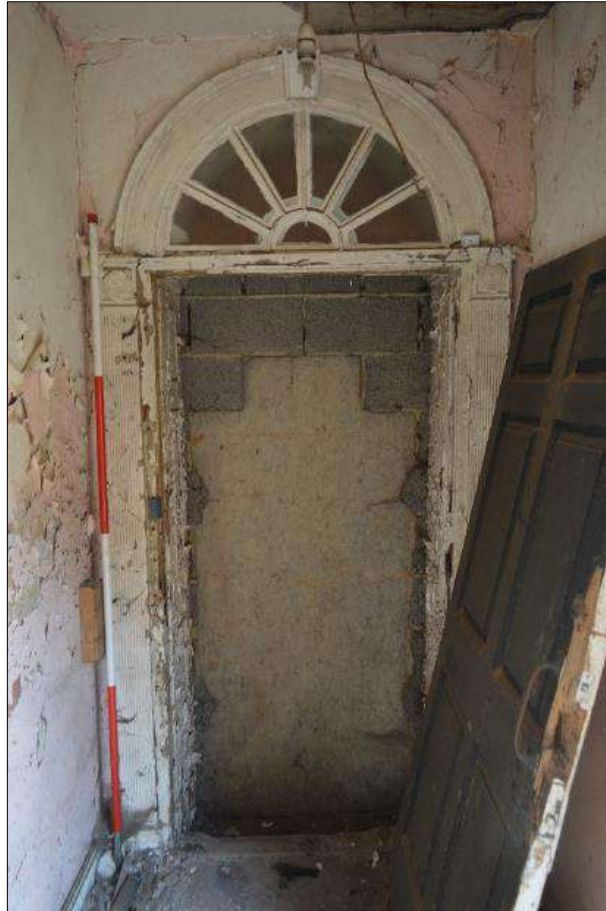
*Plate 16 (shot 142): Georgian architrave and main former entrance to the assembly room.  
Looking west-northwest, 2m scale*

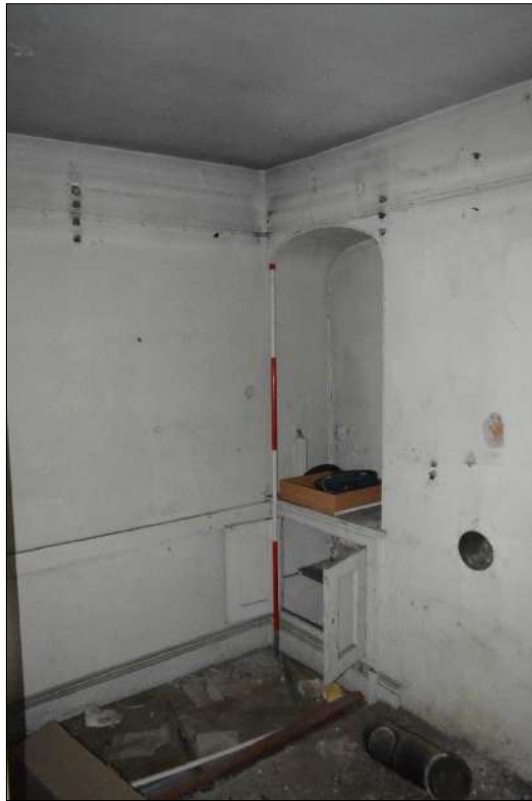
- 6.18 The bedroom/office has a storage room to the west extending to the width of the room, showing no architectural features. The main room displays similar arched niches on either side of a chimney breast as in the pub but with no mouldings (Plate 17). The small built-in cupboards with fielded panels below are likely to be contemporary with the window shutters. The window displays the original fielded panelling below the window (Plate 18). A circular hole from a flue is visible on the east wall, the skirting board cuts short along the wall where the original fireplace has been removed and blocked up.

*Plate 17 (shot 149): Niche with built-in cupboard and flue hole in the eastern wall. Looking northeast, scale 2m*

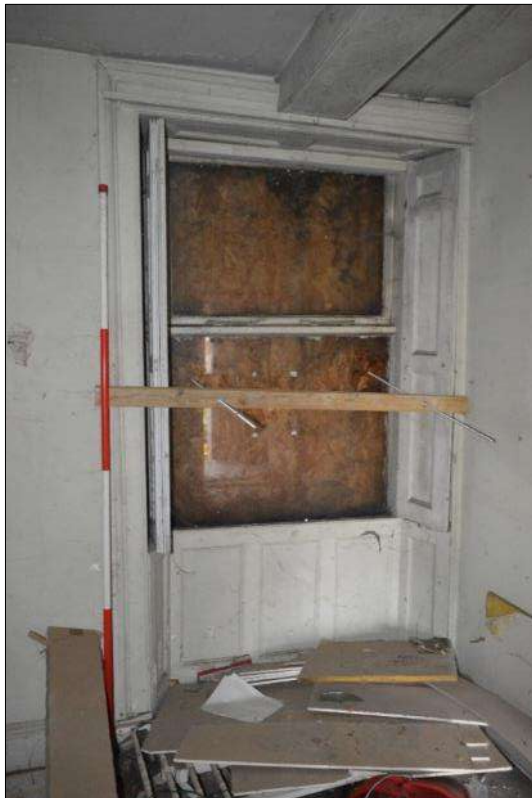
*Plate 18 (shot 150): Window with shutters and original panelling below. Looking south-southwest, scale 2m*

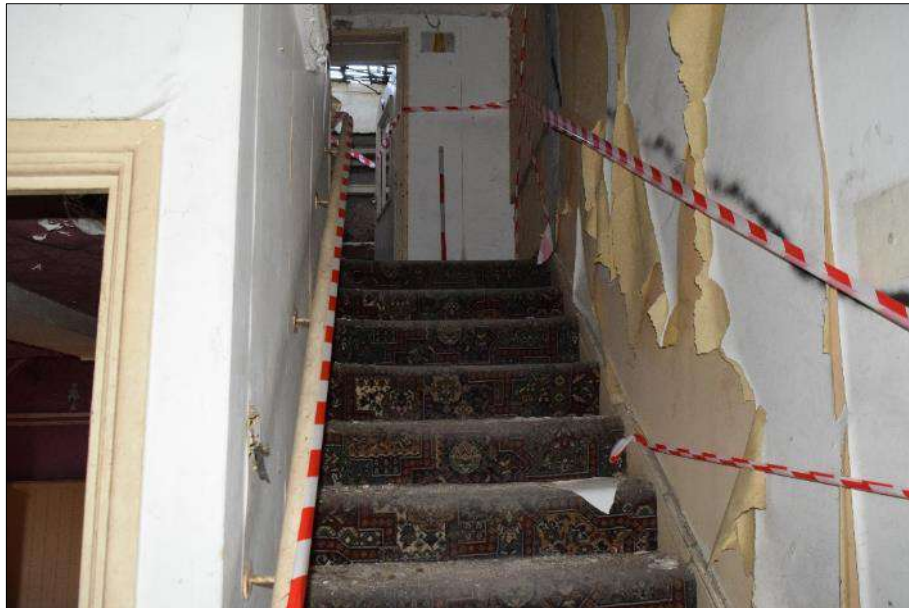
*Plate 19 (shot 211): Staircase in Structure D leading to first floor of Structure A. Looking west, 2m Scale*

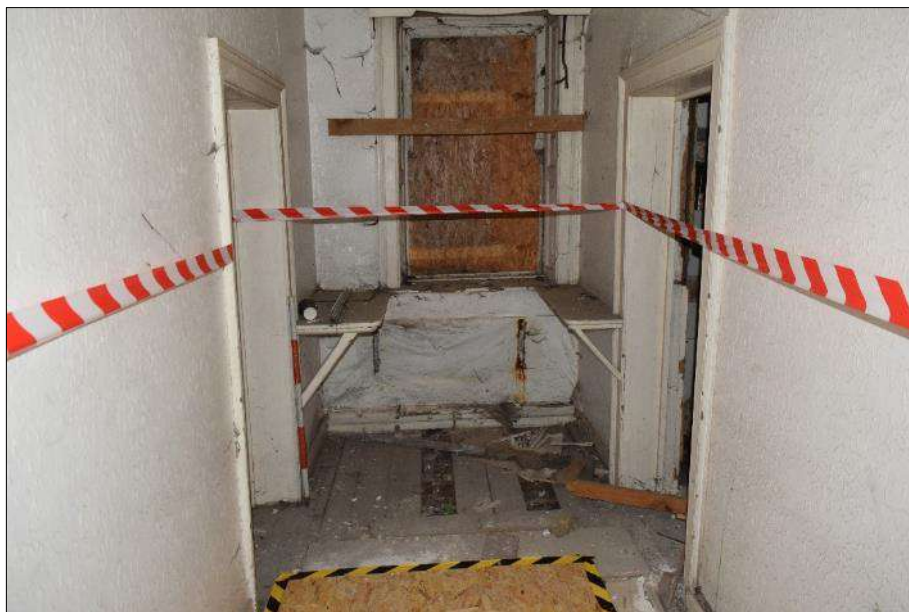
- 6.20 A1.1 and A1.2 was potentially originally a larger chamber room accessed from the corridor to the west (Plate 20), but has been later partitioned (Plate 21). The skirting board and picture rail along this partition wall are probably a later addition to follow the seemingly original features in the rest of the room. These features were not present in room A1.2.

*Plate 20 (shot 217): Hallway between rooms A1.2 and A1.3. Looking south, 1m scale*

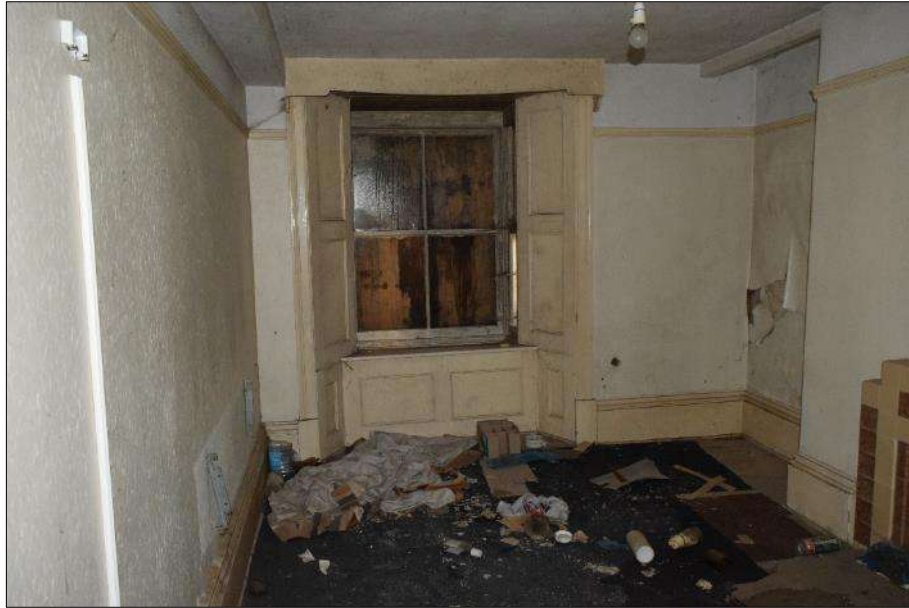
*Plate 21 (shot 214): General view of bedroom A1.1 and the oriel window. Looking south*

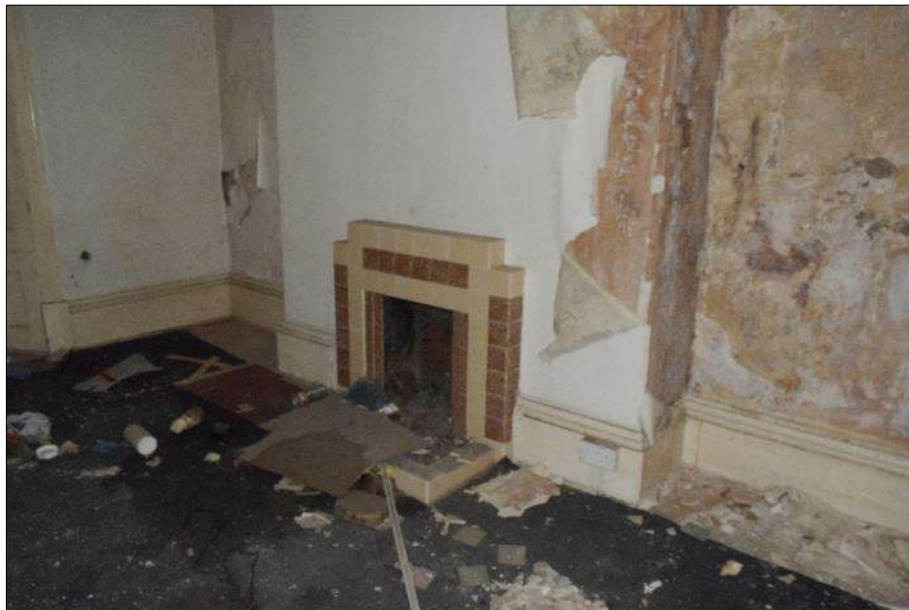
- 6.21 The art deco styled fireplace in beige and marbled mid brown tiles is probably a 1930-1950s addition (Plate 22).

*Plate 22 (shot 215): Fireplace in bedroom A1.1. Looking west-southwest*

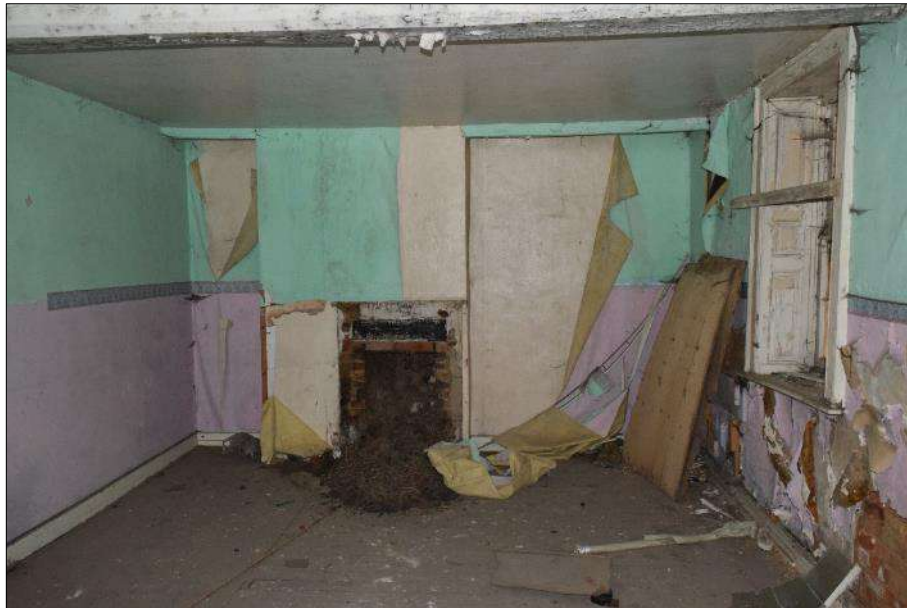
- 6.22 Bedroom A1.3 is slightly smaller than the large west chamber that now forms A1.1 and A1.2 (Plate 23). It has two windows with shutters on the south elevation. This room does not have thick skirting boards and picture rails as in A1.1, and rather than presuming these features have been removed, it may denote the lower status of this room in comparison to its larger counterpart to the west.
- 6.23 The fireplace has been partially removed. The hearth was not visible due to debris.

*Plate 23 (shot 219): General view of bedroom A1.3. Looking east*

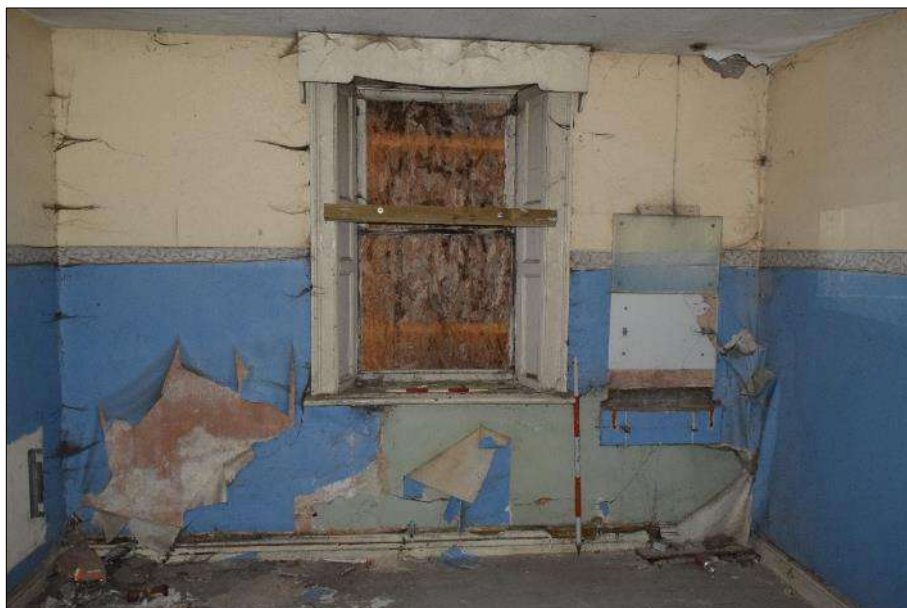
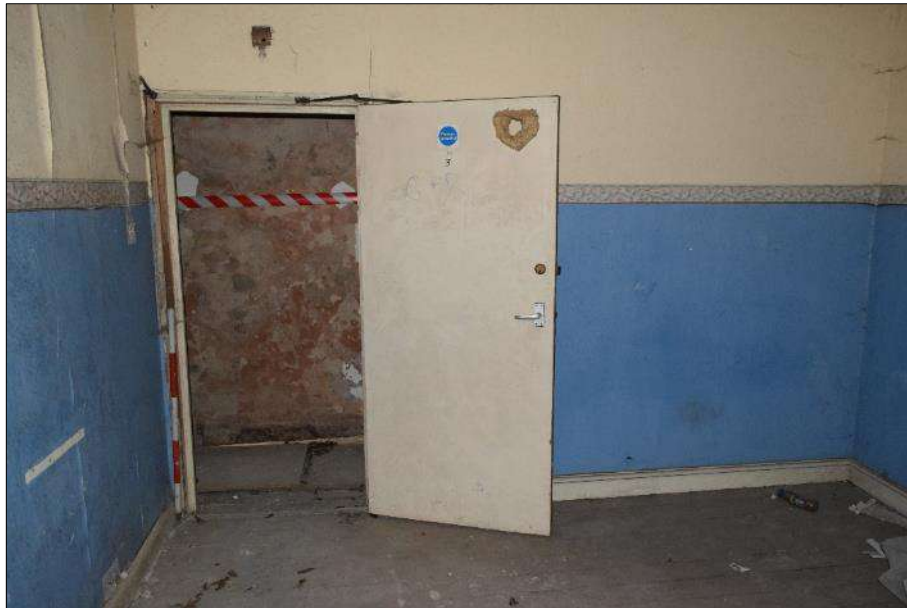
- 6.24 Room A1.4 is a small room lit by a single window above the carriage archway (Plate 24 and Plate 25). This room was without a fireplace and thus without heating, and was therefore presumably a room suited for someone less wealthy than those occupying the rooms to the west.

*Plate 24 (shot 232): General view of room A1.4. Looking south, 1m scale*

*Plate 25 (shot 235): General view towards the corridor from room A1.4. Looking north, 1m scale*

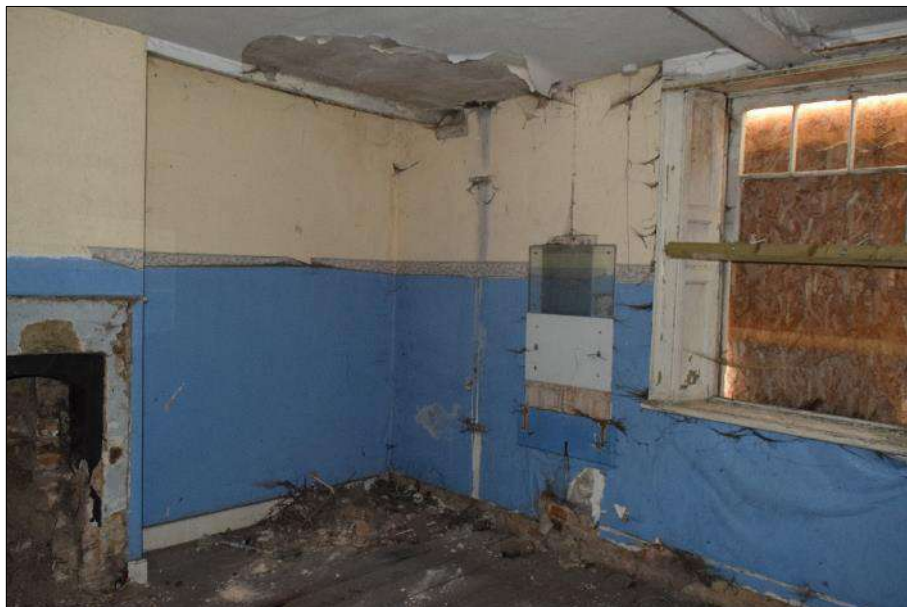
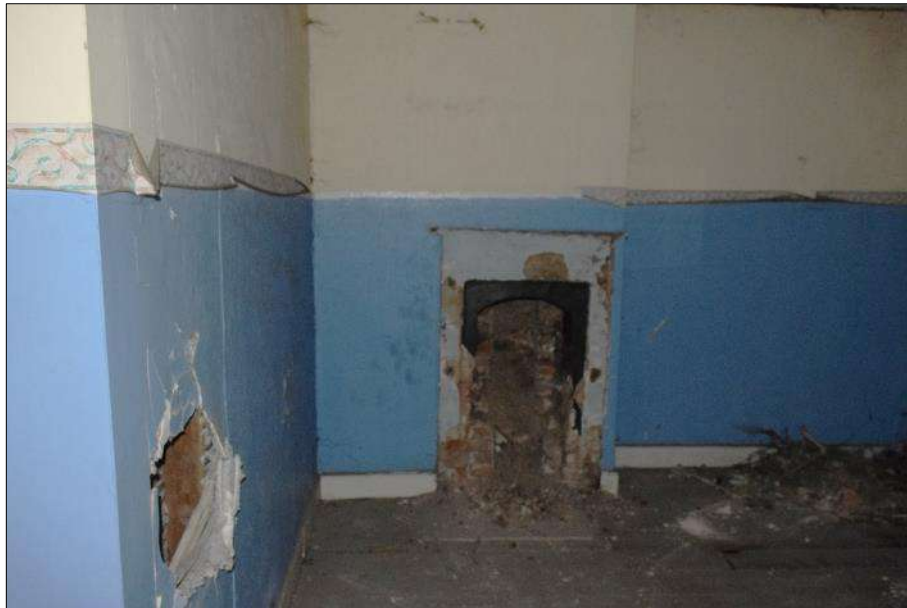
- 6.25 Room A1.5 is situated above the presumed office, east of the archway. Again, the room is quite small, but was heated with a fireplace against the east wall. The fireplace furniture has been removed. A hole in the north wall shows plaster on top of laths.

*Plate 26 (shot 231): General view of room A1.5. Looking southeast*

*Plate 27 (shot 230): Fireplace in room A1.5 on the east wall. Looking east*

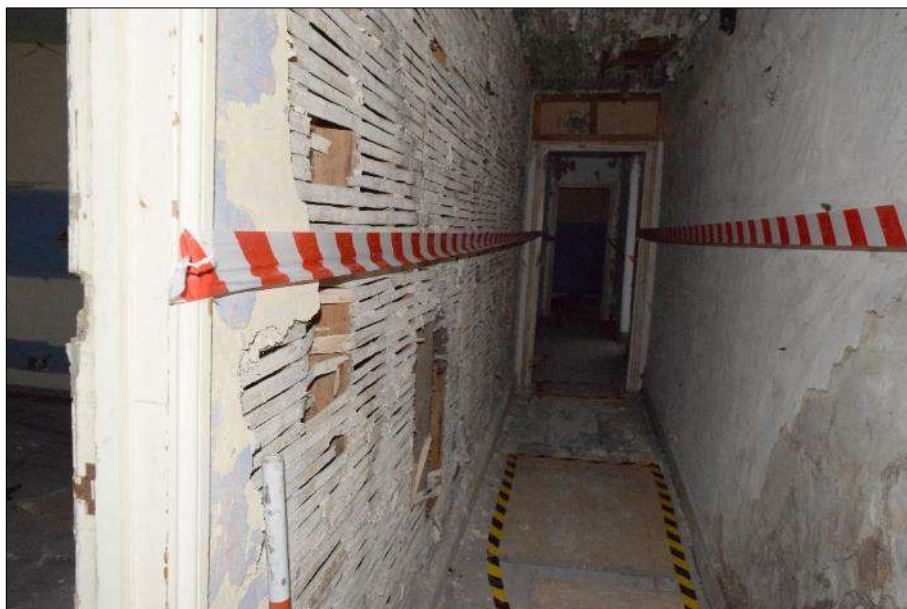
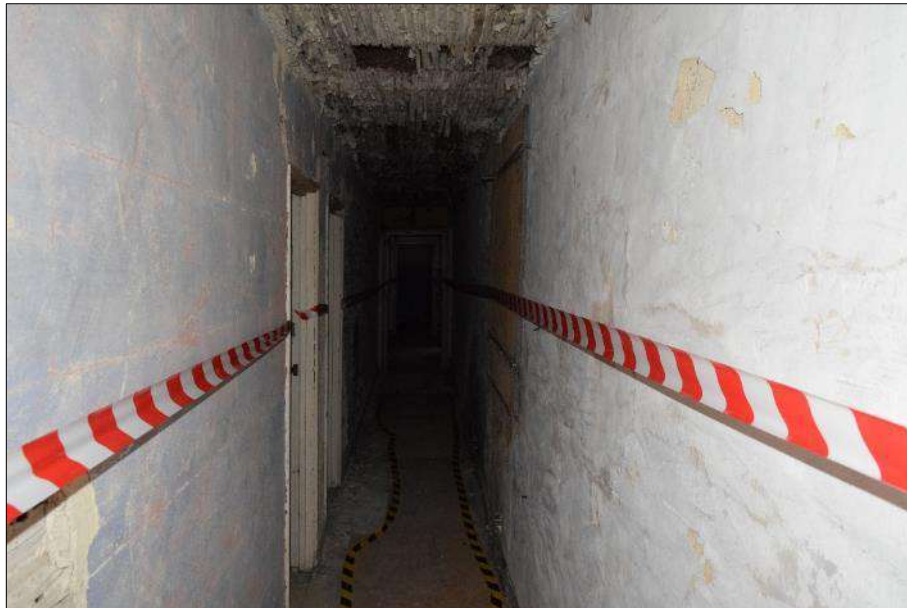
- 6.26 The second floor comprises six bedrooms (A2.1-A2.6), with room A2.5 not safely accessible. The floor is reached via a straight flight of stairs north of first floor bedroom A1.5 and via the doglegged staircase in Structure D. The rooms are all accessed from a corridor along the north side of the building. Some of the plaster had been removed prior to the survey. This exposed laths beneath, suggesting an early date of the stud wall and remaining plaster to the walls and ceiling, unless a sympathetic repair has been conducted in the recent past (Plate 28 and Plate 29). Safety restrictions limited the survey on this floor.

*Plate 28 (shot 251): View along the second floor corridor. Looking west*

*Plate 29 (shot 243): View down the corridor on second floor, showing area of removed plaster on the ceiling. Looking west*

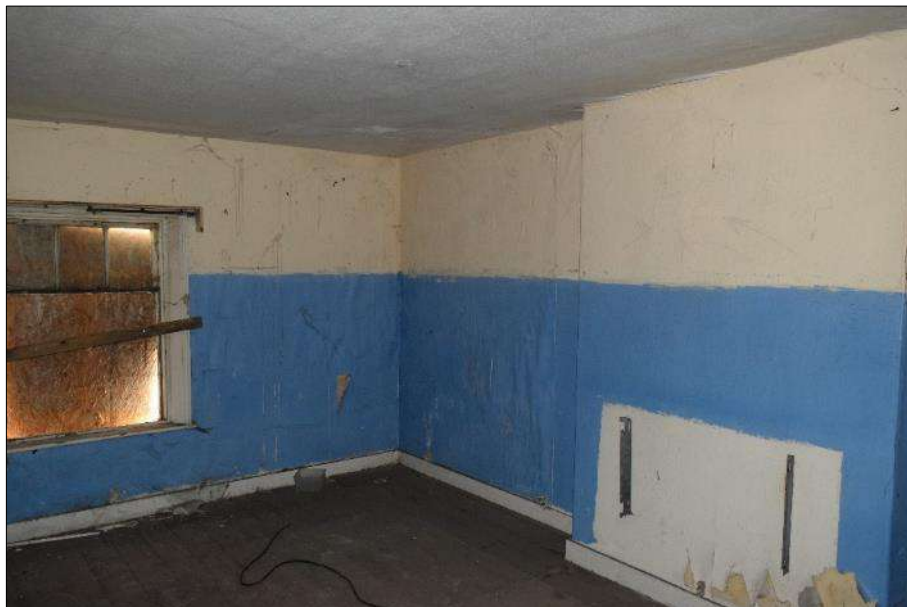
- 6.27 The westernmost bedroom A2.1 has a blocked fireplace on the west wall (Plate 30). The windows are smaller on this floor following a typical Georgian style and as such there are no window shutters on the second floor. There is little left of the window in A2.1. The plank floor is the same throughout the first and second floors and of uncertain date, potentially early 19<sup>th</sup> century.

*Plate 30 (shot 261) Room A2.1 showing blocked fireplace. Looking southwest*

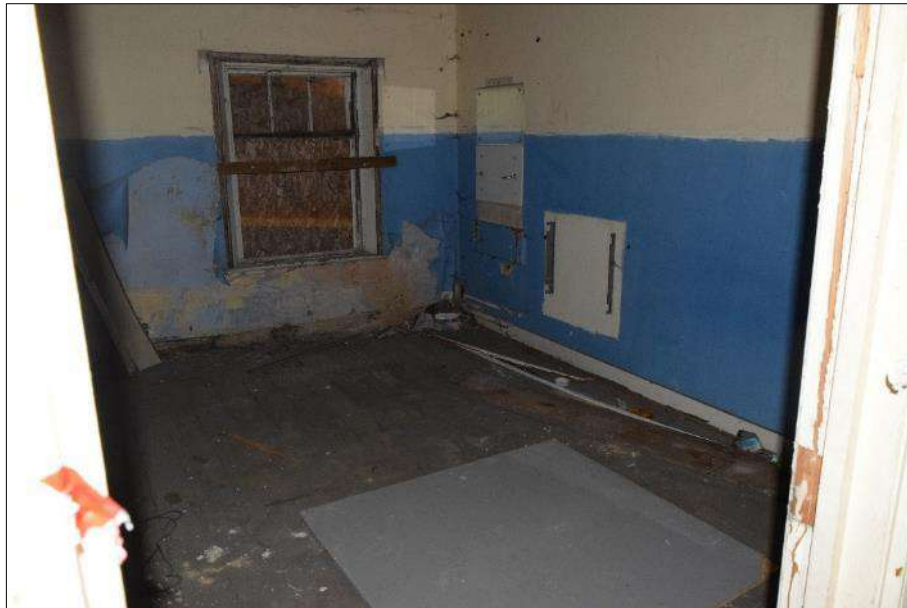
- 6.28 The smaller bedrooms to the east, A2.2 (Plate 31) and A2.3, show no features apart from the window frames and plank floor, although a hole in the partition wall between A2.3 and A2.4 shows plaster over laths, indicating an early date rather than a modern replacement. Due to the safety restrictions, the plaster was not more closely studied for inclusions such as horse hair that would indicate an early date.

*Plate 31 (shot 258): Bedroom A2.2. Looking southwest*

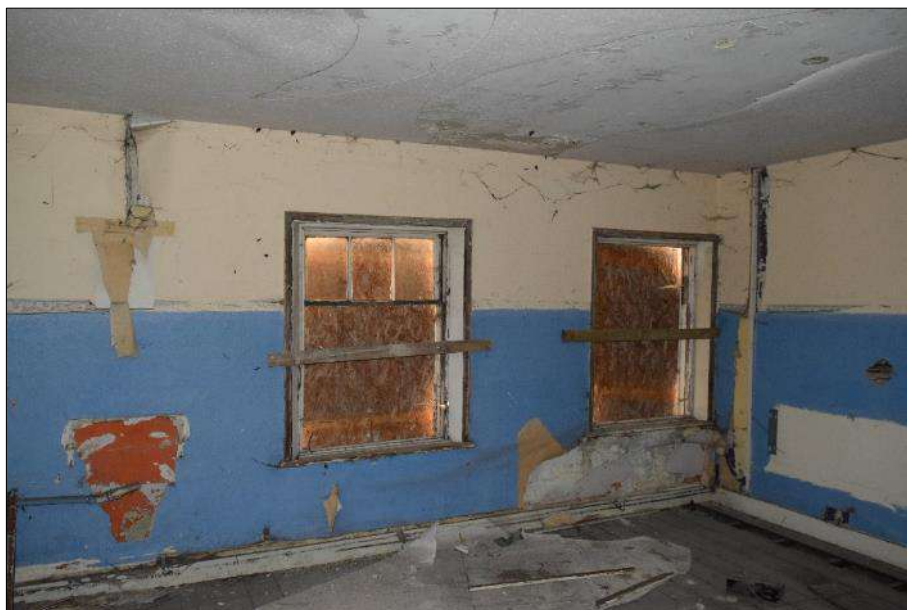
- 6.29 The largest room A2.4, has two windows on the south elevation, both in a poor state with only the window frame remaining. The plank floor is exposed as in the other rooms.

*Plate 32 (shot 250): Room A2.4. Looking south-southwest*

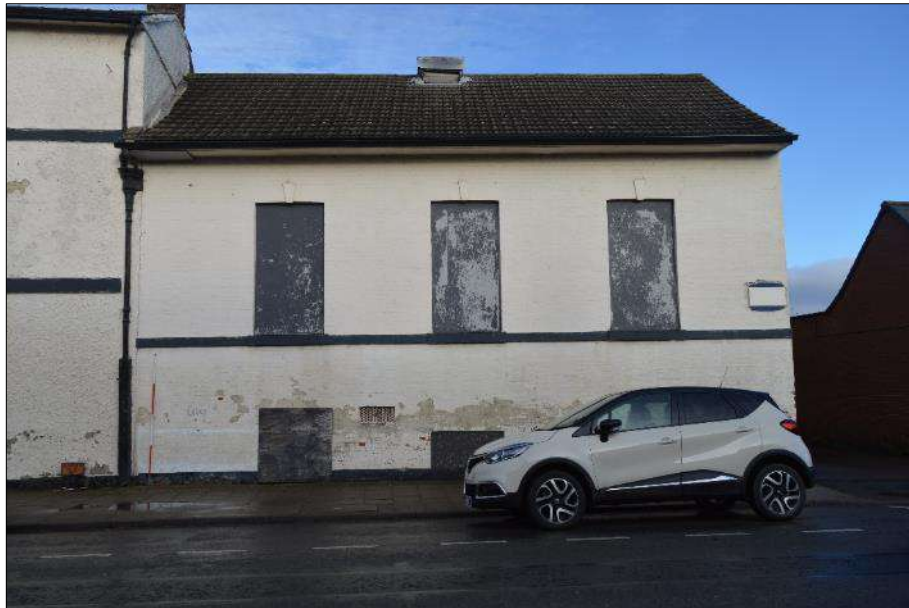
- 6.30 The Assembly Room is attached to Structure A to the east, measures approximately 11m x 7m and is two storeys high (Plate 33). The double pitched gabled roof overhangs the front and is covered in later concrete tiles. A louvred roof ventilator protrudes through the apex of the roof. The front is rendered and painted white with a matching string course, as seen on the hotel.

*Plate 33 (shot 23): The Assembly Room fronting the High Street. Looking north-northeast, 2m scale*

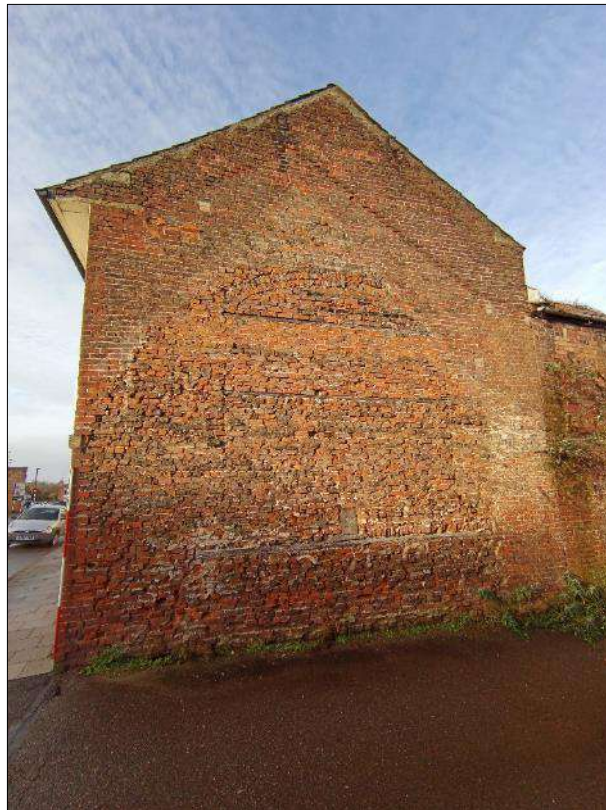
- 6.31 The ground floor starts below current ground level and cellar windows face the High Street. A large brick ventilation in honeycomb pattern (probably cast-iron) is positioned approximately 1m above the street level. Three windows above the string course on the first floor are tall with flat brick arches and a protruding keystone.
- 6.32 The east elevation shows several changes in brickwork. The remains of a segmental brick arch suggest a large bricked up opening, with the horizontal timbers below indicating the width of the former opening (Plate 34). The brickwork has been repaired at a later date and the northern end of the arch has been lost. It is cut by a scar for a double pitched roof, with another double pitched roof scar above this. Both relate to the brewery buildings seen on the late 19<sup>th</sup> century

maps that were removed in the 20<sup>th</sup> century. The lower structure appears to have been added after the opening was bricked up (Plate 35).

*Plate 35 (shot 169): East elevation of Structure B. Looking south-southwest, 2m scale*

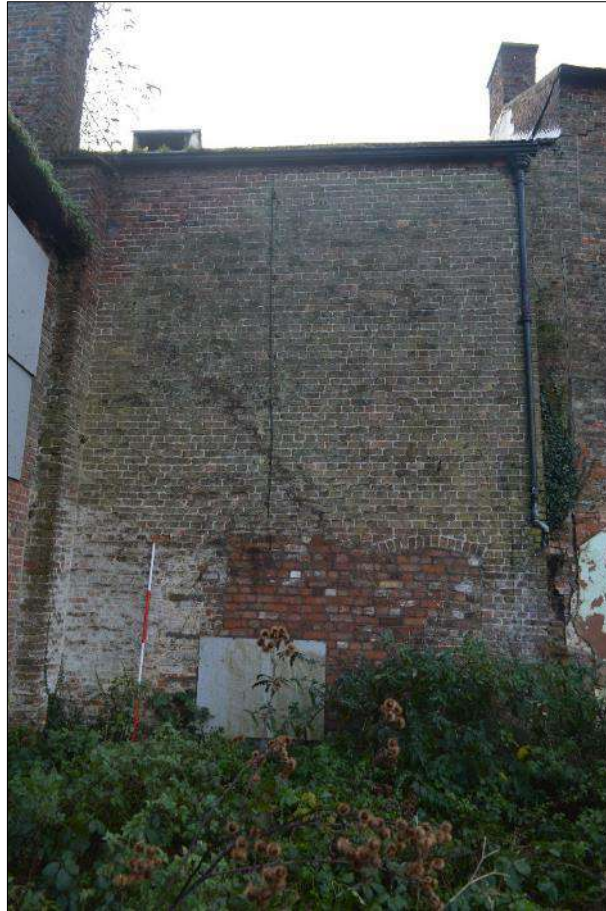
- 6.33 A section of a large tie-beam is also visible on the east elevation, approximately 1m above ground level.
- 6.34 Half of the north elevation is obscured by Structure C, extending from the northeast corner. A tall chimney stretches along the elevation from ground level and protrudes through the north eaves (Plate 7). A blocked doorway with segmental arch is positioned towards the northwest corner (Plate 36).

*Plate 36 (shot 61): North elevation of Structure B, showing blocked doorway. Looking south-southwest, 2m scale*

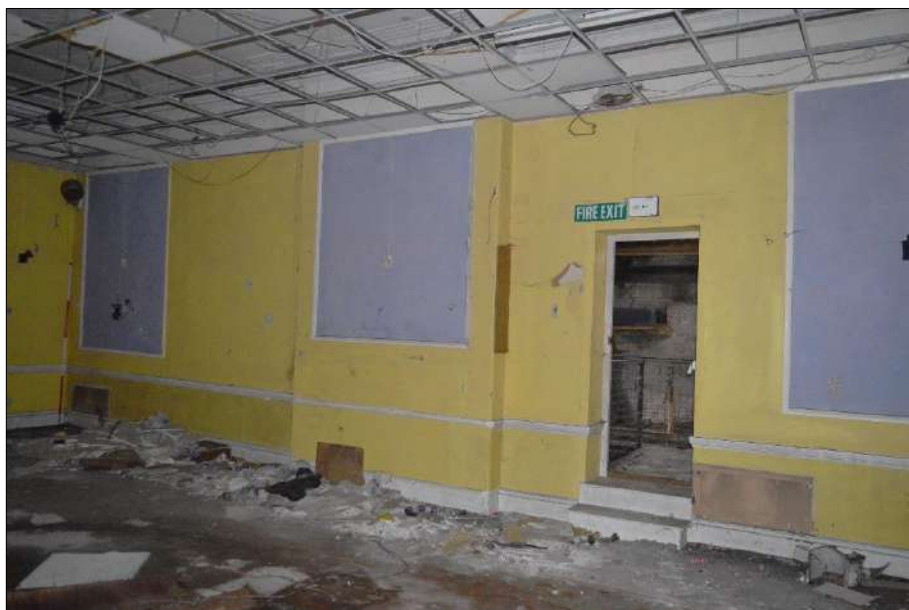
- 6.37 The single room stretches across the entire length of the building (Plate 40-Plate 42). The blocked, depressed arched opening seen on the exterior is also highlighted as a feature on the inside with a moulded architrave framing it, which follows the same style as the windows and doorways. The skirting boards are thick and a contemporary moulded dado rail follows the walls throughout. It is positioned approximately 0.6m above the floor level continues across the chimney breast and the blocked fireplace (Plate 42).

*Plate 42 (shot 157): North wall showing chimney breast with blocked fireplace and a doorway to Structure C. Looking north-northwest, 2m scale*

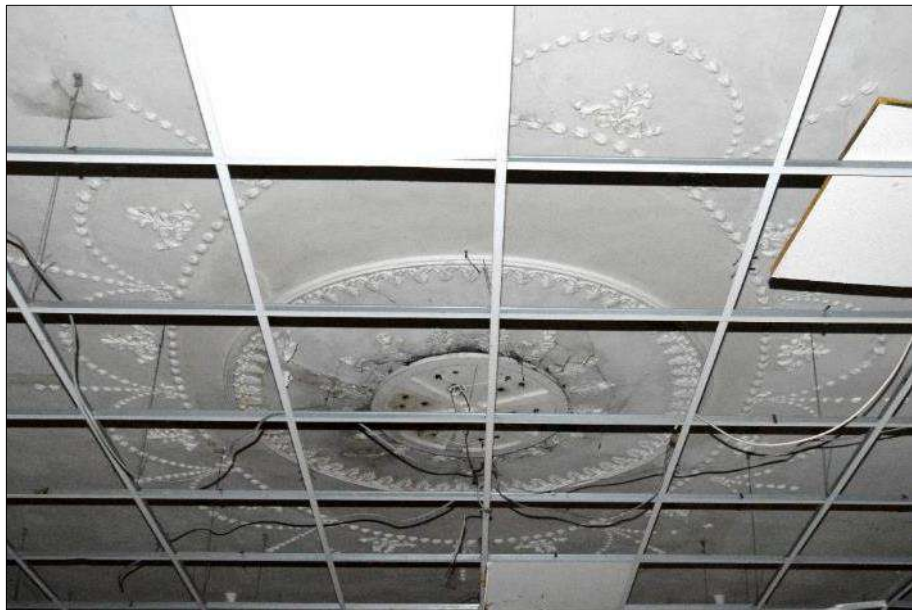
- 6.38 Above the framework of the modern suspended ceiling (partially removed) is a plastered ceiling, displaying floral motifs of possibly lilies, buds and leaves (Plate 43 and Plate 44). A thick, moulded, plastered cornice surrounds the ceiling. The original ceiling rose is partially hidden by a later rose from which an electric light - probably a chandelier - was hung. The impact of this modern feature on the older ceiling is unknown. These features appear to be late Georgian in style but a suitable specialist/conservator would be able to confirm their authenticity and also provide advice on how best to preserve them (if at all possible).

*Plate 44 (shot 160): Close-up of the ceiling. Looking west-northwest*
