**ARCHAEOLOGICAL MONITORING AND RECORDING AND HISTORIC BUILDING SURVEY AT FORMER RED  
COW HOTEL, 8 HIGH STREET, DONINGTON, LINCOLNSHIRE**

Planning Reference: H04-1190-17  
NGR: TF 20915 35710  
AAL Site Code: DOHS 20  
Museum Accession Number: 2020.178  
OASIS Reference Number: allenarc1-416605

By  
Allen Archaeology Ltd  
Report Number AAL 2021045

April 2021

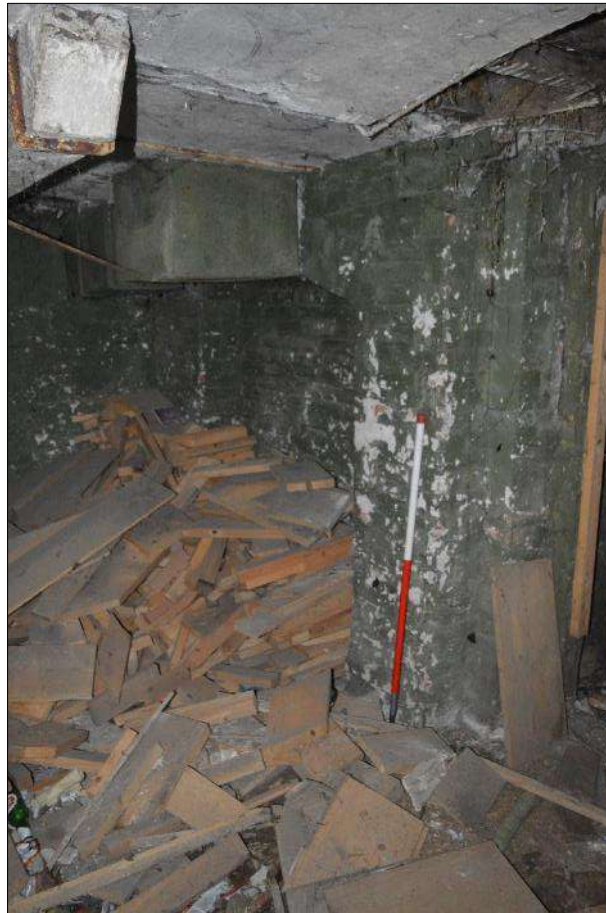
- 6.41 In the northwest corner of the room there is a removed fireplace and a segmental arched niche (Plate 47).

*Plate 47 (shot 134): Segmental arched niche and removed fireplace. Looking north-northwest, 1m scale*

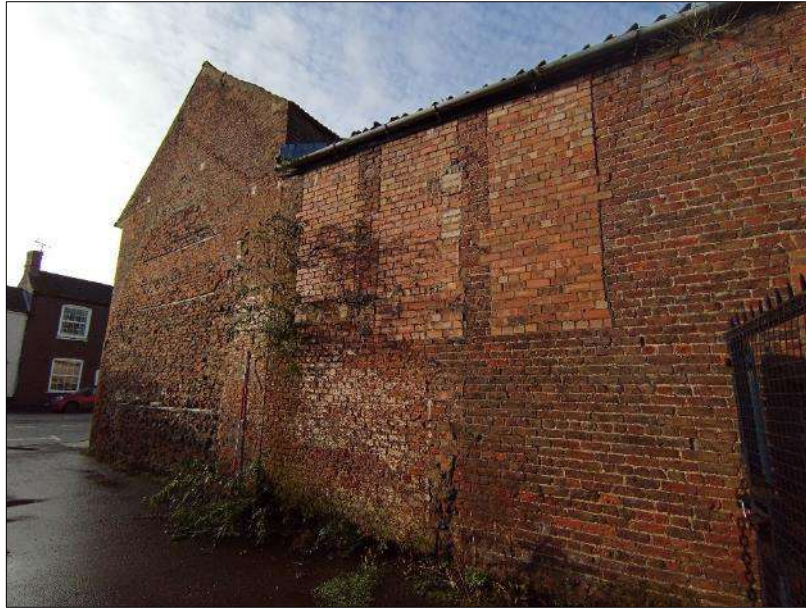
- 6.43 There is a straight abutting joint with Structure B to the south. On first-floor level there are three later, tall bricked up windows at the south end of the east elevation (Plate 48). There are a further three square blocked pitching holes on the first floor, and two smaller windows with depressed arches with stone lintels and a blocked, rounded archway on the same elevation (Plate 49-Plate 51). Two later small mono-pitched lean-to structures have been removed in the past. One was positioned below the three first-floor tall windows, and the second north of the blocked archway.

*Plate 48 (shot 170): Straight joint between Structures B and C and blocked up, later, tall windows. Looking south-southwest, 2m scale*

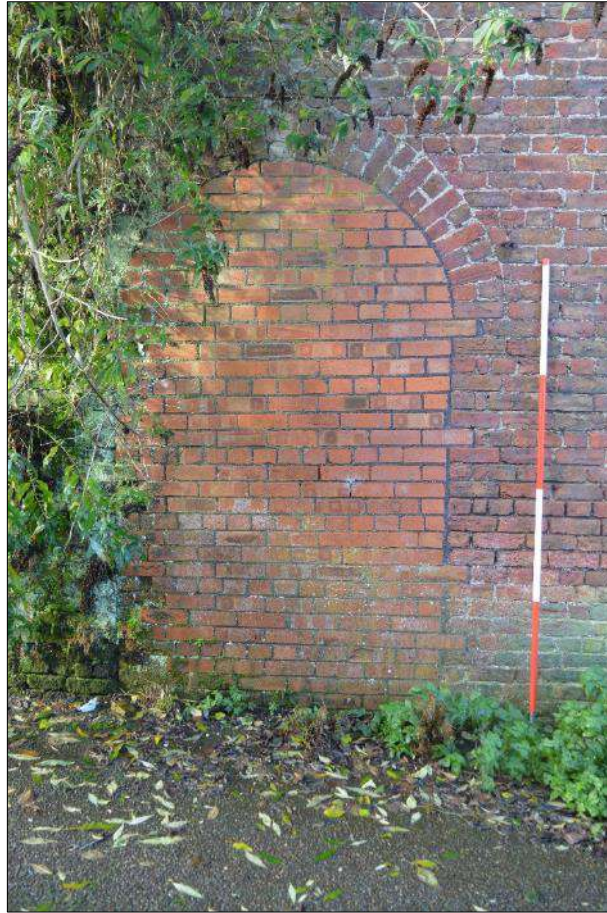
*Plate 50 (shot 32): Blocked archway on the east elevation. Looking west, 2m scale*

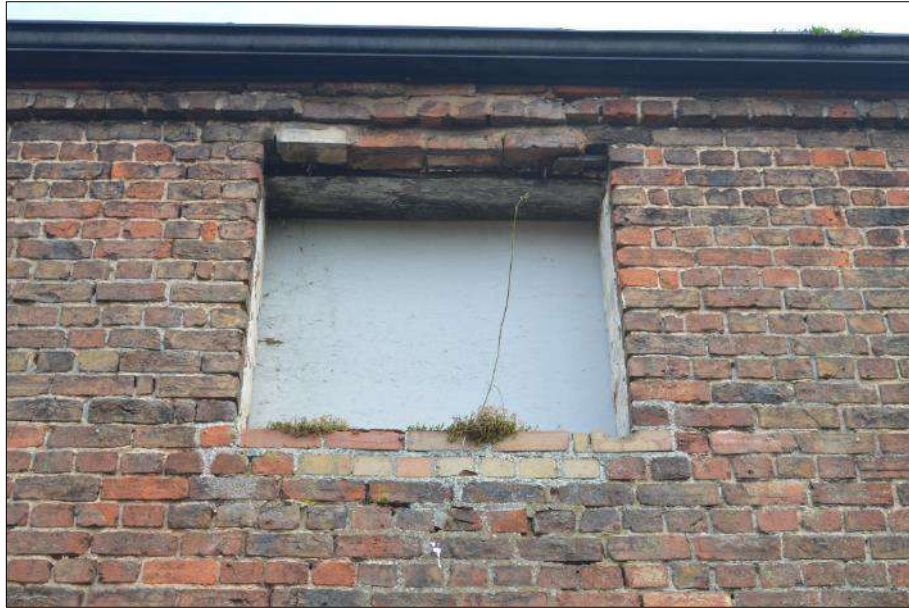
*Plate 54 (shot 49): Representative view of boarded pitching hole on first floor. Looking east-southeast*

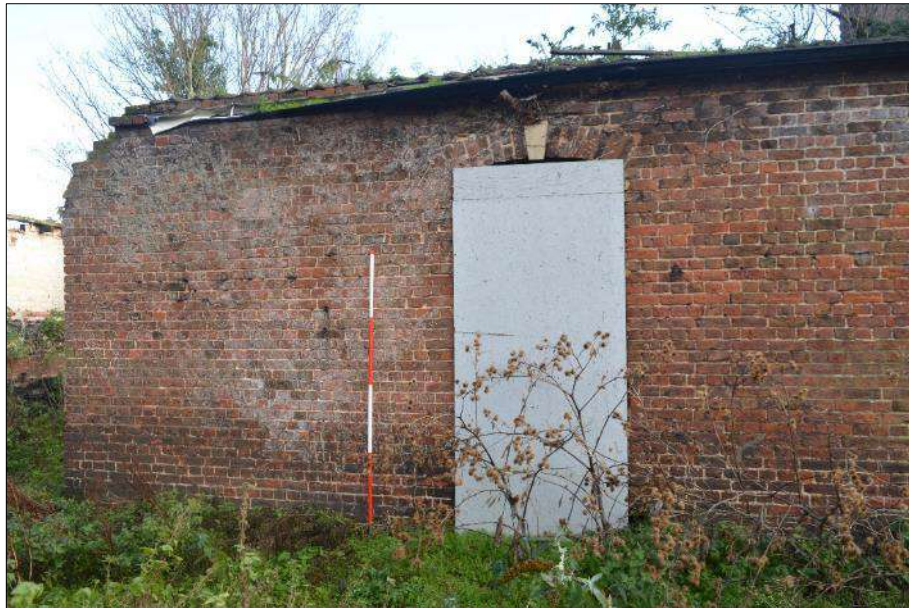
- 6.45 The single storey stable that would have accommodated at least two horses is located at the north of the range, C0.1. The roof has been removed or has collapsed. It is abutted with a straight joint by a modern structure to the east (Plate 55). The boarded doorway on the west elevation has a segmental arch with a wedge-shaped keystone (Plate 56).

*Plate 56 (shot 42): West elevation with boarded up doorway of C0.1. Looking east-southeast, 2m scale*

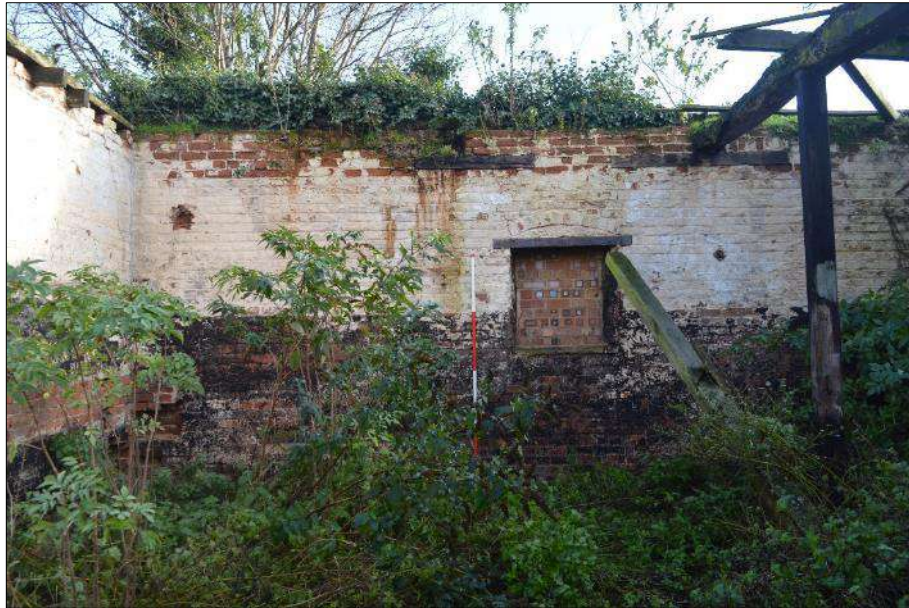
- 6.49 The interior of stable C0.1, was heavily overgrown. Most of the roof structure was gone, and that which remained comprised collapsed common rafters, and a horizontal tie-beam with two supporting timber posts. There were no fixtures or fittings noticeable along the walls.

*Plate 60 (shot 35): Interior view of C0.1, showing blocked window with segmental arch. Looking east-southeast, 2m scale*

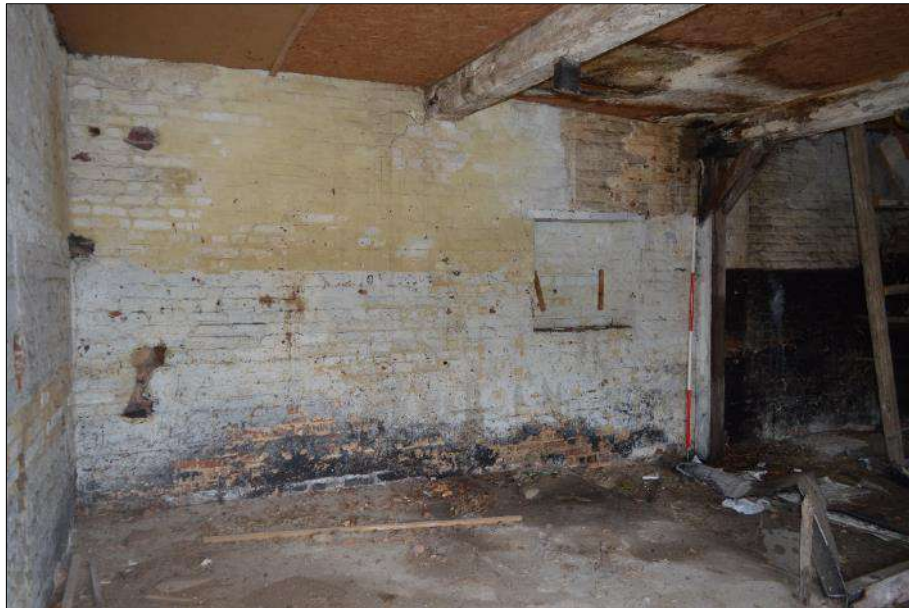
- 6.54 Stable C0.5 has been altered in recent years. The former doorway has been replaced by a wider opening and the floor in front of it has been covered in concrete (Plate 67). The four wooden upright posts have also been cut off and the ceiling covered with chipboard (Plate 68).

*Plate 67 (shot 110): View across the north area in C0.5, showing modern floor, removed timber post and blocked window. Looking southeast, 2m scale*

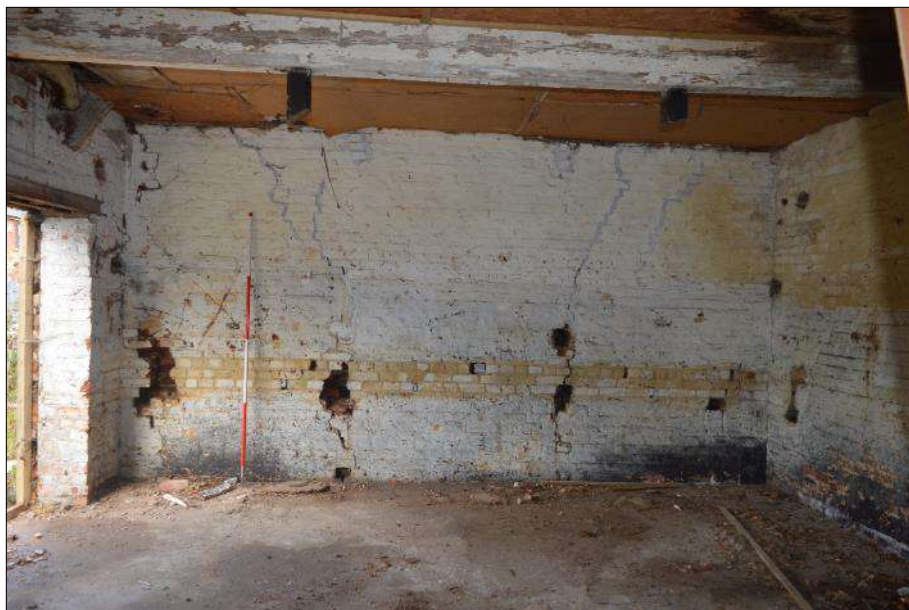
*Plate 68 (shot 114): General view towards the amended north part of C0.5. Looking north-northeast, 2m scale*

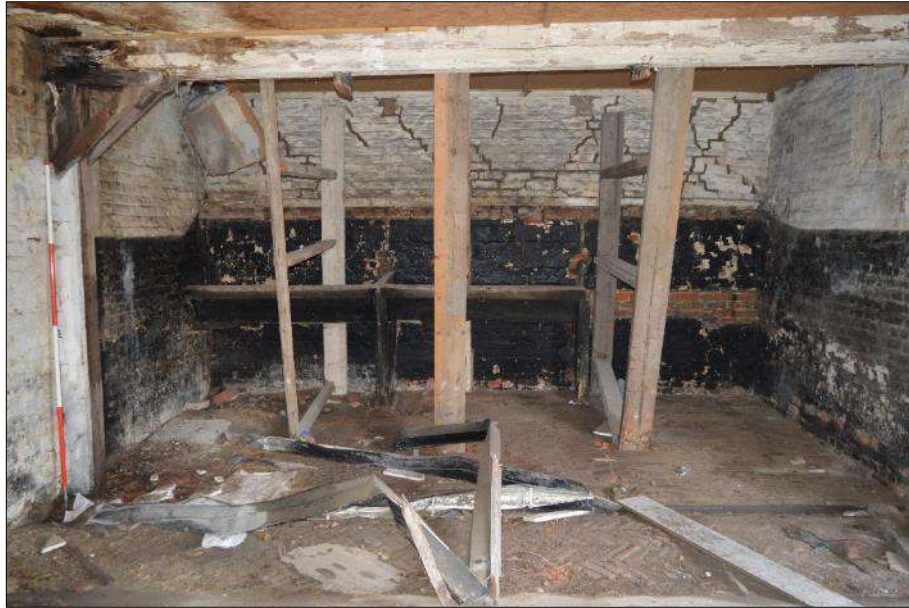
- 6.55 The southern half of C0.5 has also been modified, with the manger shortened to allow for modern supporting frames, but some original features remain (Plate 69) evident in the original axe/adze hewn main beam and supporting brace, the herringbone brick floor with drainage channel towards the centre, and the regular brick floor to the south.

*Plate 69 (shot 111): View towards the south end of C0.5, showing herringbone brick floor, amended trough, modern supporting timber frames and hewn original main beam and diagonal brace.*

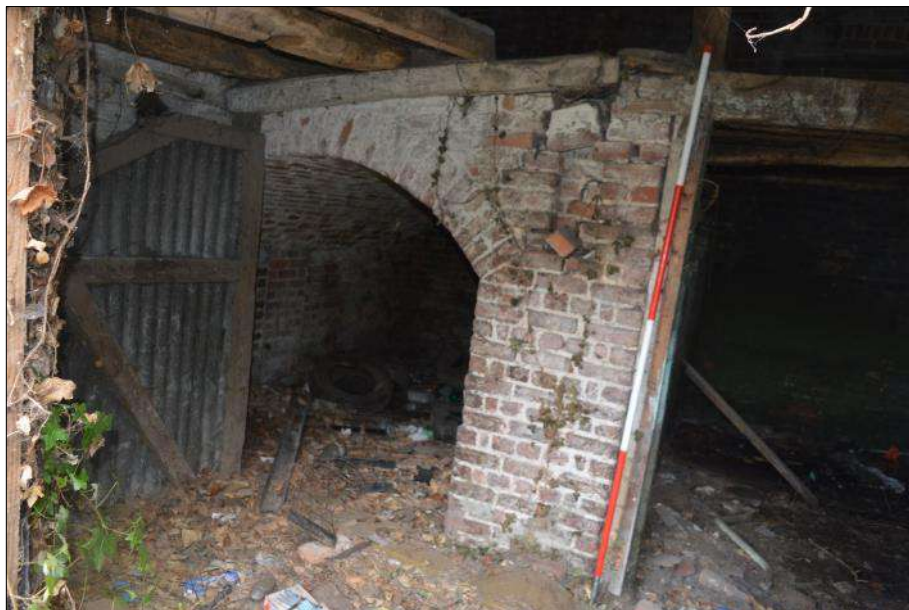
- 6.61 A vaulted store has been created at the north end of C0.7 (Plate 76). And may have house goods or beverages such as beer. It has a makeshift door with a timber frame holding a corrugated (asbestos?) sheet (Plate 77).

*Plate 77 (shot 125): General view towards the vaulted storage room in C0.7. Looking east-northeast, 2m scale*

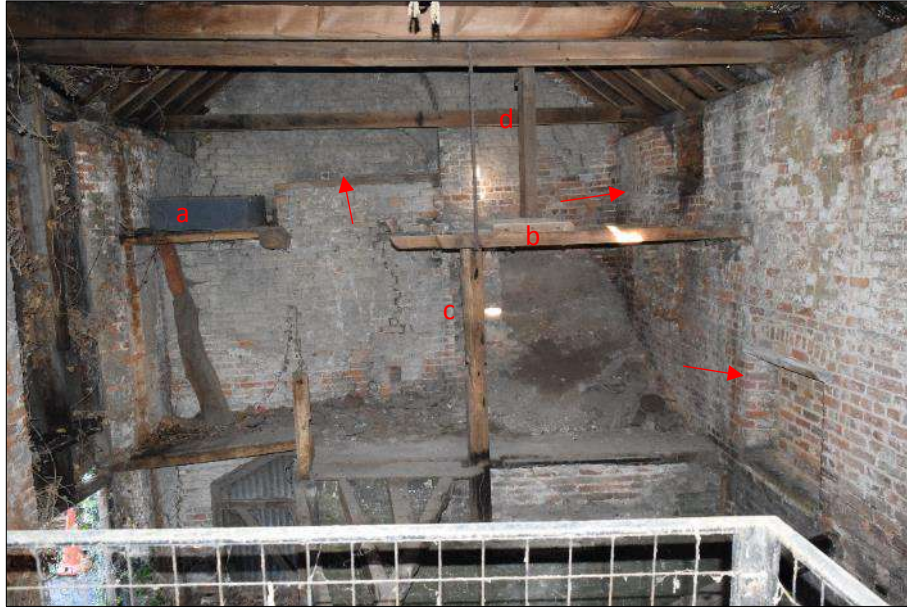
- 6.62 The mezzanine to the north has a plank floor of a rough L-shape. A reclaimed timber in the northwest corner supports a platform holding a possible coolship (a) for the wort (Plate 78). Adjacent to the vessel is a blocked up louvred opening. The northeast corner was covered in debris presumably from a collapsed structure. Between the north mezzanine and the roof is a wooden walkway/platform (b) suspended by an upright timber (c) from below and one from

*Plate 78 (shot 268): View across C1.1, arrows point to blocked louvred openings. a-d denotes positions of contraptions mentioned in the text, eg: (a) coolship. Looking north-northeast*

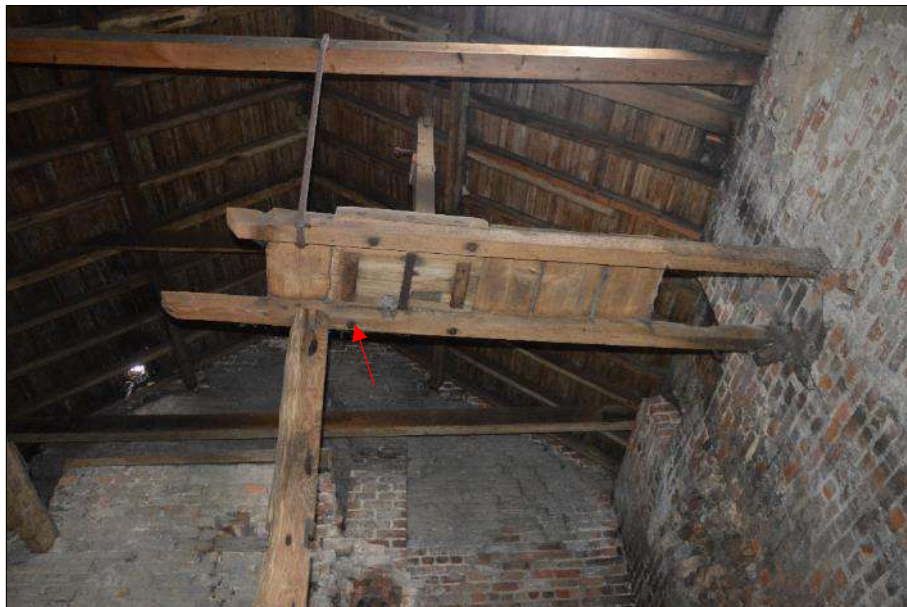
above (d). This may have offered access to a large hopper contraption/alternatively a grist case placed across the wooden framework beneath and held above a vat/mill on the ground floor (Plate 79-Plate 80). There is a circular hole in the suspended platform that would presumably have fitted a chute. Remains of ropes hanging from rafters and eyelet fittings may be related to hoist mechanisms.

*Plate 79 (shot 139): Platform above north mezzanine, arrow points to circular cut hole in a square platform fixed in position by square nots and bolts/tails. Looking north-northeast*

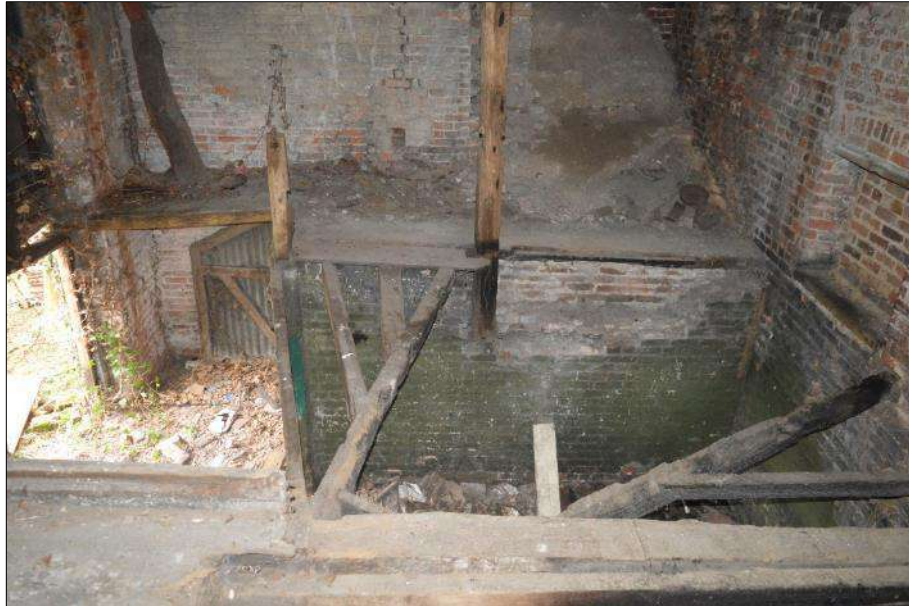
*Plate 80 (shot 153): Close up of mezzanine and branching floor structure. Looking north-northeast*

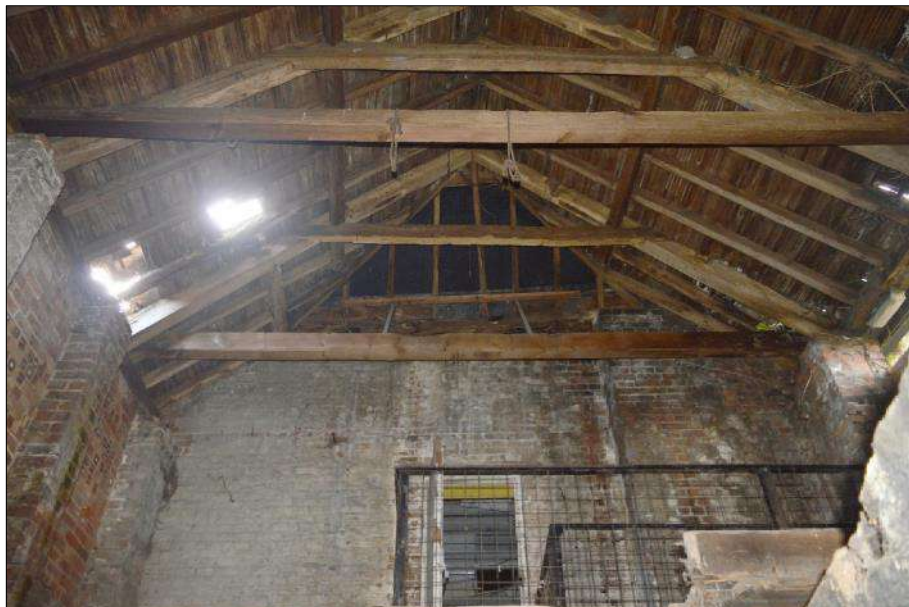
- 6.63 The axe/adze hewn principal rafters in this part of the structure are reclaimed and show large mortice holes from former post or strut joints, as well as trenches from former purlins. The current roof structure consists of two principal rafters with a supporting horizontal tie beam below the purlins (Plate 81). The purlins support common rafters above which is a tightly fitted lathed roof. The horizontal tie-beams are of later date, displaying regular set of vertical kerf marks, suggesting these were cut by a mechanical pit saw. The purlins and common rafters are presumably contemporary, the timbers could only be viewed from a distance.

*Plate 81 (shot 137): View towards the south mezzanine showing the roof structure. Looking south-southwest*

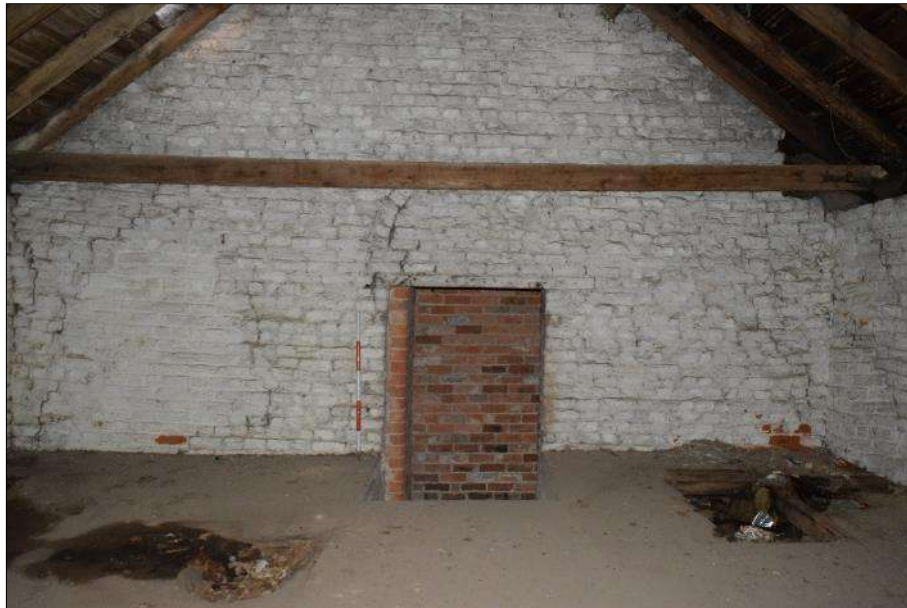
- 6.64 A full loft spans the length of the remaining structure from the partition between C1.1 and C1.2. A blocked louvred opening is visible above the brick staircase to the south (Plate 82).

*Plate 82 (shot 277): Partition and loft entrance between C.1.1, notice blocked opening above the staircase.*

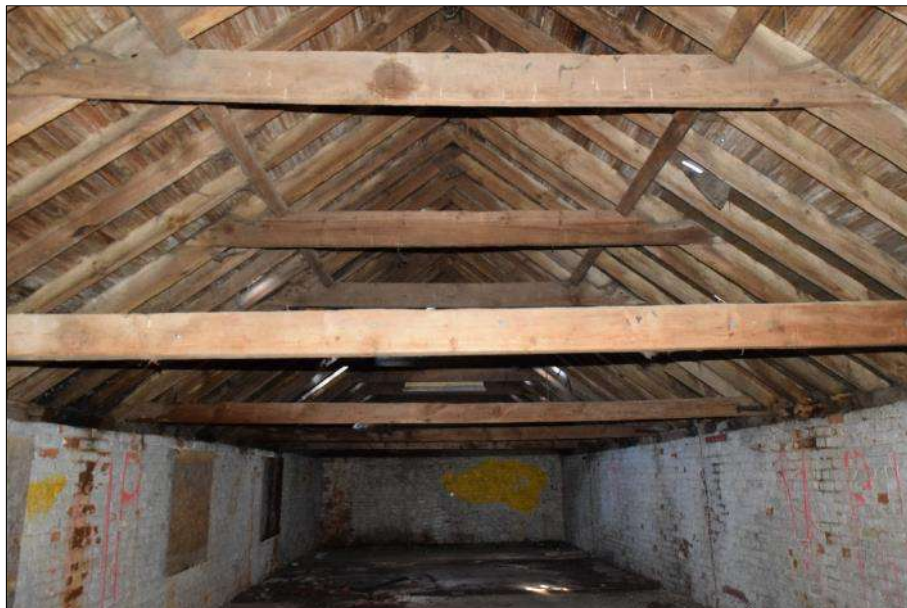
- 6.65 The common rafter roof structure above C1.2 does not show any reclaimed timbers. The tie-beam offers extra fixture to the wall plate, whilst the horizontal collar supports the purlins above. The roof is tightly lathed.

*Plate 83 (shot 275): General view along loft, C1.2, showing timber roof structure. Looking north-northeast*

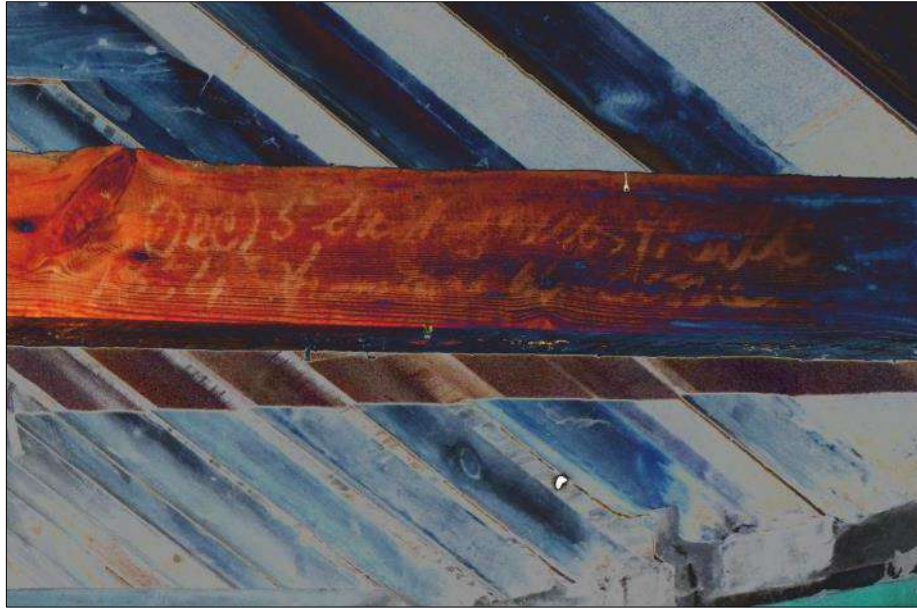
- 6.66 One of the tie-beams had a shallow text carved in it and only partially legible “Dec 15 1854 Sa...  
...t .... from ... wife(?) Irene?”

*Plate 84 (shot 281): Close up of carved inscription on tie-beam, supposedly dated 1854.  
Looking north-northeast*

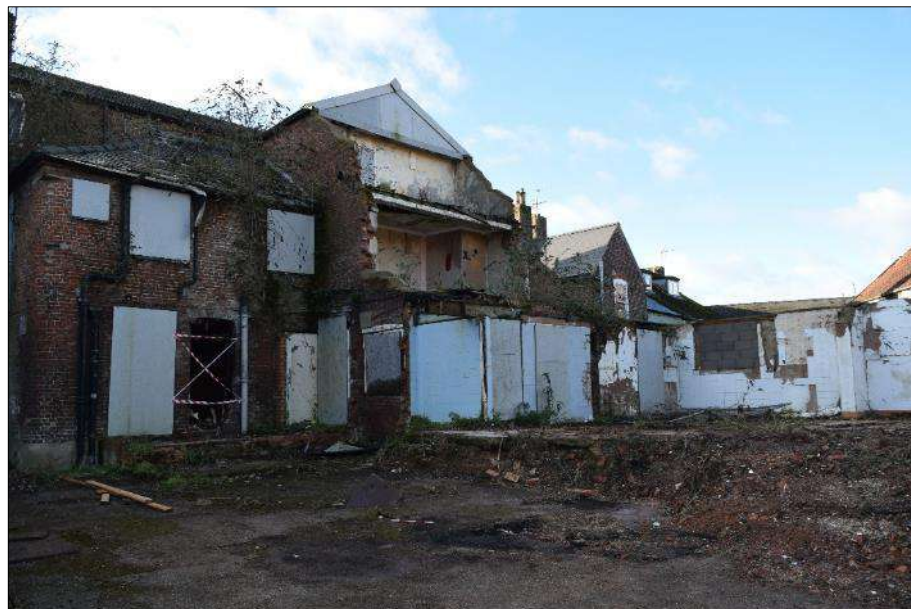
- 6.67 Very little remained of the three storey, north wing D, and the interior was inaccessible for safety reasons. It appears to have been built in the same brick stock as A and adjoining two-storey extension to the east and appear to be of contemporary date (Plate 85-Plate 86). The modern tiling is probably related to a kitchen and/or lavatory.

*Plate 85 (shot 207): General view of partially demolished north wing D. Looking southwest*

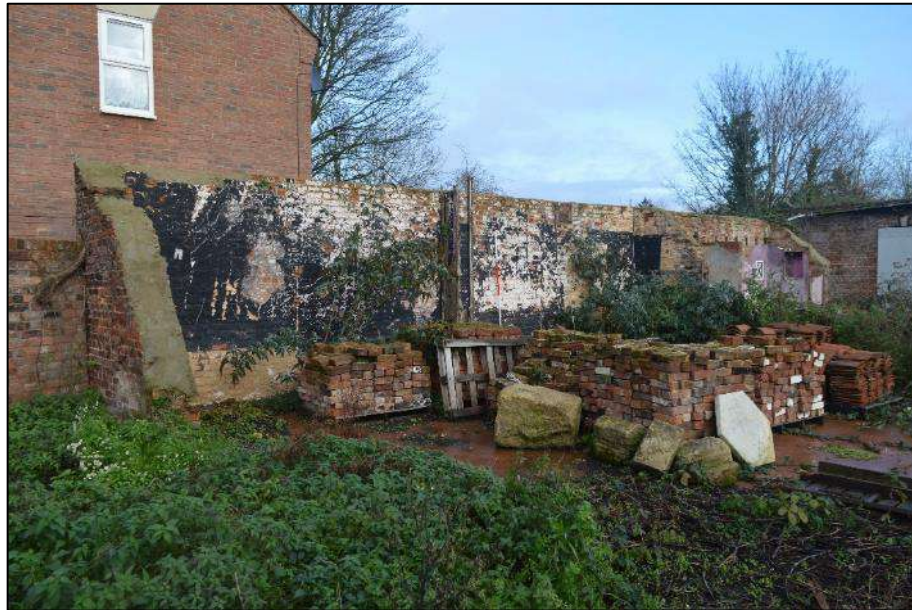
- 6.69 The former Tap Bar (Swann Edwards 2017) is a small rectangular structure with walls three headers wide, which had been largely demolished prior to the survey. The brick stock was of similar type as that used on Structures A, B, C and D. An English Garden Wall bond of three

courses of stretchers between each course of headers had been utilised on the west wall as seen on the east elevation of Structure C.

*Plate 88 (shot 168): General view of the remains of Structure E. Looking northeast, 2m scale*

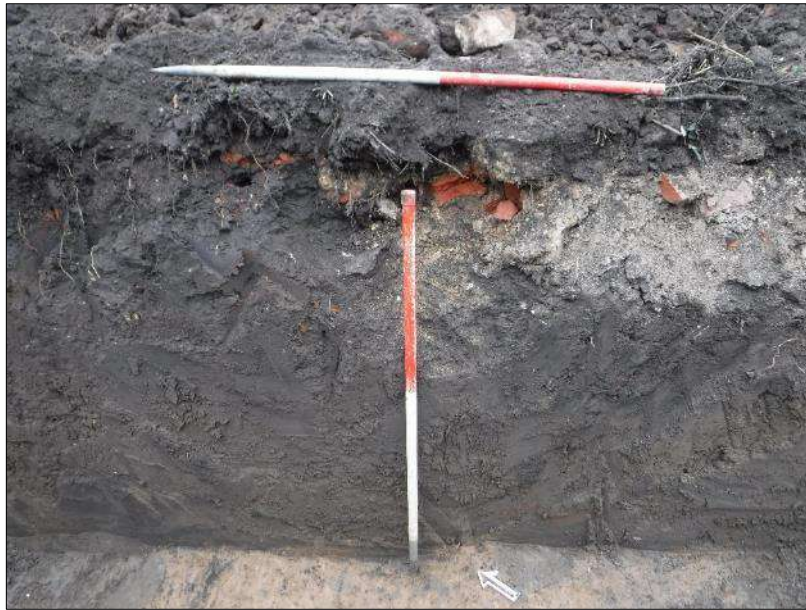
- 6.70 Trench 1 was located at the southwest end of the site. This trench was aligned east to west and measured 10m long x 1.4m wide.
- 6.71 The earliest deposit exposed in Trench 1 was a natural deposit of light brownish yellow silty sand, 102, which was overlain by a deposit of dark brownish grey sandy silt, 101, measuring 1.12m thick. This was sealed by a layer of rubble and hardcore material, 100.

*Plate 89: South-facing representative section of Trench 1, looking north, scales 1m*

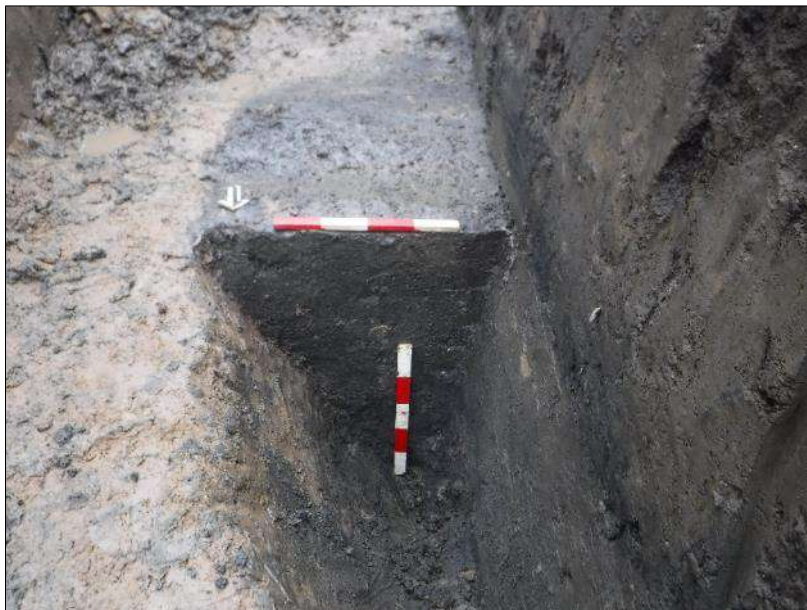
- 6.72 Trench 2 was located approximately 10m east of Trench 1. It was aligned north to south and measured 6m long x 1.4m wide.
- 6.73 The earliest deposit exposed in Trench 2 was a light brownish yellow natural, 202. Cut into the natural and extending beyond the trench to the west was a sub-oval pit, [203], measuring 2.26m long and 0.88m deep, which had been backfilled with dark brownish grey sandy silt, 204, from which two pieces of post-medieval pottery were recovered. This was sealed by dark brownish grey sandy silt, 202, measuring 1.04m thick, which in turn was sealed by a hardcore surface, 100, measuring 0.16m thick.

*Plate 90: North-facing section of pit [203], looking south, scales 0.5m and 0.4m*

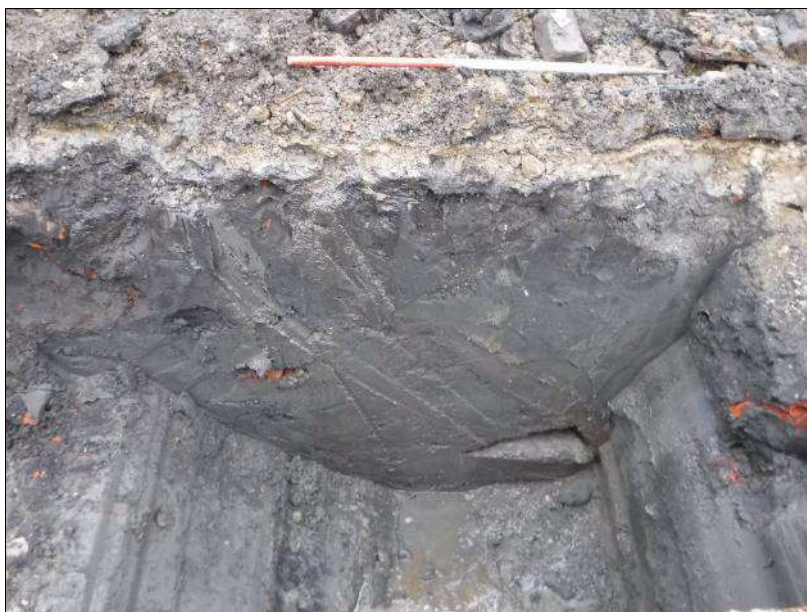
- 6.74 Trenches 3 and 4 were located in the northeast area of the site, and were both aligned broadly east to west. Trench 3 was 9m long x 1.4m wide and Trench 4 was 7m long x 1.4m wide.
- 6.75 The stratigraphy in Trenches 3 and 4 was the same; it consisted of a light brownish yellow silty sand natural layer, 303 and 403, overlain by dark brownish grey sandy silt, 301 and 401, measuring 2.2m thick, which in turn was sealed by a layer of hardcore, 300 and 400, measuring 0.2m thick.

*Plate 91: North-facing representative section of Trench 3, looking south, scale 1m*
