**Condition Survey  
Report**

**Timber & Metal Windows**

**Thomas Cowley High School  
School Lane  
Donington  
Spalding  
PE11 4TF**

**October 2022**

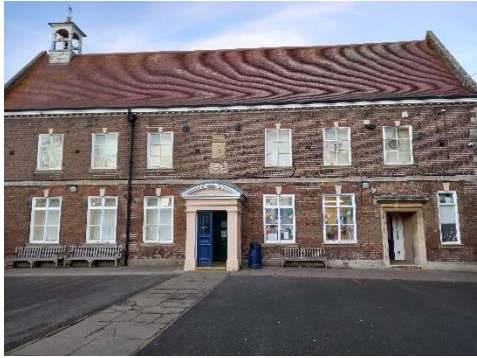
| <p><b>Figure: 1</b><br/>Location: Original Building<br/>General view of Original Building</p> | <p><b>Figure: 2</b><br/>Location: Original Building<br/>General view of Original Building</p> |
