## **Stage One Environmental Desk Study of**

**Plot 5, Highstock Lane, Gedney Hill**

**REPORT NUMBER 20-02-01**

## **Environmental Risk Assessment of Plot 5, Highstock Lane**

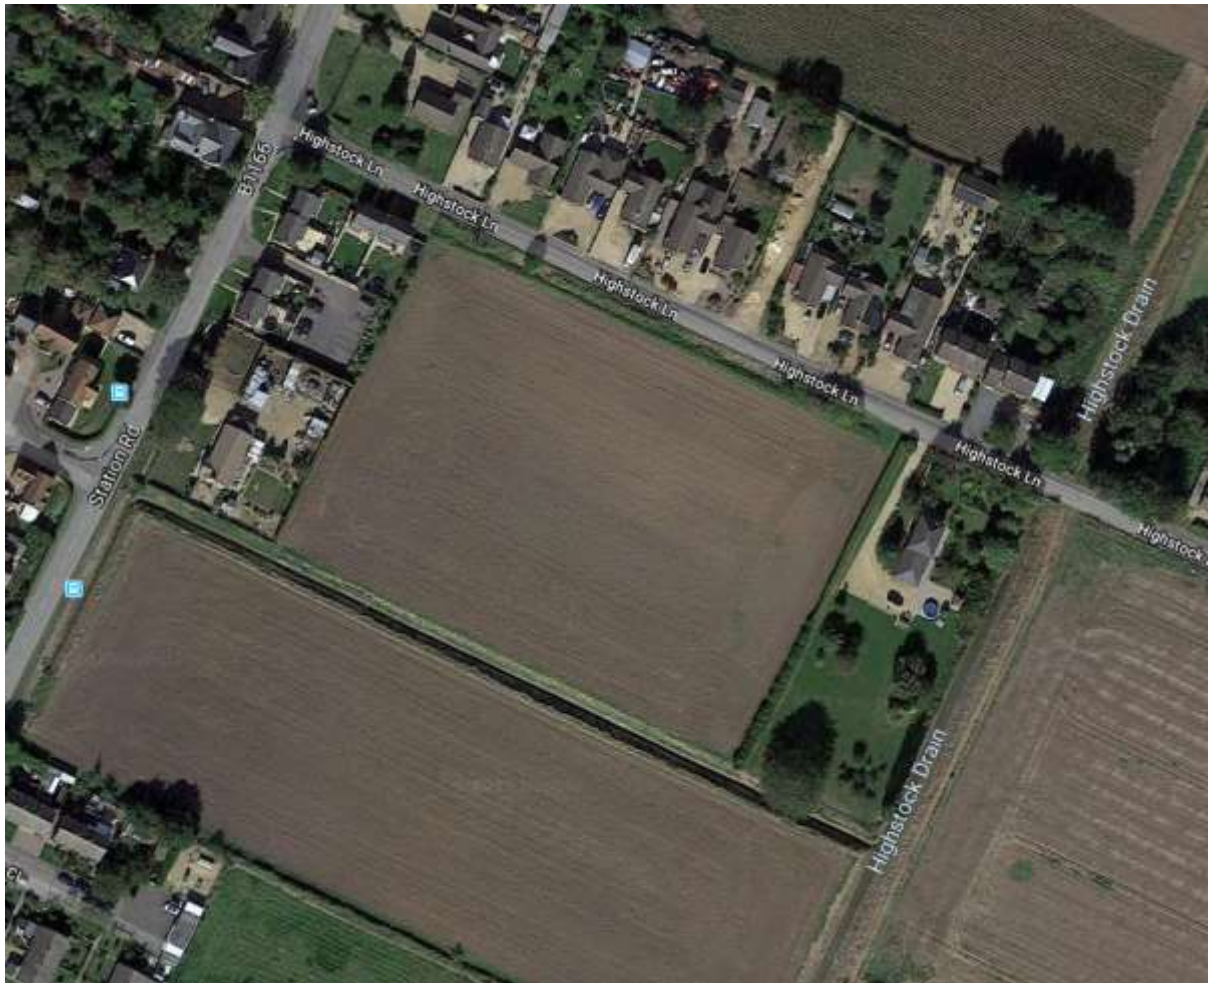
Figure 1 Google satellite image showing fields and houses near to the site

2.2 The Google satellite image (Figure 1) shows that site is in a rural area with houses along the roads and fields in close proximity.
