**Phase 2 (ground investigation) assessment report**

**Land between 10 and 12 Risegate Road, Gosberton**

Produced for JC Architectural Consultant

December 2024

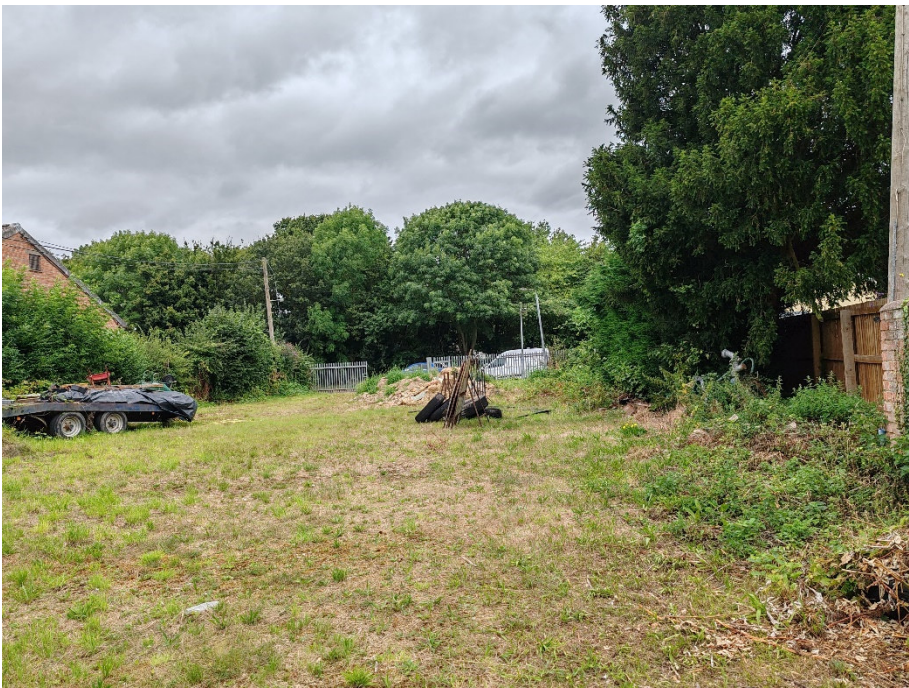
Site works photo: 1      Date: 05 Aug 2024  
Photo direction: North  
Description: View of existing grassed yard, scrub vegetation and stockpiles

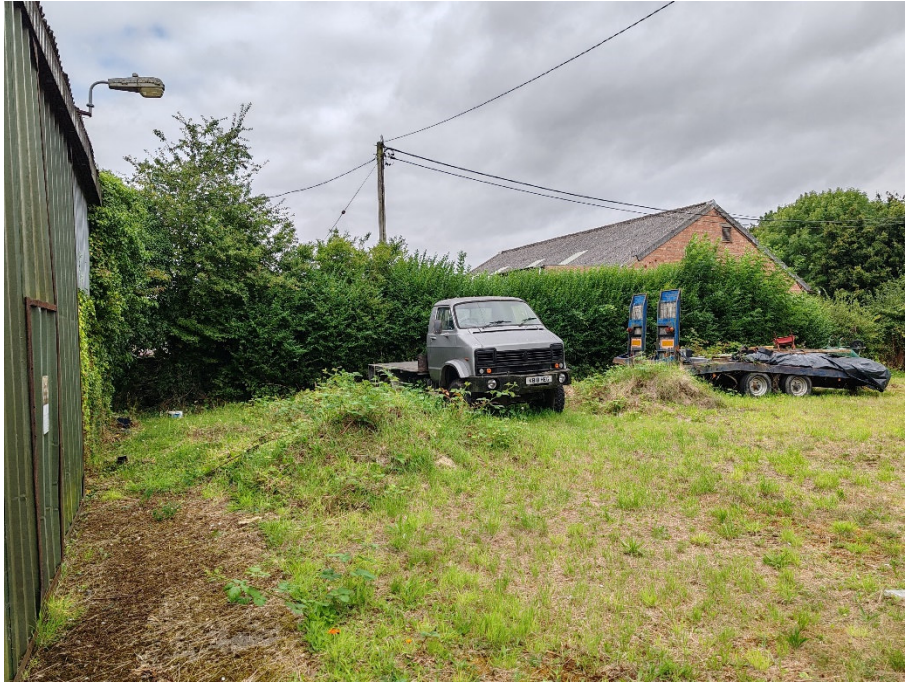
*Site walkover photo: 2*    *Date: 05 Aug 2024*  
*Photo direction: West*  
*Description: View of side of barn, vehicle on site, trailer and grassy yard*

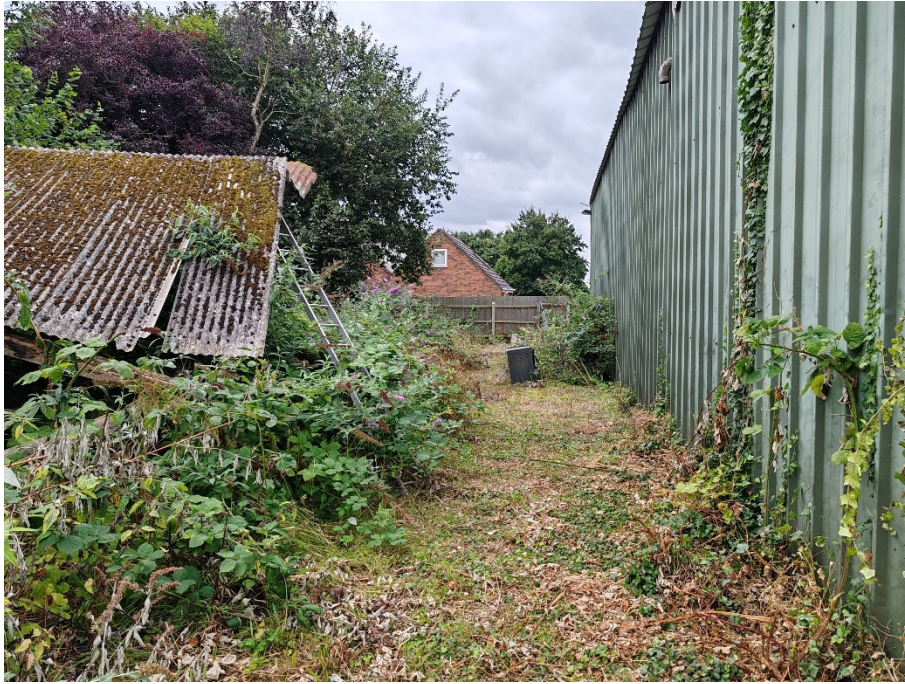
*Site walkover photo: 4*    *Date: 05 Aug 2024*  
*Photo direction: South*  
*Description: View of side of barn, disused cattle shelter and surrounding overgrown vegetation*

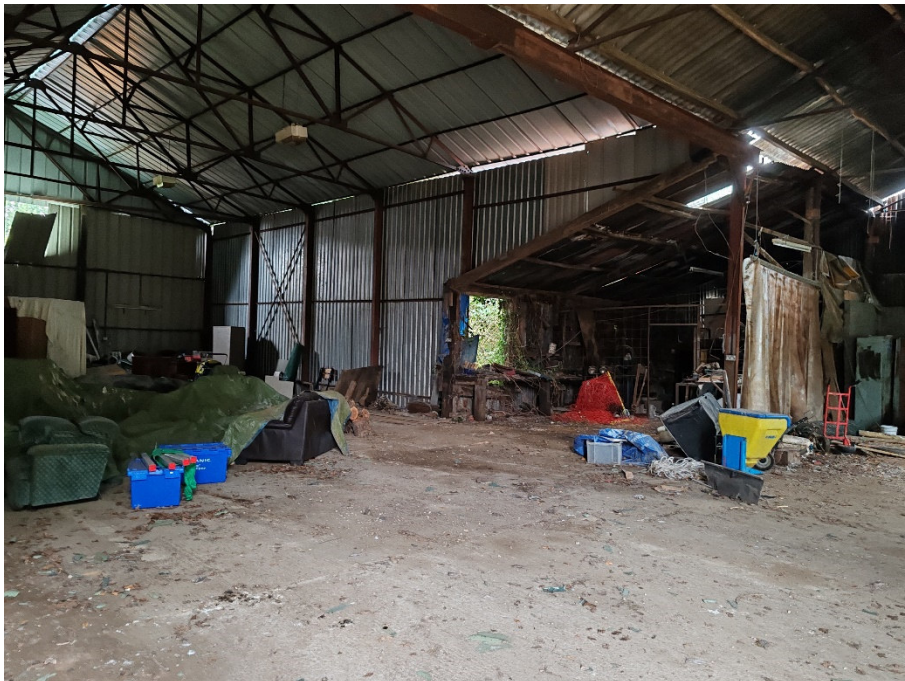
*Site walkover photo: 5*    *Date: 05 Aug 2024*  
*Photo direction: Southwest*  
*Description: View inside of barn with miscellaneous items such as sofas and bins*

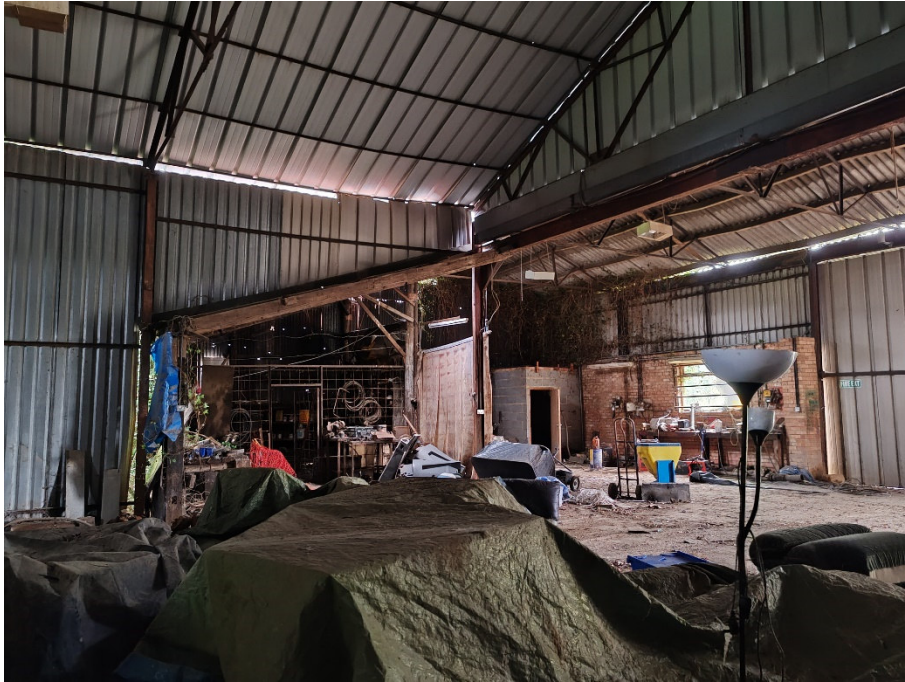
*Site walkover photo: 8*    *Date: 05 Aug 2024*  
*Photo direction: West*  
*Description: View inside of barn and stored wares including furniture and carpentry tools*

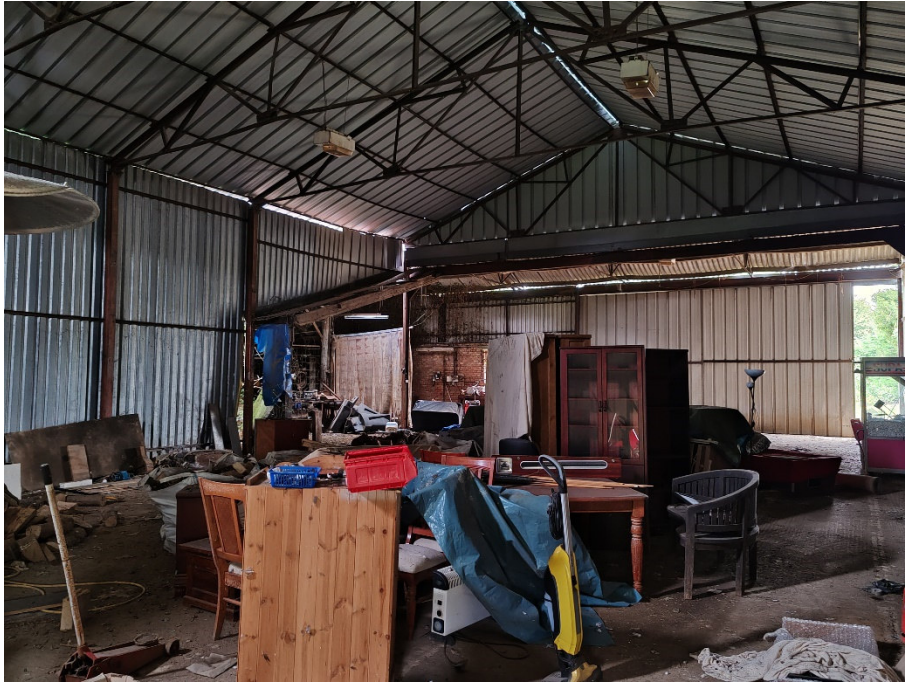
*Site walkover photo: 10*    *Date: 05 Aug 2024*  
*Photo direction: North*  
*Description: View of inside barn including assorted wares (furniture and carpentry tools)*

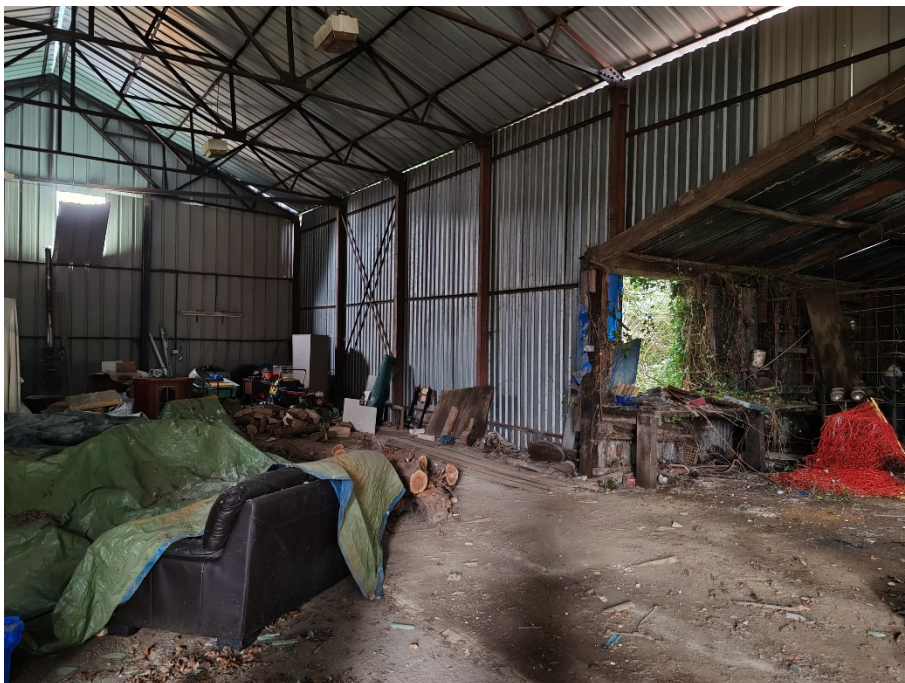
*Site walkover photo: 11*    *Date: 05 Aug 2024*  
*Photo direction: Southwest*  
*Description: View inside of barn with log supply, carpentry tools and area of overgrown garden*

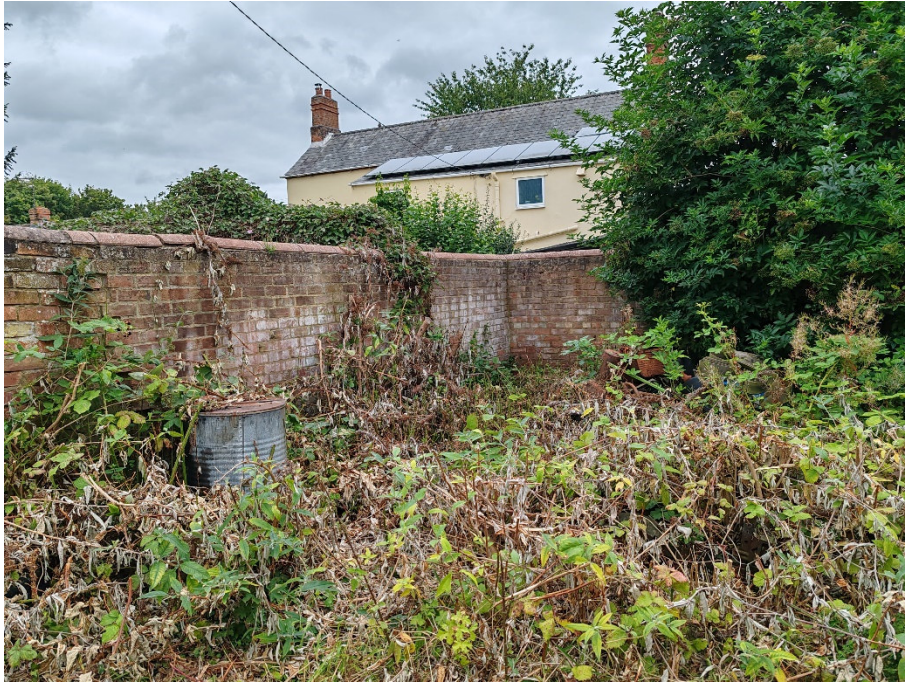
*Site walkover photo: 12*    *Date: 05 Aug 2024*  
*Photo direction: Southeast*  
*Description: View of overgrown garden area behind barn*

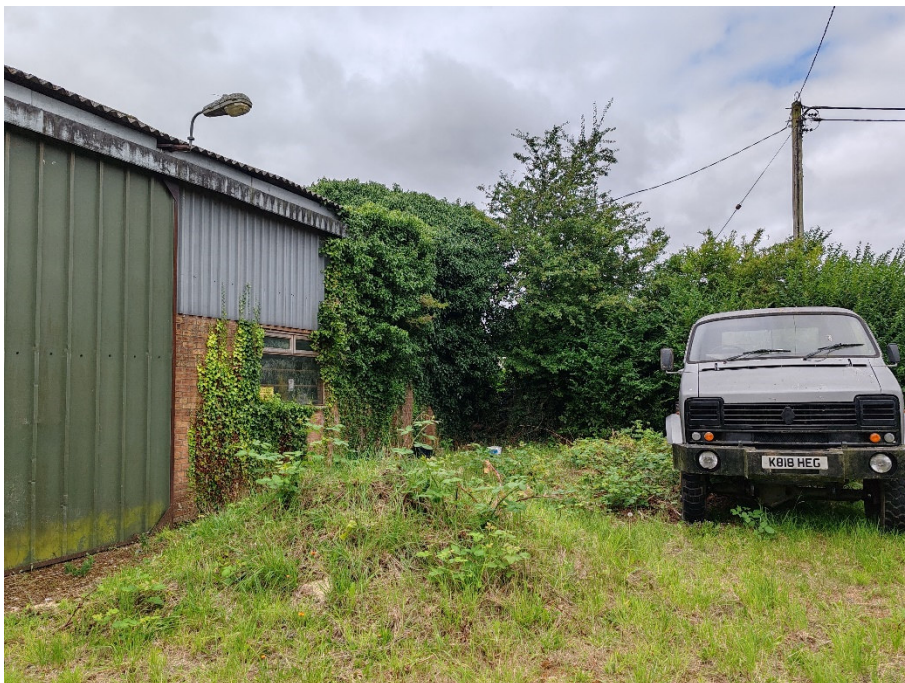
*Site walkover photo: 13*    *Date: 05 Aug 2024*  
*Photo direction: West*  
*Description: View of parked vehicle, front of barn and overgrown vegetation in yard area*

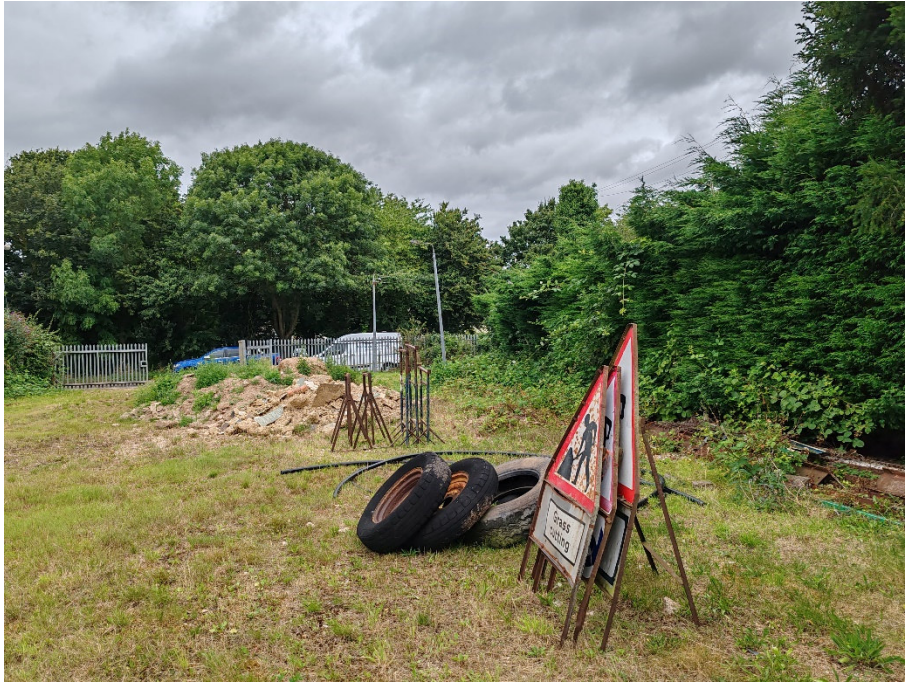
*Site walkover photo: 14*    *Date: 05 Aug 2024*  
*Photo direction: North*  
*Description: View of grassed yard, stockpiles (materials from barn extension) and road signs*

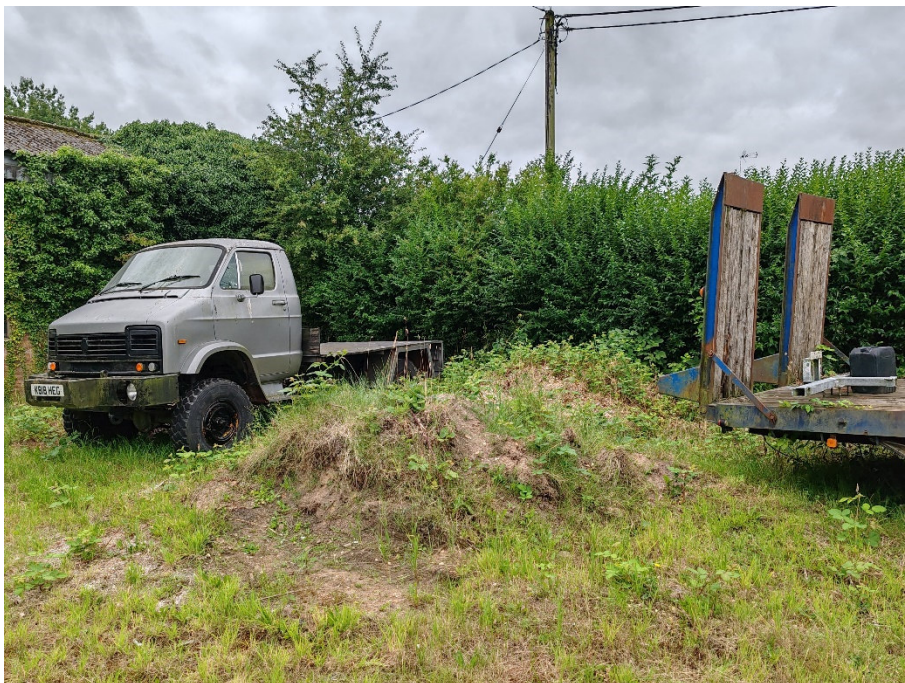
*Site walkover photo: 15*    *Date: 05 Aug 2024*  
*Photo direction: West*  
*Description: View of vehicle, trailer and pile of ground material with some scrub vegetation*

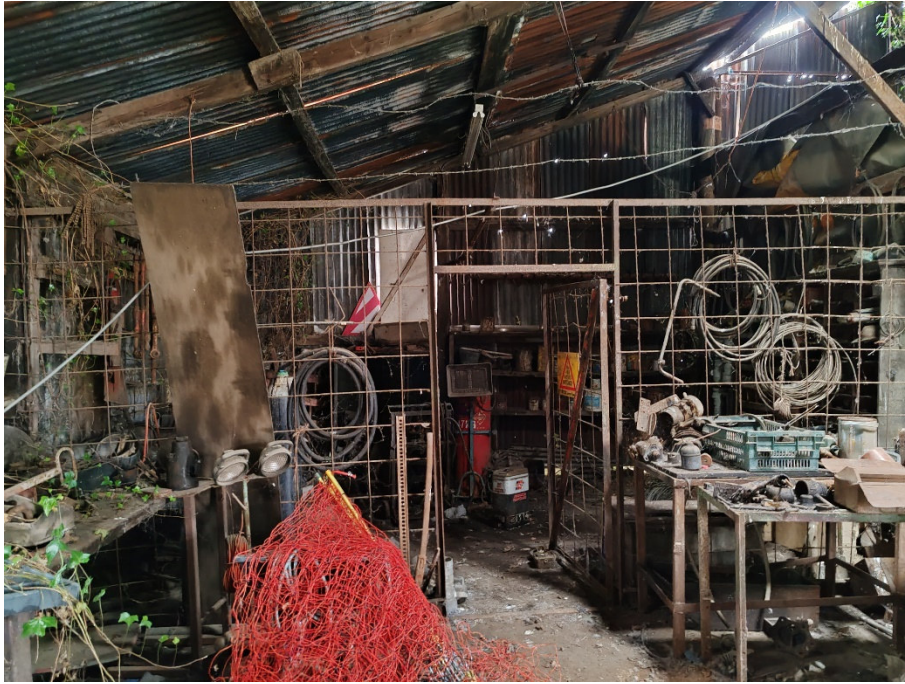
*Site walkover photo: 16*    *Date: 05 Aug 2024*  
*Photo direction: West*  
*Description: View of disused carpentry area in barn with some small appliances*
