David Aldridge Architecture Limited  
 Leadenhall House, Holbeach St. Marks  
 'As existing' photographs  
 Sheet No. 1

Ref: 0219-10

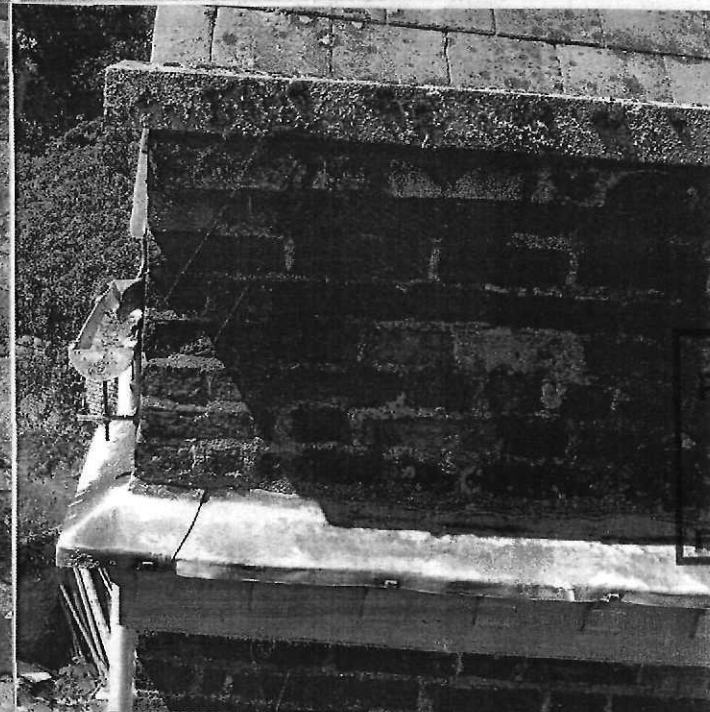
South west corner parapet.
