# Inspection Report

## Seas End Hall, Spalding

Reference: J7238

Date: 23 August 2024

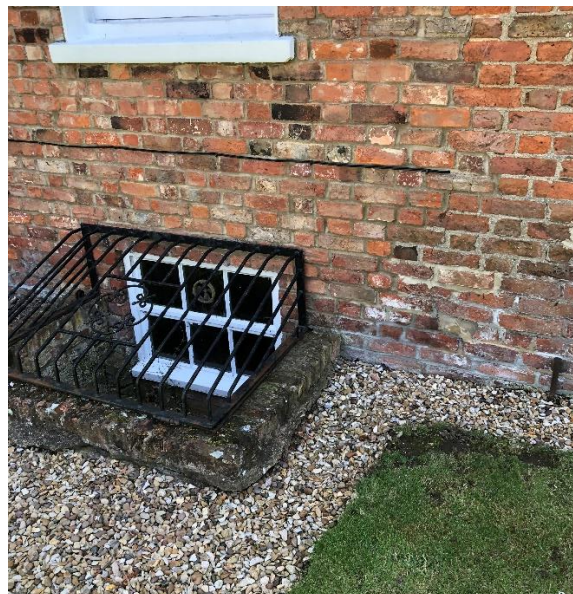
*Figure 3-2 Basement Window*

The brickwork walls enclosing the basement are susceptible to rising damp. The ends of the timber beams are built into the wall, and it is unknown whether damp proof courses have been installed to protect the timber from rot. The old timber members should be investigated by a timber specialist to determine the extent of rot.

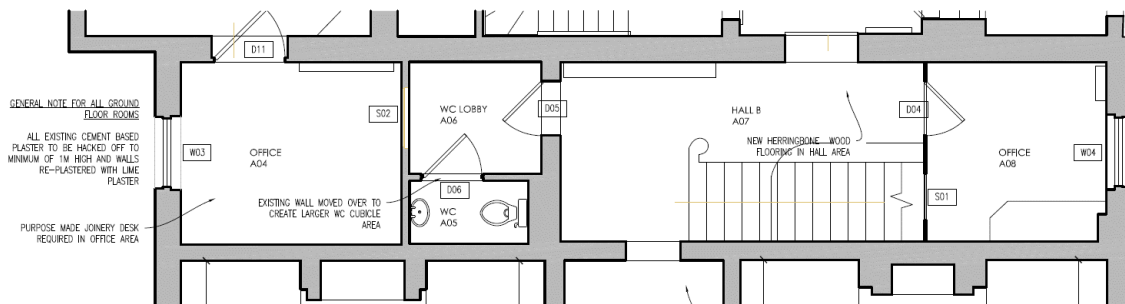
**Ground Floor Plan Over Basement**

Brickwork walls surrounding the basement support the ground floor above, which is a mix of different constructions as shown below.

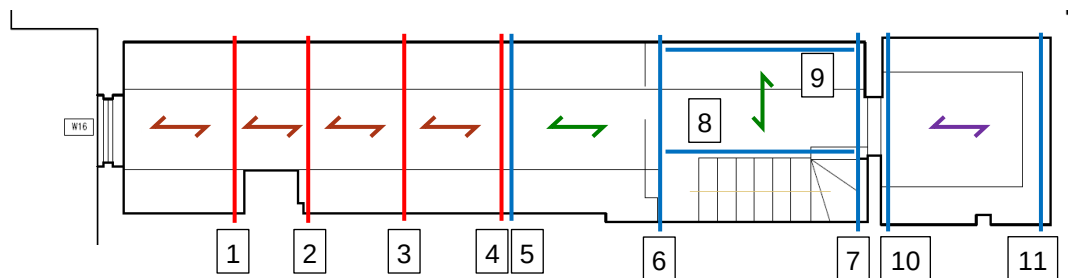
**Basement Plan Showing Structure Over  
(with beam number references)**

| Beam no. | Photographs with comments | |
|---|---|---|
| 1 | <p>70x150mm deep timber beam and supported joists appear to be in good serviceable condition.</p> | <p>Whilst there are no apparent defects, there is a lack of support to the beam end. We recommend this is rectified either with installation of a short timber post or filling the recess with brickwork to provide support.</p> |
| 2 | <p>The timber beam is not a modern regular timber section. Approximate size is 210x230mm deep. We recommend that a timber specialist investigates the extent of rot in the beam, with the member replaced if significant loss of section is found.</p> | |

| 3 | <p>80x170mm deep timber beam and supported joists appear to be in good serviceable condition.</p> | |
| 4 | | <p>The timber beam is not a modern regular timber section. Approximate size is 230x260mm deep. It supports timber joists from one side only and most likely the masonry wall above. We recommend that a timber specialist investigates the extent of rot in the beam, with the member replaced if significant loss of section is found.</p> |

| <p>5, 6, 7,<br/>8, 9</p> | <p>Modern concrete slab on steel composite decking supported on steel beams. Beams supported on padstones in the brickwork wall. Structure in good condition.</p> | |
| <p>10, 11</p> | <p>Modern timber joists supported on steel beams. Structure in good condition.</p> | |
