HISTORIC BUILDING SURVEY

Seas End Hall
Moulton Seas End
Spalding
Lincolnshire
PE12 6LB

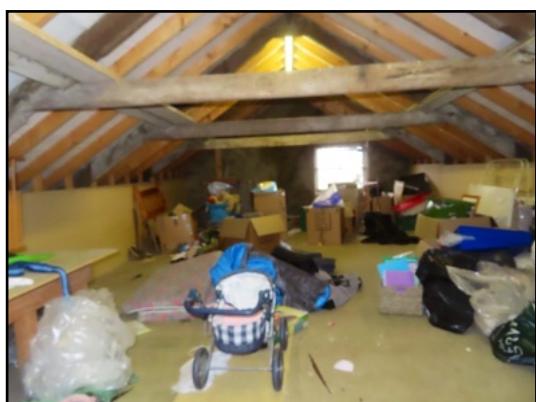
Roof Spaces and Access

A staircase leading up from the first floor landing gives access into the roof space above the central structure and this roof space area has been boarded for access and storage. From here a doorway leads into the roof space above the front structure although access into and around this roof space area was restricted as thick quilts of loft

insulation material have been laid across the ceiling joists, concealing areas of safe passage.

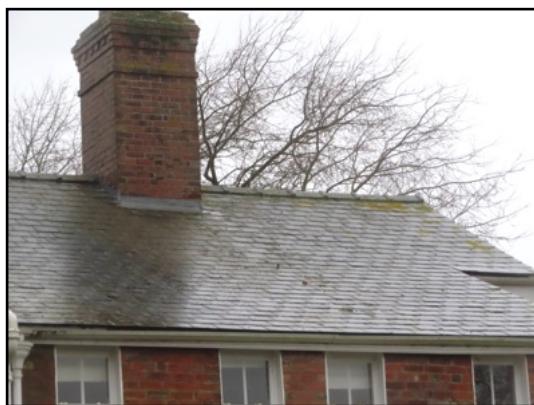
5.2 Pitched Roof Coverings

The main pitched roofs are covered externally with natural slates along with sheets of a breathable sarking membrane beneath the slates and their supporting battens where visible. The valleys formed where the roofs meet are lined and lead flashings are in place to protect the vulnerable junctions where these slates

meet overlying masonry, including where the various structures meet and around the bases of the chimney stacks.

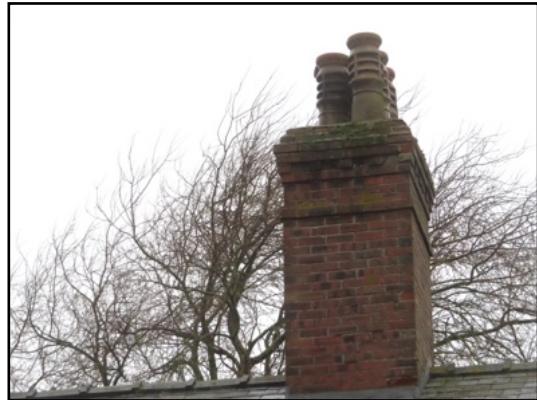
The property is served by six separate brick-build chimneys and these rise into large brick-built chimney stacks above roof level. There are two chimney stacks within the rear roof slope of the front structure and these contain three flues each. There is a single flue chimney stack to the front left-hand corner of the central structure and a two flue stack to the rear right-hand corner. There is also a two flue stack above the rear gable of the central structure. The rear structure has a five flue chimney stack rising through the centre. My inspection was limited to an external inspection from ground level and from within accessible areas. I was unable to properly check the mortar flaunchings to the tops of the chimney stacks.

There are high top cowls to the chimney pots above the front structure and vent caps to the chimneys to the rear right-hand corner of the central structure and to the rear structure. The chimney to the rear gable of the central structure has hooded caps as does the chimney to the front left-hand corner of the central structure. The chimney to the rear structure has one pot with a hooded cap whereas the others are louvred pots.

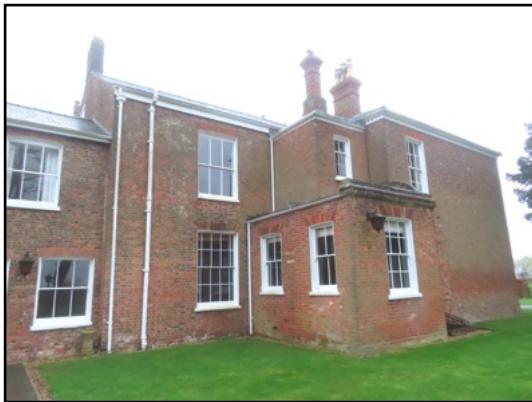
6.1 Type of Construction

The various structures making up the main house are all of a traditional construction with solid external walls built in brick. The external walls of the three main structures are of one and a half brick thickness (340mm) although the rear gable wall of the central structure reduces the single-brick thickness (225mm) at roof

space level and is rendered internally. The external walls of the additional structures to the left- and right-hand sides, being the two-storey and single-storey additions to the left-hand side and the two-storey structure housing the porch and bathroom above to the right-hand side have external walls of single-brick thickness (225mm). The brickwork is largely exposed externally although part of the rear wall of the rear structure has been clad externally in a cement render application at ground floor level. Internally, these external walls have been plastered and decorated. The rear gable wall of the rear structure has been partly rebuilt at ground floor level suggesting that there was previously an adjoining structure which has now been removed.

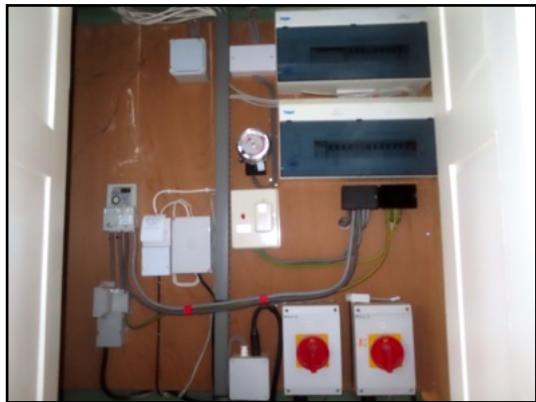
Mains electricity is connected. The mains switch gear and consumer units are located in the boot room to the rear and there is a secondary consumer unit within the cloakroom to the left-hand side of the hallway.

I carried out a visual inspection of the visible elements of the installation only. The electrical installation can only be ascertained through proper testing and should be checked by a suitably competent electrician before you take ownership unless there is an Electrical Installation Condition Report from within the last twelve months showing that the whole installation has been safety checked and found to be safe and satisfactory. This test should include the whole installation, including within the grounds and any garages and outbuildings.

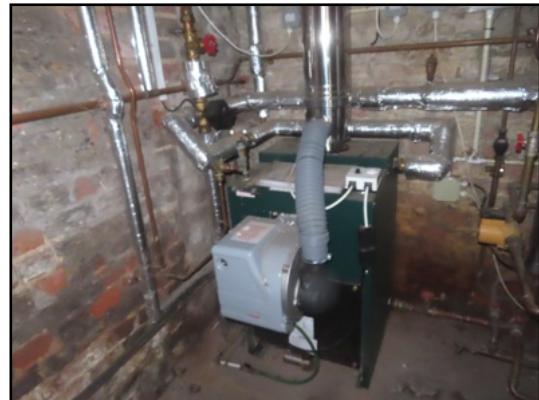
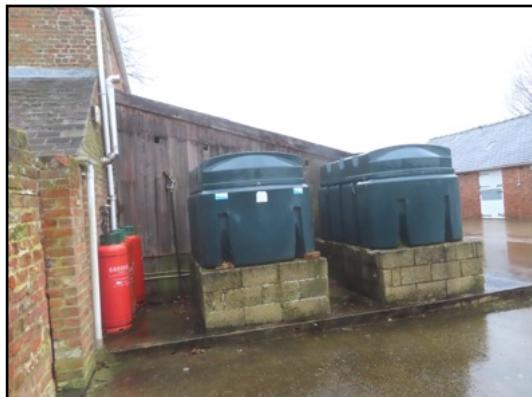
Central Heating

The boiler is located within an outbuilding attached to the right-hand side of the Coach House and this discharges via an open metal flue. This is fuelled by plastic oil tanks positioned externally to the rear, although the rear tank appears to connect to a fuel pipe which is hanging on the wall of the timber structure behind the Coach House and this may be full of diesel fuel. There is also an oil-fired range cooker in the kitchen.

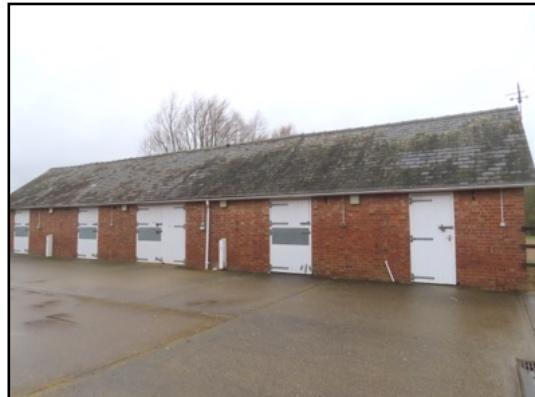
This structure is in a generally reasonable condition. It is structurally stable and the roof appears to be in a reasonable condition. Some minor repair and maintenance is needed. This and the Coach House both provide ample opportunity for conversion.
