## Design and Access + HIA Details

Address:- Seas End Hall. Moulton Seas End. Spalding. PE12 6LB

Proposal:- Proposed Refurbishment/Extension/conversion Of Coach House

Revisions:- REV A Mar 2026

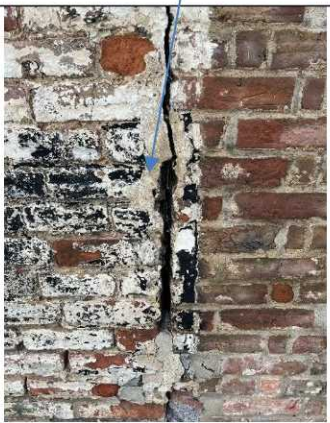
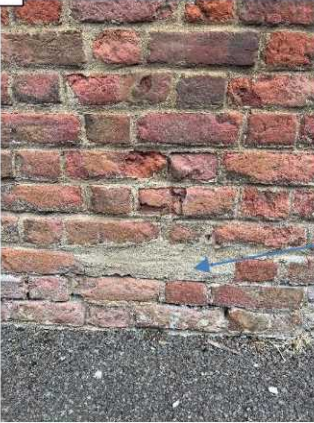
Timber Lintel Failure  
Causing cracking

The gable end of coach house has 1 first floor door and one 1 ground floor door that was bricked up some time ago and has since suffered movement due to the failing timber lintel. Lintel to be replaced with new steel lintel and bottom plate to allow for new oak lintel to the outside.  
Poor Mortar repairs around whole building will be raked out and re-pointed.

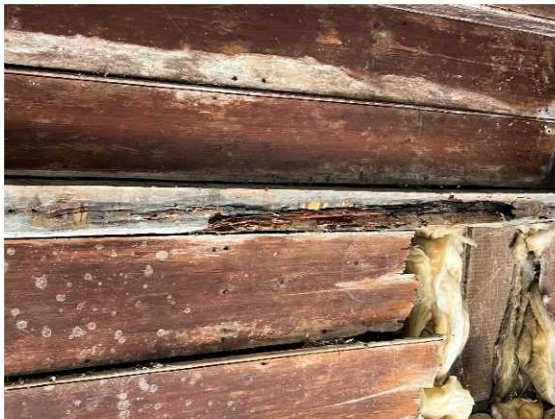
Floor joists have either been boarded up individually or the whole area boarded. Many of the upper boards will be replaced as all rotten.

New Floor joists to be fitted as required, underside of joists to have 15mm plasterboard sound deadening quilt fitted between joist, with new floor boarding
