Design and Access + HIA Details

Address:- Seas End Hall. Moulton Seas End. Spalding. PE12 6LB

Our Ref:- SA/MLJ/001/2025

Proposal:- Proposed Refurbishment/Extension/conversion Of Coach House

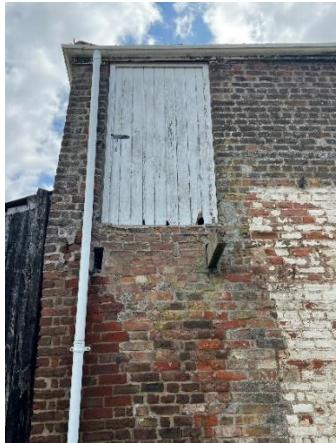
Timber Lintel Failure
Causing cracking

The gable end of coach house has 1 first floor door and one 1 ground floor door that was bricked up some time ago and has since suffered movement due to the failing timber lintel. Lintel to replaced with new steel lintel and bottom plate to allow for new oak lintel to the outside.

Poor Mortar repairs around whole building will be raked out and re-pointed.

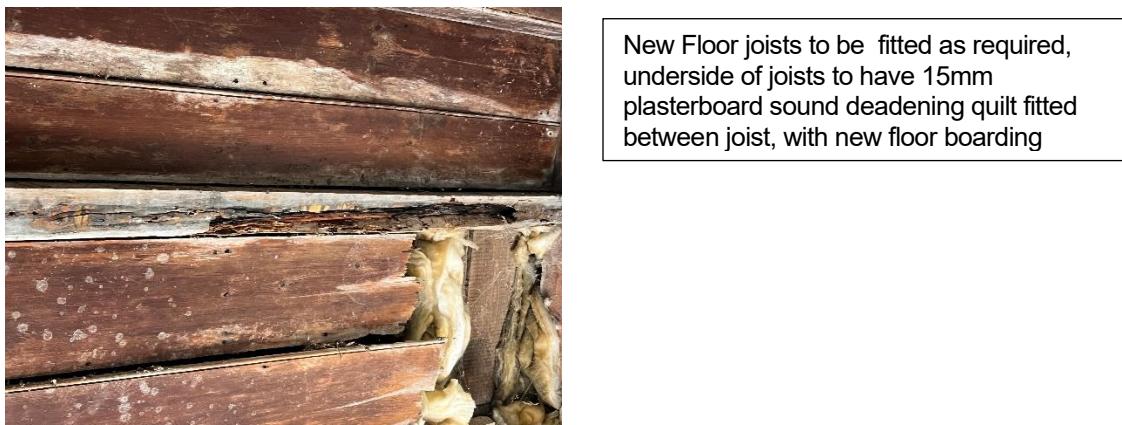
Plant Room.

Floor joists have either been boarded up individually or the whole area boarded. Many of the upper boards will be replaced as all rotten.
