BS5837:2012 Tree Survey  
Land off Surfleet Road  
Pinchbeck  
South Holland  
Lincolnshire  
NGR TF24479 26600

| | Report ref:<br><b>P2473 /0122 / 01</b> | C B E Consulting<br>Highbank, 5 Grantham Road, Navenby<br>Lincoln. LN5 0JJ.<br>Telephone (01522) 810086.<br>www.cbeconsulting.co.uk |

# **BS5837 Tree Survey, Land off Surfleet Road, Pinchbeck**

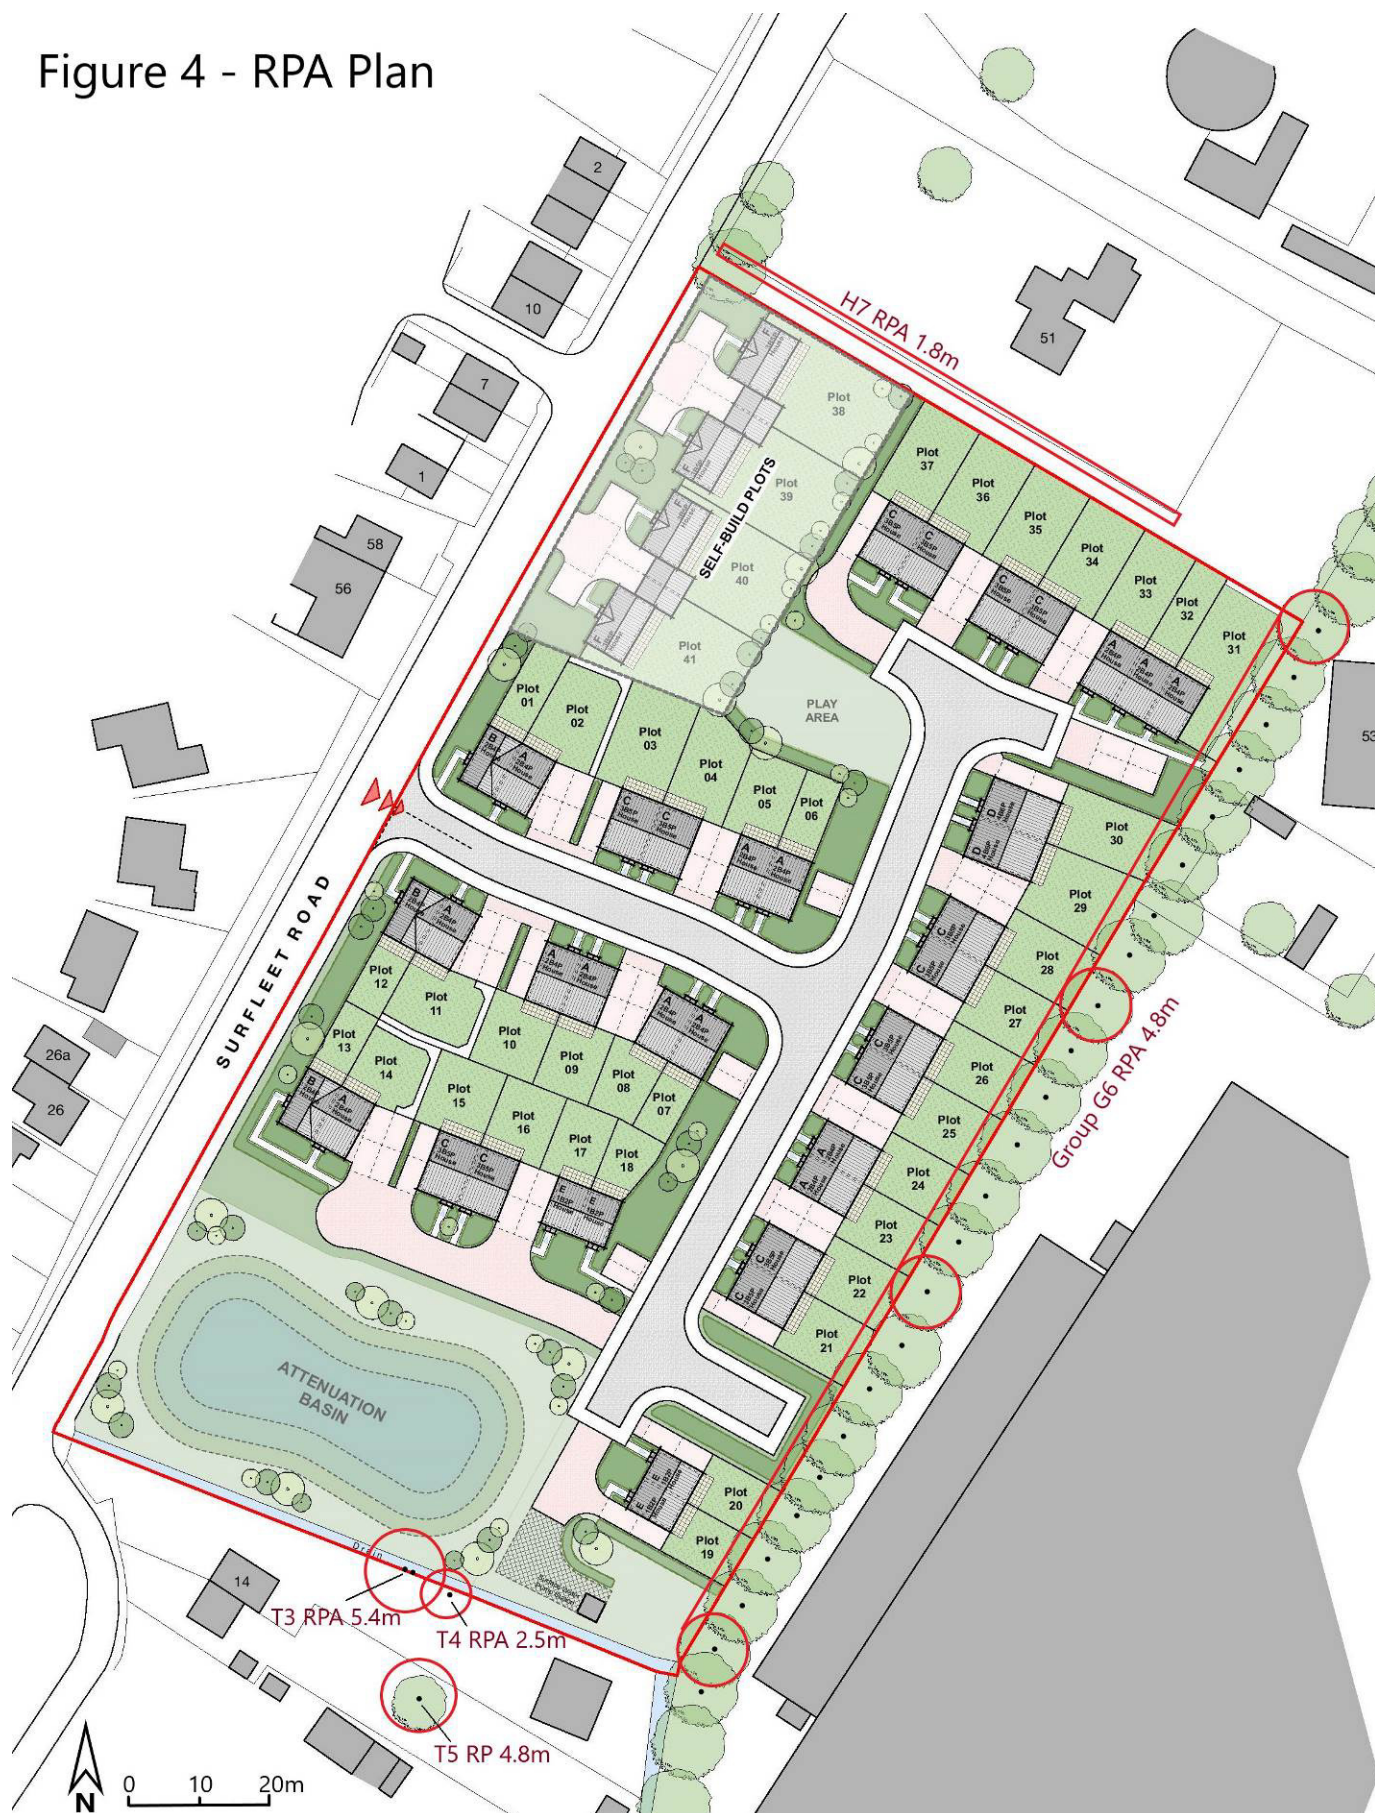
Figure 4 - RPA Plan

In the context of this site the proposed development will comprise residential houses situated within the interior of the field with a new access from Surfleet Road as shown in **Figure 4**. The table below summarises the potential impact of the proposed development on the trees present within the area surveyed based on this conceptual development plan.

- All trees retained adjacent to the site should be protected by barriers or ground protection around the calculated Root Protection Area (RPA) and as indicated on any Tree Constraints Plan (TCP) that may be produced in association with the assessment.
- Any fencing required should be erected prior to commencement of construction and before demolition including erection of any temporary structures. Once set up fences should not be removed or altered without prior consultation with the arboricultural advisor.
