| Contractor To Check All Dimensions On Site Before Work Commences. | | | |
|---|---|---|---|
| Project:<br>MR & MRS A.D. BOOR.<br>PROPERTY AT<br>MILESTONE LANE, PINCHBECK. | | | |
| Drawing:<br>PLAN AS EXISTING | | | |
| Scale:<br>AS SHOWN | | Drawing No.<br>3366-1 | |

Project:  
MR & MRS A. D. BOOR.  
PROPERTY AT  
MILESTONE LANE, PINCHBECK.

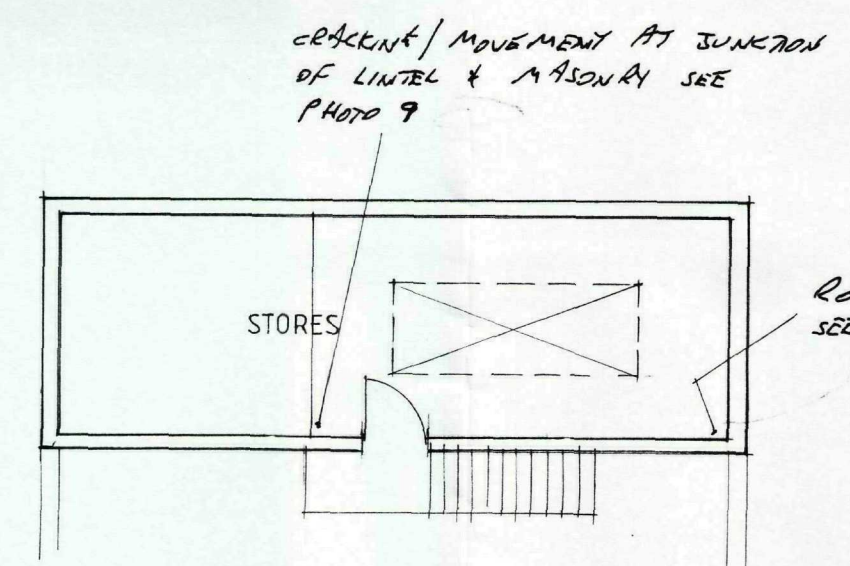
FIRST FLOOR 1-100

ROOF LEAK SEE PHOTO 7

LARGE CRACK IN WALL SEE PHOTOS 1 & 2

CRACKS & SETTLEMENT IN FLOOR. CRACKS DO NOT SHOW UP CLEARLY ON PHOTOS

MAIN CRACKS IN FLOOR

CRACK BY SIDE AND ABOVE BLOCKED UP DOORWAY

ADJOINING BUILDING IN POOR CONDITION DEMOLISHED 2008
