BS5837:2012 Tree Survey  
Land adjacent to Pennyfields  
Pinchbeck  
Lincolnshire  
NGR TF23769 25095

Survey by  
Christopher Barker CEnv dipHort ACIEEM

| | Report ref:<br><b>P1332 /0517 /01</b> | |

# **BS5837 Tree Survey, Land adjacent to Pennyfields, Pinchbeck**

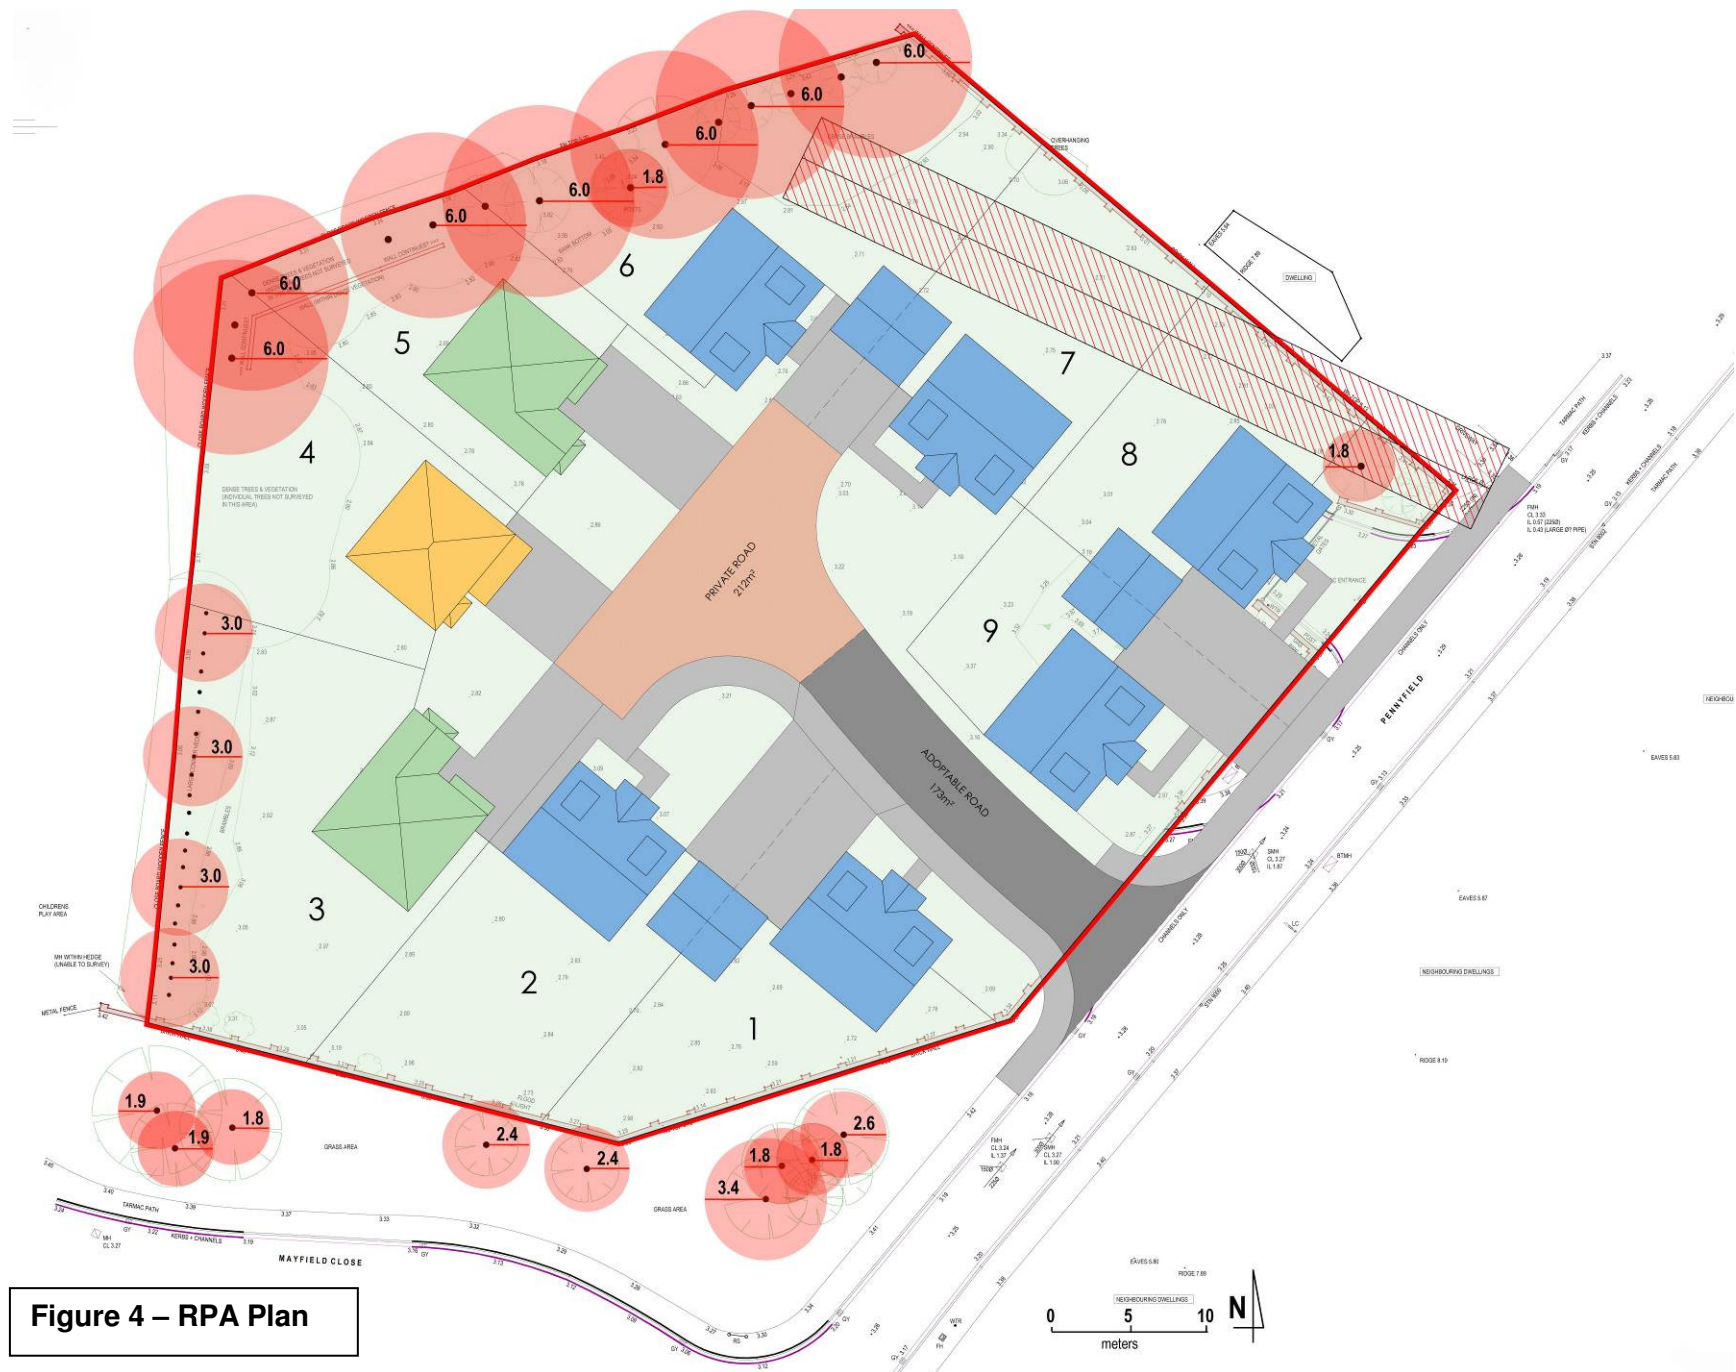
### Figure 3 – Tree Location Plan

Whitebeam T9 and T10 are both of good quality at the present time with no obvious defects or problems. Both are individual specimen trees of small stature planted in the road verge to the south of the proposed development area outside of the boundary wall. Both trees have good shape and sufficient space to develop into reasonable trees in this position. Both trees are placed in Category B.

Further east is a group of three individual specimen trees T11 – T13 comprising two Cherry and One Rowan. These are also planted in the road verge to the south of the proposed development area outside of the boundary wall. These trees are placed in Category B and C. Rowan T12 closer to Pennyfields is the better quality tree with sufficient space to develop a balanced crown. Cherry T11 is of reasonable quality but Cherry T13 behind the others has limited space to develop. It might be prudent to consider removing T13 to provide additional space for the other two trees to continue to develop.
