BS5837:2012 Tree Survey  
Land north of Otway House  
Spalding Road,  
Pinchbeck  
Lincolnshire  
NGR TF 24382 25164

Survey by  
Christopher Barker CEnv dipHort ACIEEM

| | Report ref:<br><b>P1162C/ 0916 /01</b> | C B E Consulting<br>Highbank, 5 Grantham Road, Navenby<br>Lincoln. LN5 0JJ.<br>Telephone (01522) 810086.<br>www.cbeconsulting.co.uk |

# **BS5837 Tree Survey, Land NORTH OF Otway House, Pinchbeck**

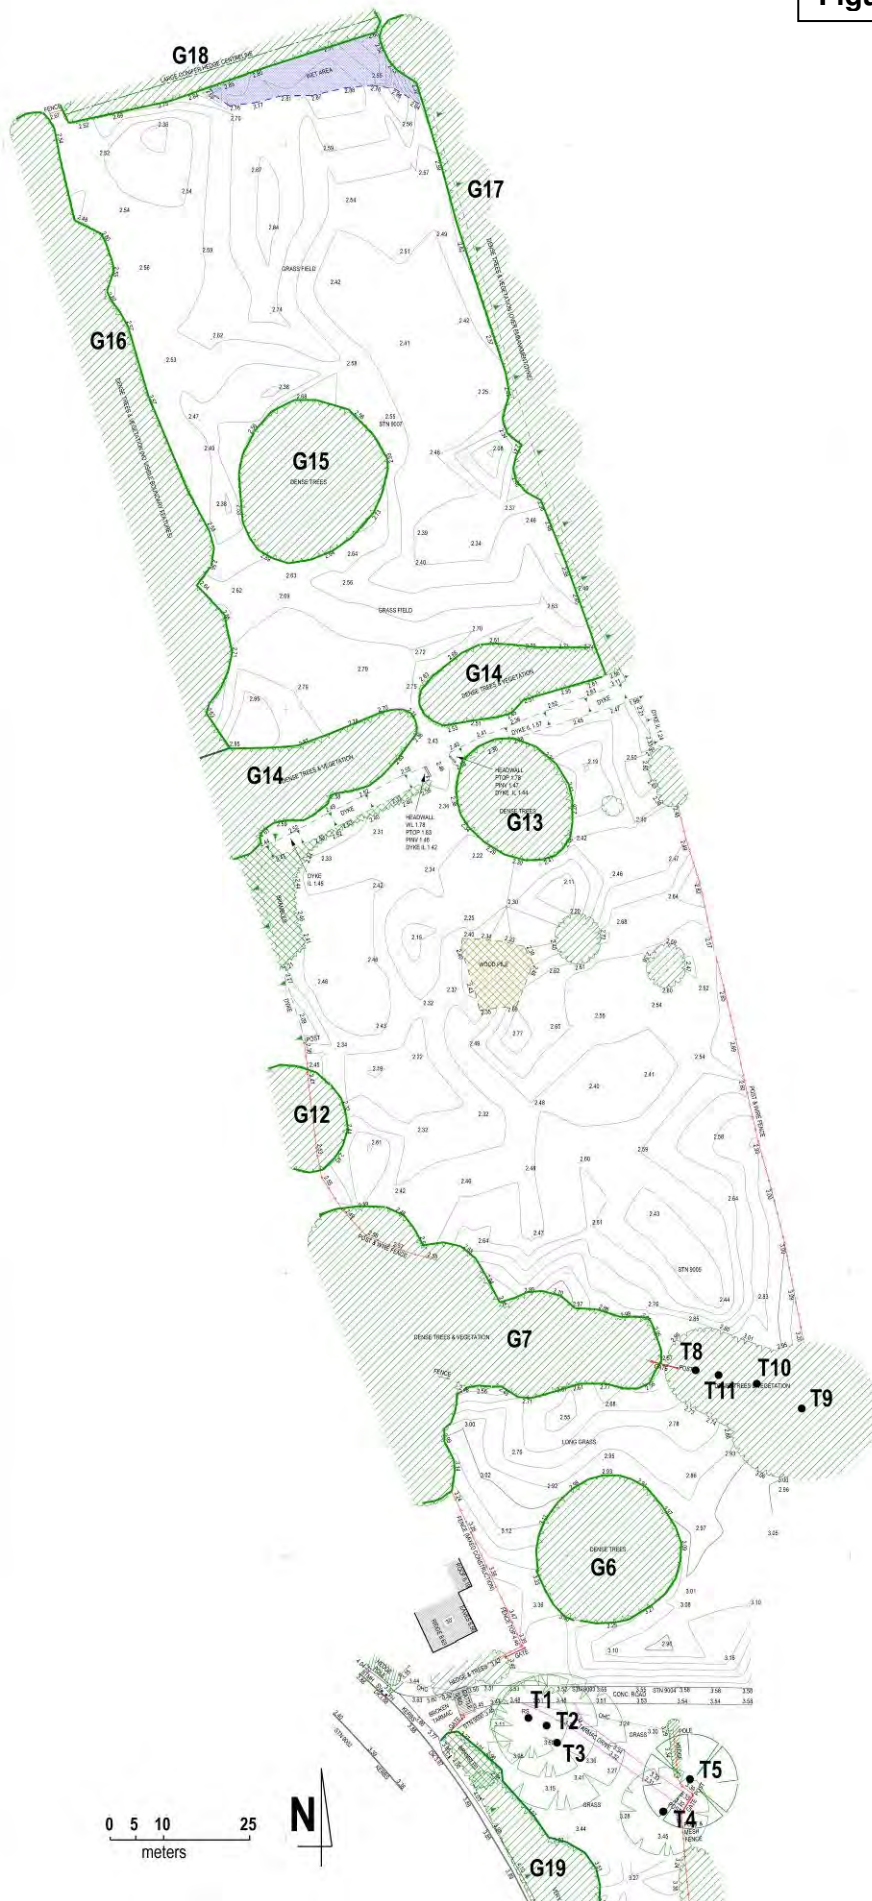
Figure 3: Tree Location Plan

Overall, assuming the key trees on the boundaries of the site are retained and protected during any proposed development, the impact on the canopy cover within the local landscape will be negligible. Certain trees of poor quality such as T10 and T11 could be removed to benefit better quality trees being retained within the scheme and others such as G13 and G15 may benefit from crown lifting and removal of under canopy saplings and scrub to benefit visual amenity and a sense of security within a new residential area.

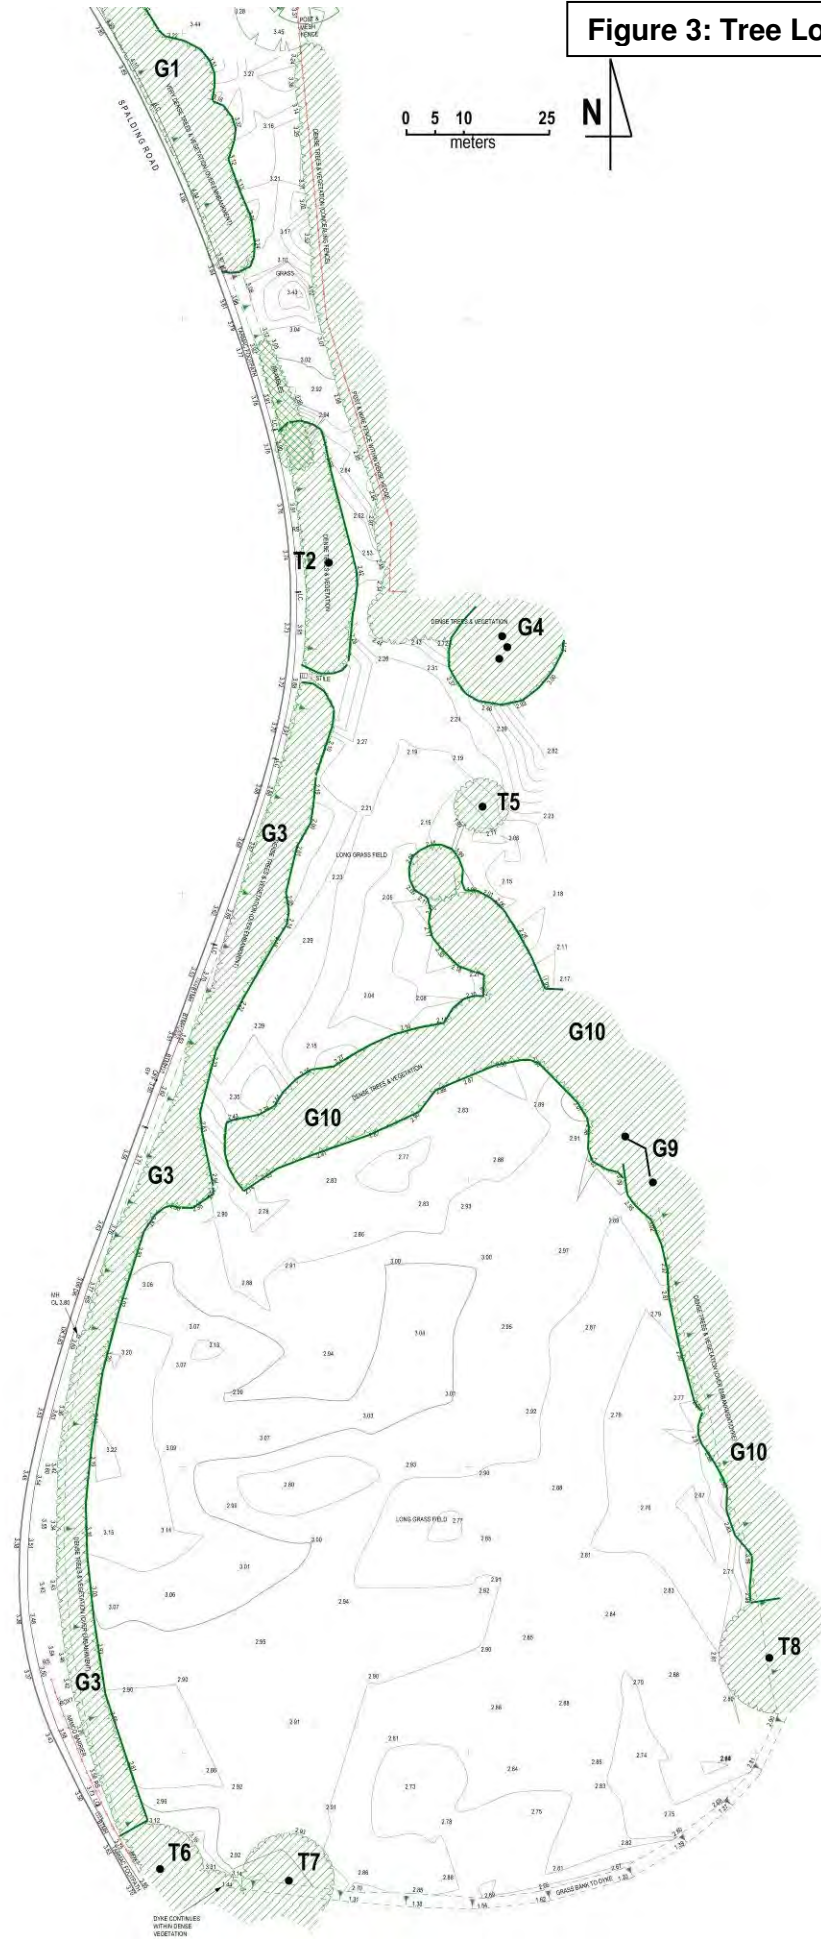
Figure 3: Tree Location Plan

Overall, assuming the key trees on the boundaries of the site are retained and protected during any proposed development, the impact on the canopy cover within the local landscape will be negligible. Certain trees of poor quality such as T2 and T5 should be considered for removal. Others, such as T6 and T9 with poor shape and low visual amenity value should be considered for crown reduction or pollarding within the context of the development.
