## SCHEDULE OF WINDOW CONDITION

Proposed Window Refurbishment / Replacement at The Square, Spalding – Schedule of Windows Condition

Reference Project: A1424  
Tender issue 02.10.19

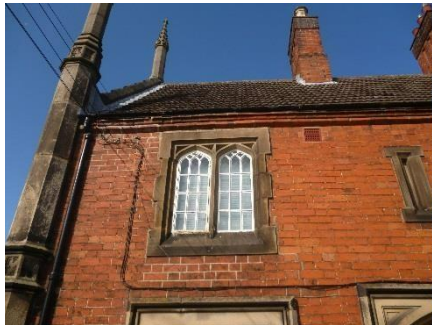
Window Ref: FFW01

(Type B)

Areas of window indicate heavier rust grinning through as can be seen. The recent redecoration within the last 3 years indicate substantially set in rust to the window sections.

Stone Mullion damaged / split at cill seating on RH side.

Historic stone misalignment of head stooling to jamb stone sections. (Allowance to be made for window proposal works).

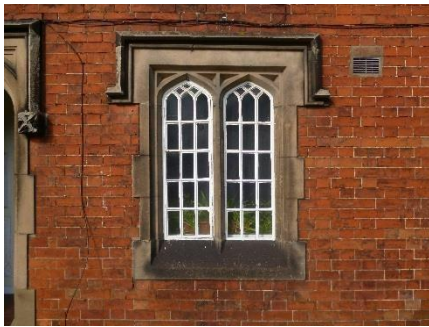
Window Ref: GFW02

(Type A):

Cast iron window set in stone. LH opening casement and RH fixed glazing.  
One left hand mid-side window pane replaced since decoration on LH casement.  
One window pane broken (fourth pane) up on right side of opening casement.  
RH casement in good condition.

Opening casement shows no sign of being openable as paint covering seal split but unbroken.

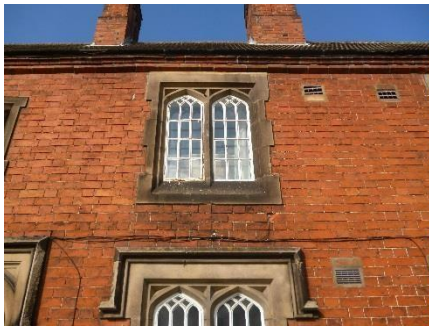
Ref: FFW02

(Type B)

Paint broken off / in places and heavy rust evident to frame. Frame bedding seal broken at mid base length of frame.

Central 2<sup>nd</sup> window pane up replaced since decoration.

Paint broken off / in places and heavy rust evident to frame and opening casement.

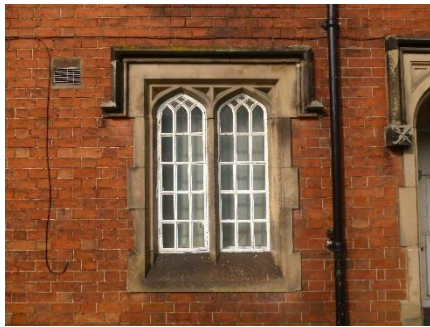
Window Ref: GFW03

(Type A):

Paint broken off / in places and rust grinning through paint in places.

Stone cracked / split towards top of RH jamb section. Possibly due to ferrous fixings of window frame.

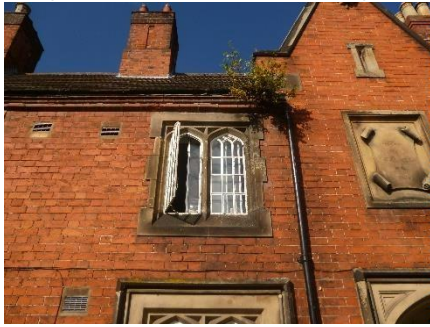
Ref: FFW03

(Type B)

Cast iron window set in stone. LH opening casement and RH fixed glazing. Opening casement is openable as indicated in image.

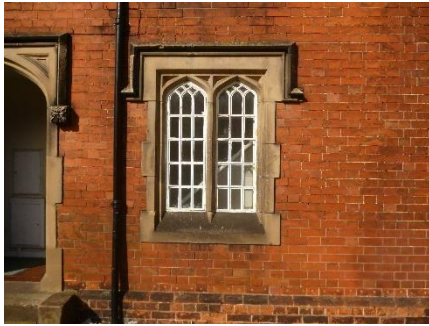
Window Ref: GFW04

(Type A):

Cast iron window set in stone. LH opening casement and RH fixed glazing.  
Opening casement shows signs of being openable as paint covering does not seal edges of casement.  
Centre bottom pane of LH opening casement smashed.  
Central stone mullion seating on stone cill which shows signs of heavy weathering.

Stone cill mullion seating heavily weathered and locally breaking up.

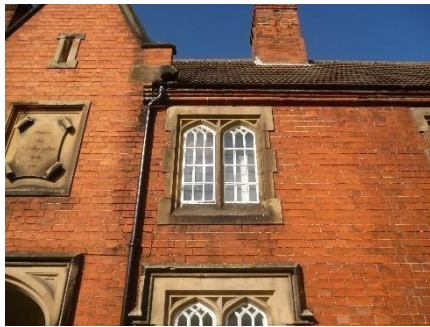
Ref: FFW04  
(Type B)

Cast iron window set in stone. LH opening casement and RH fixed glazing. Opening casement shows signs of being openable as window casement is already partially open as images.

Small damaged piece of stone locally to top LH stone head ribbon detail.

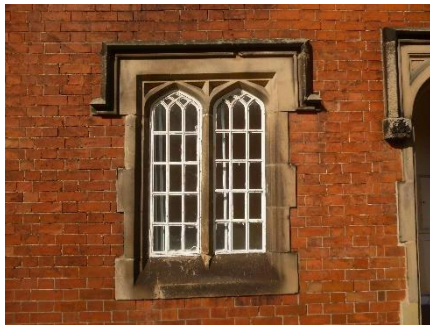
Window Ref: GFW05

(Type Ai):

Stone mullion seating of stone cill is heavily weathered and crumbling away. Crack through stone cill section beneath opening casement.

Crack through stone head section above opening casement from pinnacle of gothic arch.

Large piece of stone damage to stone ribbon head detail above RH fixed casement.

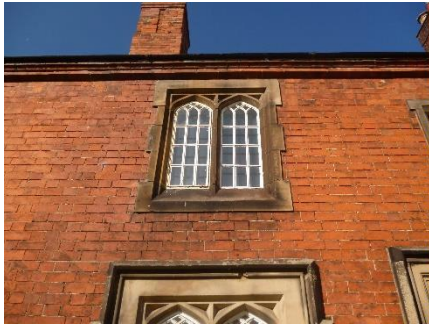
Ref: FFW05

(Type B)

Cast iron window set in stone. LH opening casement and RH fixed glazing. Opening casement shows signs of being openable as paint covering broken and edges of casement heavily corroding.

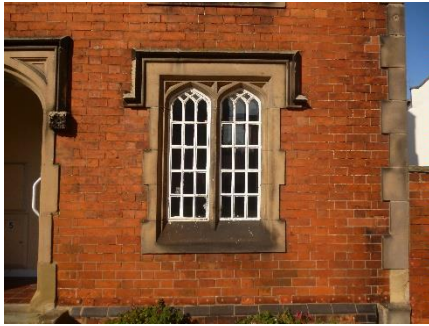
Window Ref: GFW06

(Type A):

Bottom right hand pane of opening casement cracked. Sections of putty glass bedding has detached, paint de-bonded and cast iron window and frame exposed.

Corroding window frame edges.

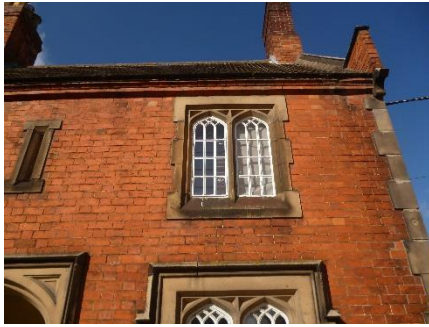
Ref: FFW06

(Type B)

Cast iron window set in stone. LH opening casement and RH fixed glazing. Opening casement shows signs of being openable as overpainting to edges of casement is less evident.

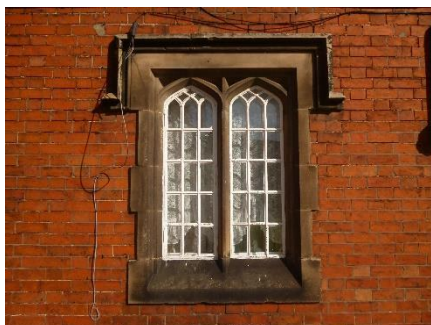
Window Ref: GFW07

(Type A):

Cast iron window set in stone. LH opening casement and RH fixed glazing. Opening casement shows signs of not being openable as paint covering still seals edges of casement.

Stone mullion base and partial seating of stone cill is heavily weathered and crumbling away. Split section of stone mullion on opening casement side of mullion bearing.

Small area of stone weathering to top central section of head ribbon detail. Paint is very glazed / cracked and peeling in most locations.

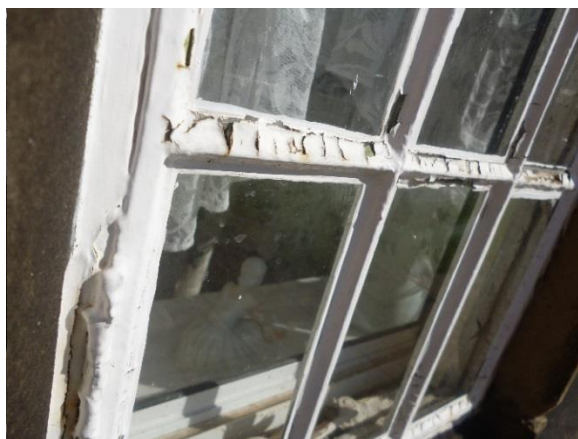
Paint coating failing and corrosion coming through.

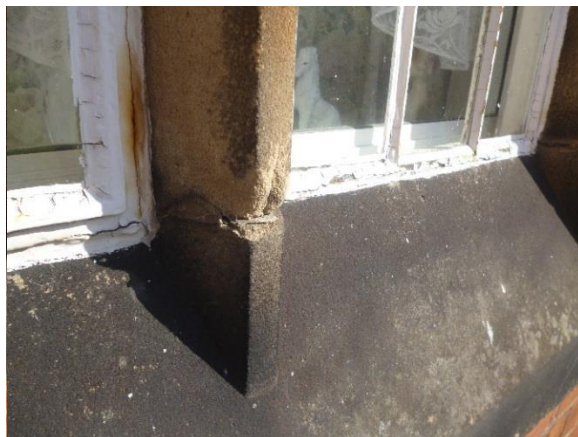
Mullion seating and base of mullion weathering and split.

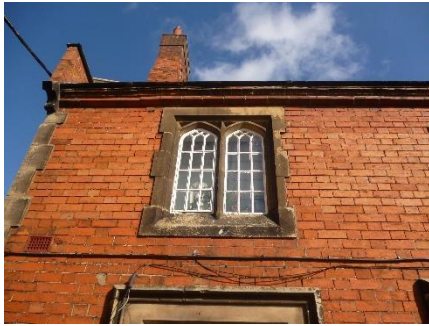
Ref: FFW07

(Type B)

Cast iron window set in stone. LH opening casement and RH fixed glazing.  
Opening casement shows signs of being openable as overpainting to edges of casement is less evident.  
Top RH shaped glass pane damaged to RH fixed casement.

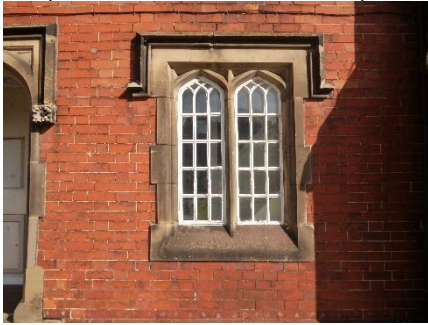
(Type A):

Cast iron window set in stone. LH opening casement and RH fixed glazing.  
Opening casement shows signs of not being openable as overpainting to edges of casement is more evident.  
Paint is very glazed / cracked and peeling in most locations.

Missing sections of glazing putty and paint coating failing.

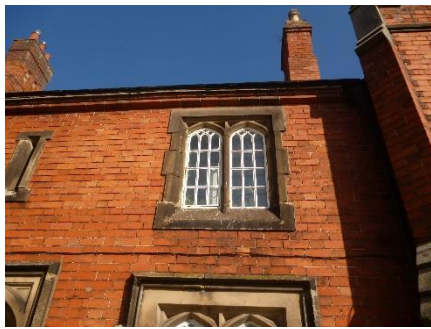
(Type B)

Cast iron window set in stone. LH opening casement and RH fixed glazing. Opening casement shows signs of not being openable as paint covering still seals edges of casement.

Stone split and local weathering damage to LH jamb of opening casement and LH side of stone mullion seating.

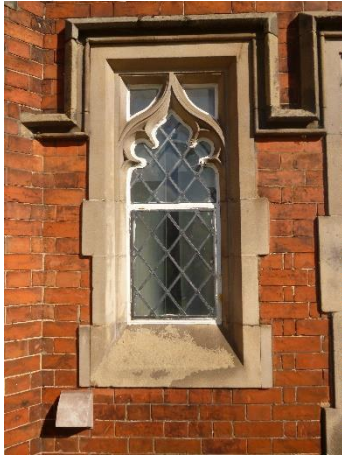
(Type F):

Leaded light glass window set directly in stone with Trefoil head detail and 2 pane segments set within stone head detail.  
Stone slender edges of Trefoil detail are heavily weathering and delicate.  
Glazing around the stone detail is damaged and cracking. Possible due to the weathering expansion / contraction of the stone detail surround.  
Lower leaded square casement, side hung glazing casement appears to be a recent replacement.

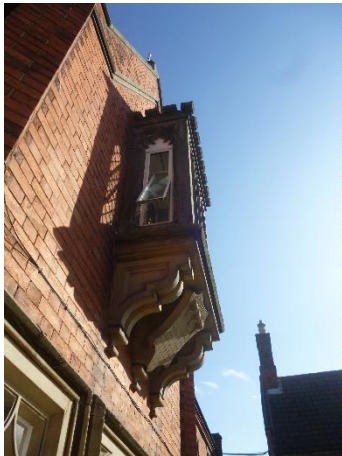
Ref: FFW09

(Type K)

Steel horizontal pivot rectangular opening casement installed within side of stone projecting bay. Painted timber inserts at infill to Trefoil detail at head of casement. Window generally in good order and appears operable. Decoration appears intact and satisfactory.

Window mechanical gear opening evident at window head.

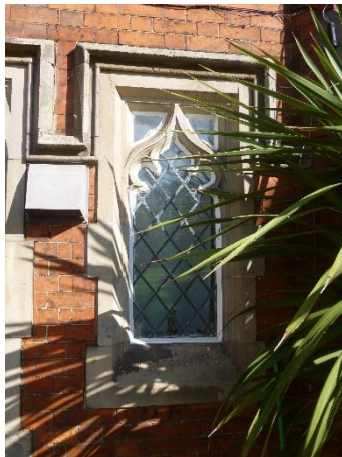
Window Ref: GFW10

Leaded light glass window set directly in stone with Trefoil head detail and 2 pane segments set within stone head detail.  
Stone slender edges of Trefoil detail are heavily weathering and delicate.  
Glazing in good condition and stone surround details appear to have had recent repair work.

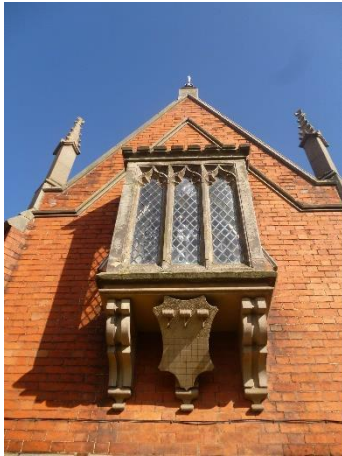
Ref: FFW10

3 Nr. Leaded light glass windows set directly in stone with Trefoil head detail and 2 pane segments set within stone head detail.

Stone slender edges of Trefoil detail are heavily weathering and delicate in each. Left to right, the first panel (LH) appears in reasonable condition. The second panel (central) of glazing around the stone detail is damaged and cracking. A temporary repair is evident with some silicone bonded plastic over the outer face to seal the glazing.

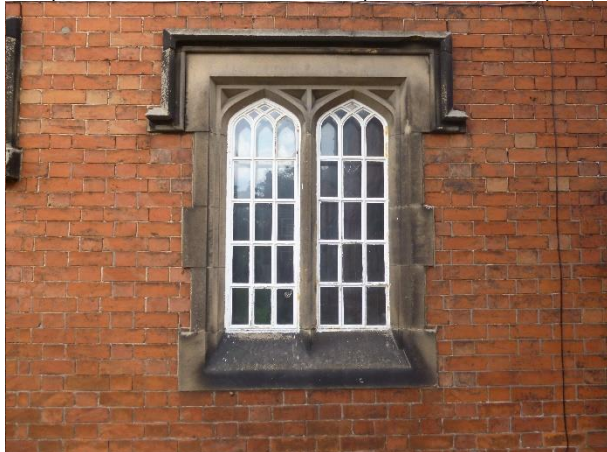
Window Ref: GFW12

Cast iron window set in stone. LH opening casement and RH fixed glazing.  
Opening casement shows signs of not being openable as paint covering still seals edges of casement.  
Perimeter of top right hand glazing pane in casement showing signs of corrosion breaking through the failing paint covering.

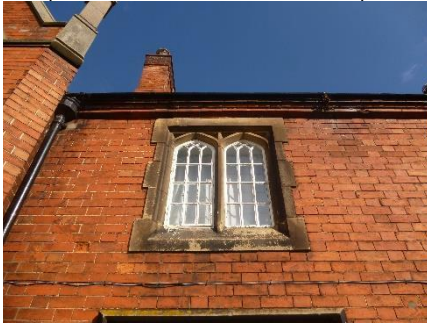
Ref: FFW12

Cast iron window set in stone. LH opening casement and RH fixed glazing. Opening casement shows signs of being openable as overpainting seems to be less evident and casement partly ajar.

Perimeter of fixed casement and opening casement showing signs of corrosion breaking through the failing paint covering.

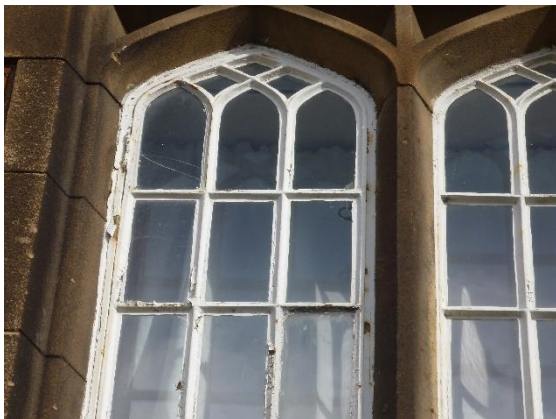
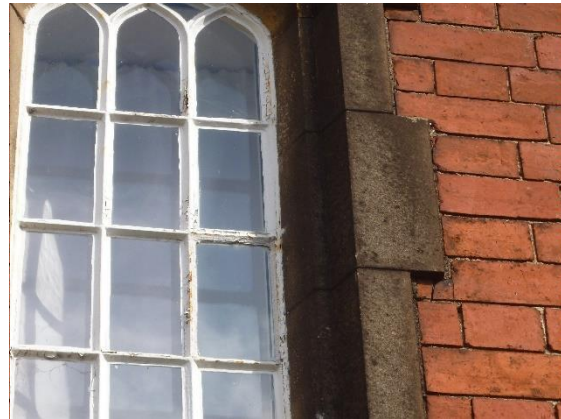
Weathering damage to bottom RH of Mullion and mullion seating stool of cill section.

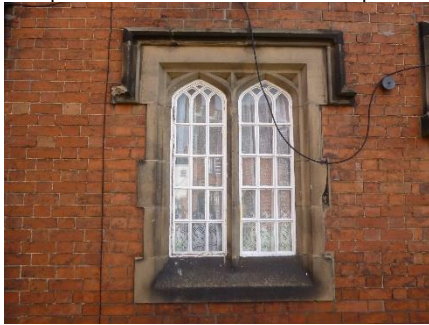
Window Ref: GFW13

Cast iron window set in stone. LH opening casement and RH fixed glazing. Opening casement shows signs of being openable as overpainting seems to be less evident and casement edge clear. Perimeter of fixed casement and opening casement showing signs of corrosion breaking through the failing paint covering.

Small section of damage to upper section of stone mullion.

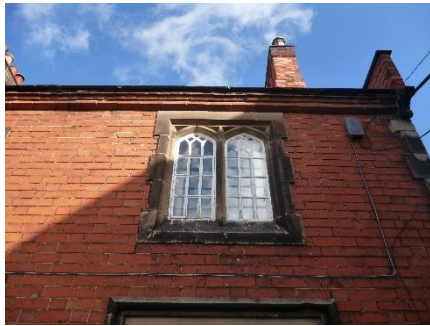
Ref: FFW13  
(Type Bi)

This is a Type B variant window with a rectangular opening casement. Cast iron window set in stone. LH opening casement and RH fixed glazing. Opening casement shows signs of being openable as overpainting seems to be less evident. Perimeter of fixed casement and opening casement showing signs of corrosion breaking through the failing paint covering.

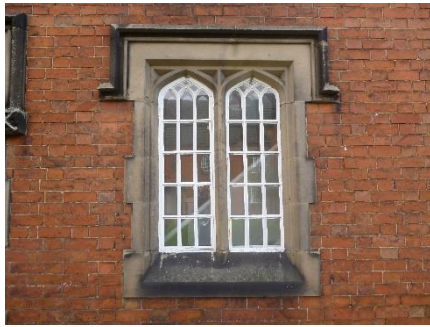
Window Ref: GFW14

Cast iron window set in stone. LH opening casement and RH fixed glazing. Opening casement shows signs of being openable as overpainting seems to be less evident and casement edge clear. Perimeter of fixed casement and opening casement showing signs of corrosion breaking through the failing paint covering.

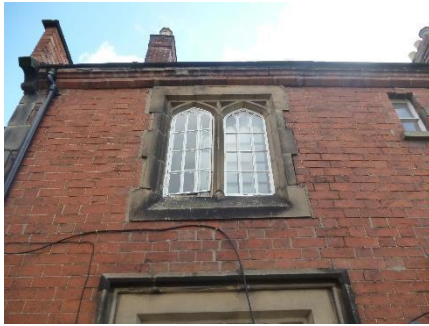
Ref: FFW14

Cast iron window set in stone. LH opening casement and RH fixed glazing. Opening casement shows signs of being openable as overpainting seems to be less evident and casement edge clear and casement partly open as image. Perimeter of fixed casement and opening casement showing slight signs of corrosion breaking through the failing paint covering. Stone mullion base and partial seating of stone cill is heavily weathered and crumbling away. Split section of stone mullion on opening casement side of mullion bearing.

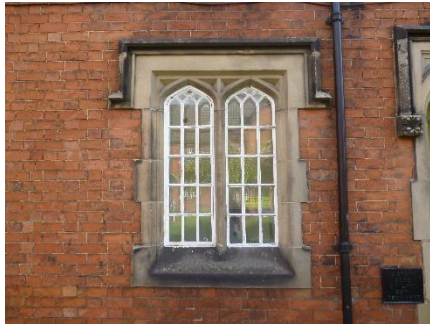
Window Ref: GFW15

Cast iron window set in stone. LH opening casement and RH fixed glazing. Opening casement shows signs of being openable as overpainting seems to be less evident and casement edge clear and casement partly open as image. Perimeter of fixed casement and opening casement showing slight signs of corrosion breaking through the failing paint covering. Top central arch top pane within opening casement broken with 2" hole evident. Previous repair evident to Stone mullion base and seating of stone cill. Stone crack from peak of RH gothic arch through stone head.

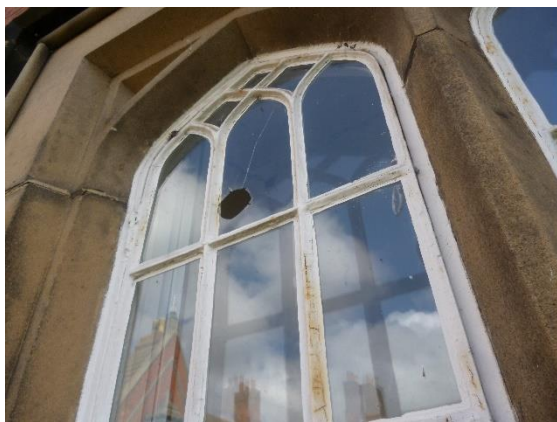
Broken window pane to opening casement

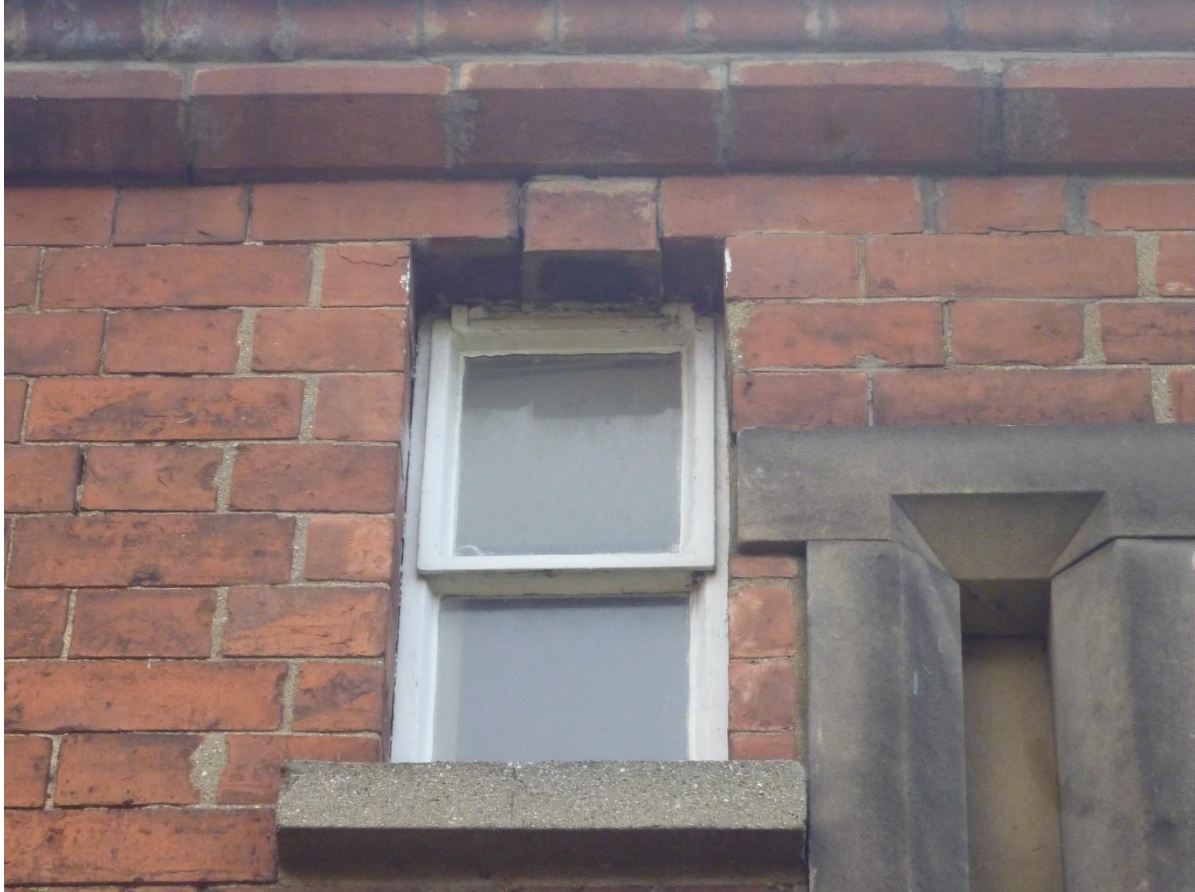
Ref: FFW15  
(Type D)

A small steel casement window consisting of a small fixed lower pane and upper top hung manual opening casement. Recent redecoration evident and coatings appear well adhered.

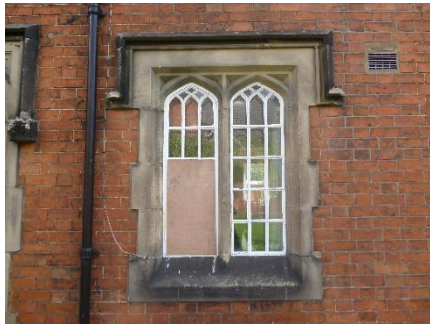
**Window Ref: GFW16**

Cast iron window set in stone. LH opening casement and RH fixed glazing. Opening casement shows signs of being openable as overpainting seems to be less evident and casement edge clear and casement partly open as image. Perimeter of fixed casement and opening casement showing slight signs of corrosion breaking through the failing paint covering. Sections of glazing putty have detached and fallen out. Previous repair evident to Stone mullion base and seating of stone cill. Large plywood covering pattress applied to opening casement covering 9 panes of glass.

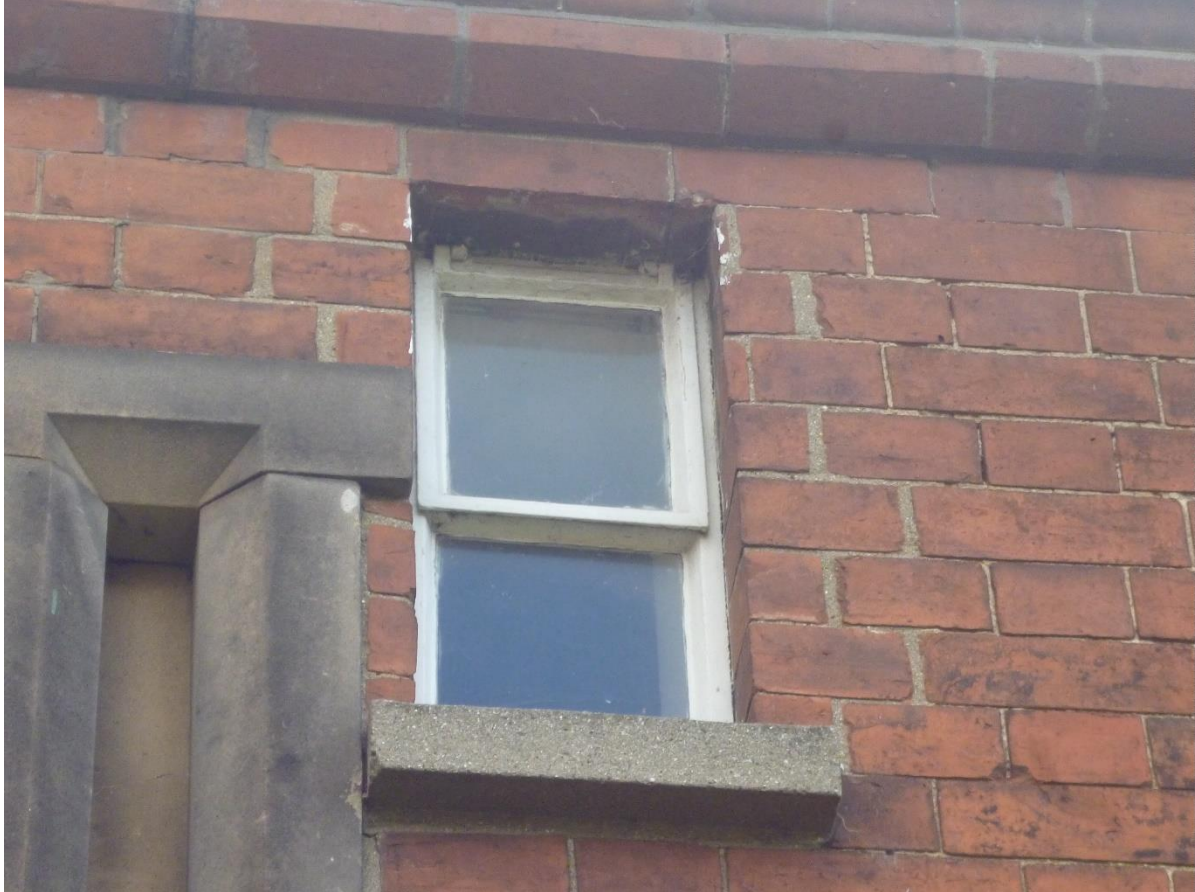
Ref: FFW16  
(Type D)

A small steel casement window consisting of a small fixed lower pane and upper top hung manual opening casement. Recent redecoration evident and coatings appear well adhered.

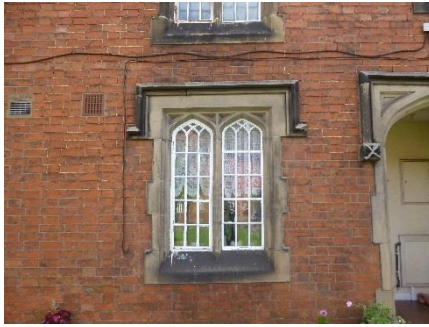
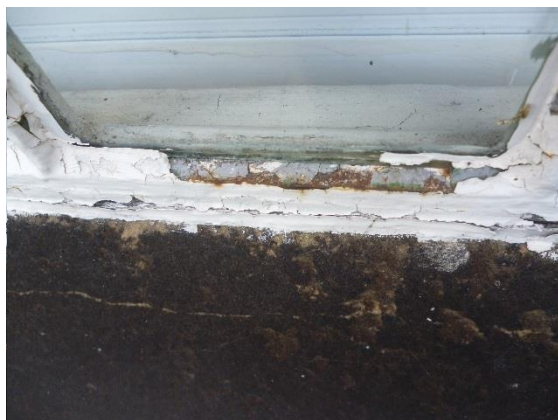
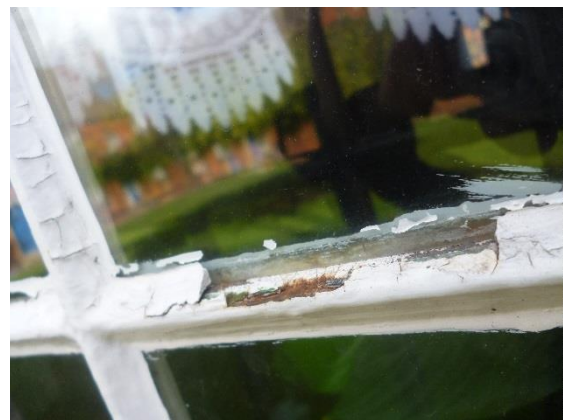
Window Ref: GFW17

Cast iron window set in stone. LH opening casement and RH fixed glazing. Opening casement shows signs of not being operable as it appears very overpainted. Perimeter of fixed casement and opening casement showing slight signs of corrosion breaking through the failing paint covering. A number of sections of glazing putty have detached and fallen out. Previous repair evident to Stone mullion base and seating of stone cill. Large plywood covering pattress applied to opening casement concealing nine panes of glass.

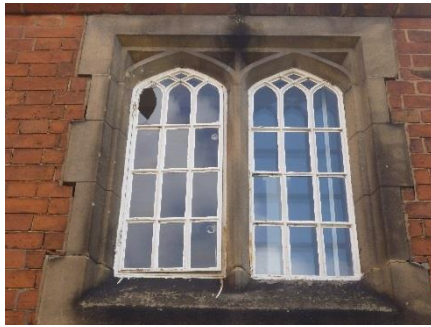
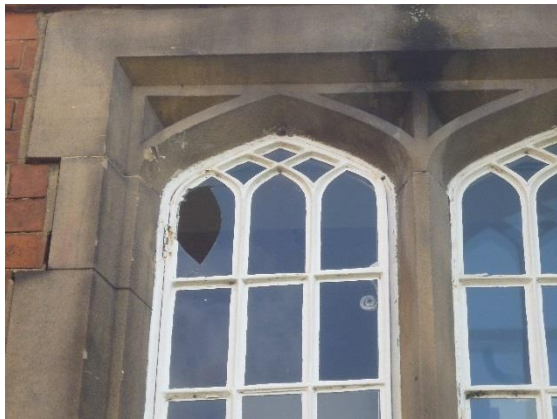
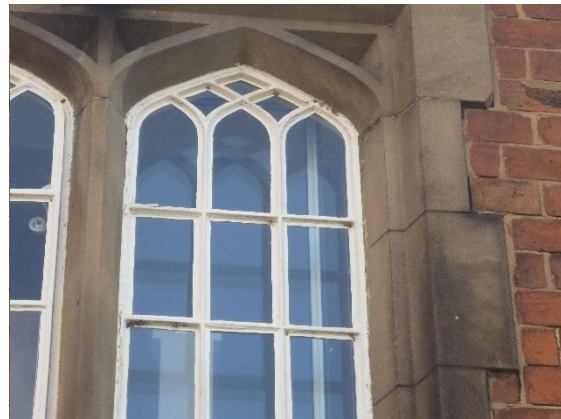
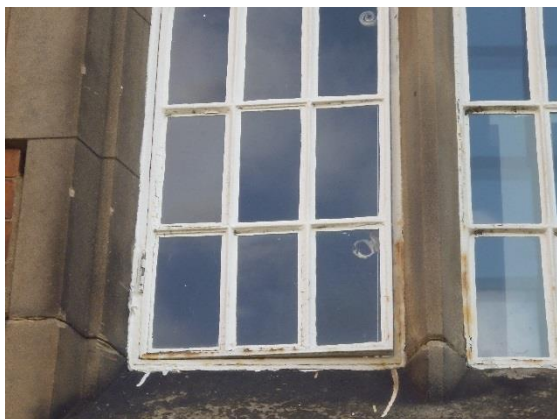
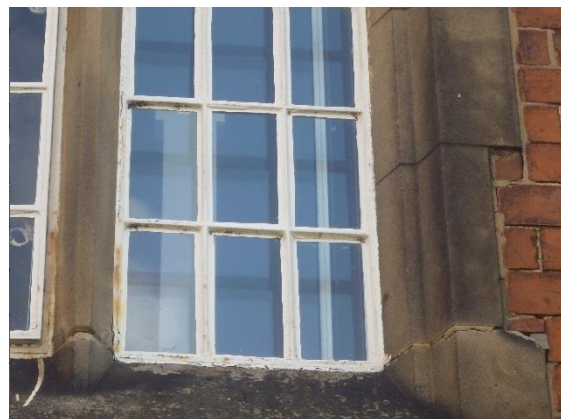
Ref: FFW17

Cast iron window set in stone. LH opening casement and RH fixed glazing. Opening casement shows signs of being openable as overpainting seems to be less evident and casement edge clear and casement partly open as image. Perimeter of fixed casement and opening casement showing slight signs of corrosion breaking through the failing paint covering. Top LH pane of glass within the opening casement is smashed. Re-pointing re to stone mullion and mullion seating.

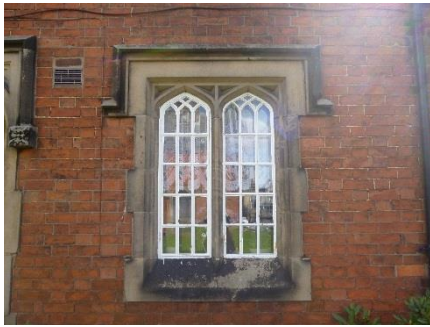
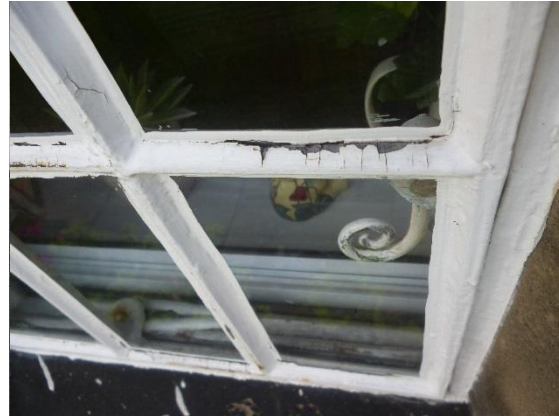
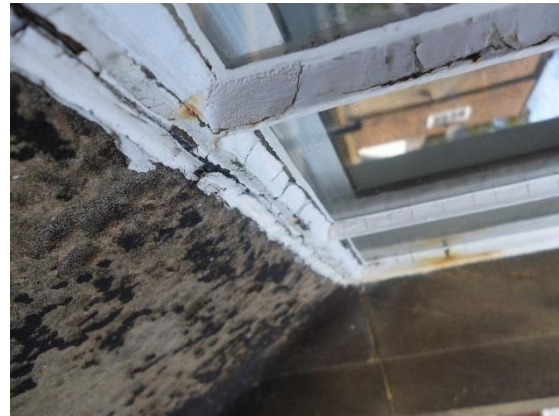
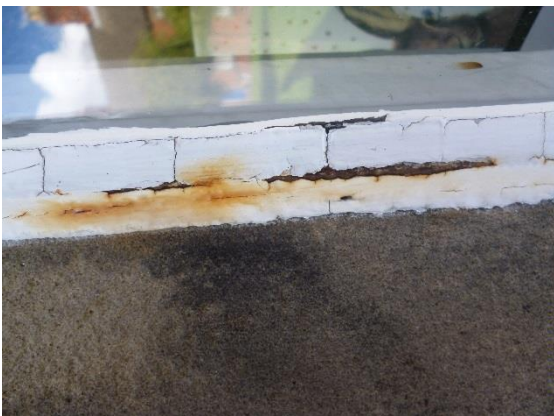
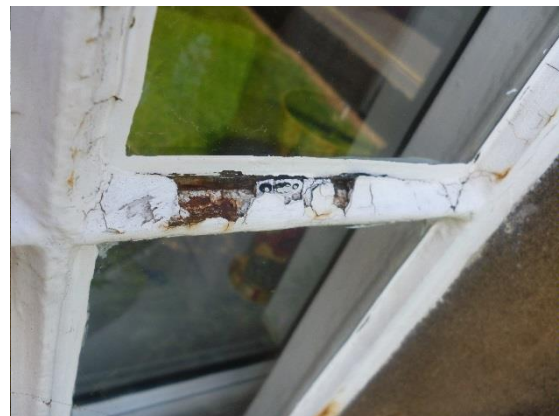
Window Ref: GFW18

Cast iron window set in stone. LH opening casement and RH fixed glazing. Opening casement shows signs of being openable as overpainting seems to be less evident, casement edge clear and casement partly open as image. Perimeter of fixed casement and opening casement showing heavy signs of corrosion breaking through the failing paint covering. Top LH pane of glass within the opening casement is smashed. Re-pointing re to stone mullion and mullion seating.

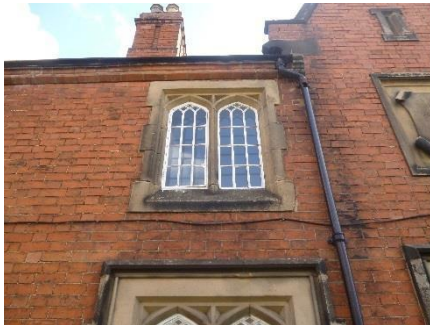
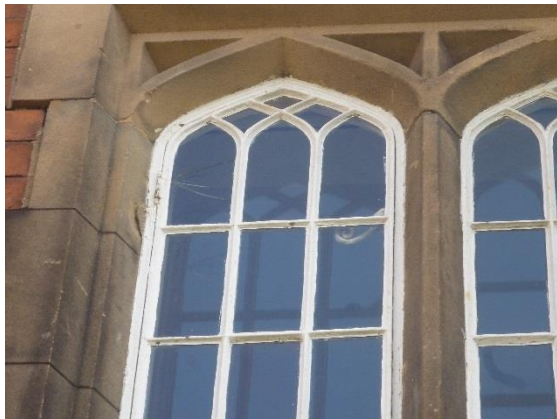
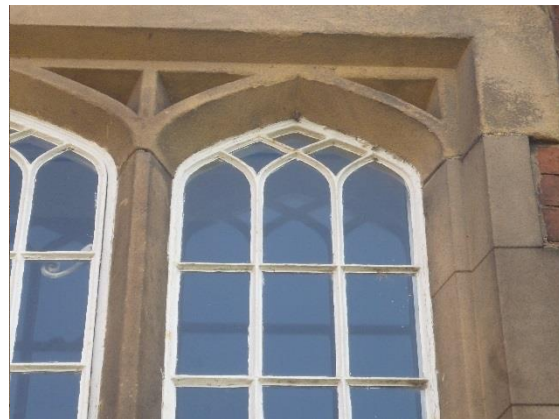
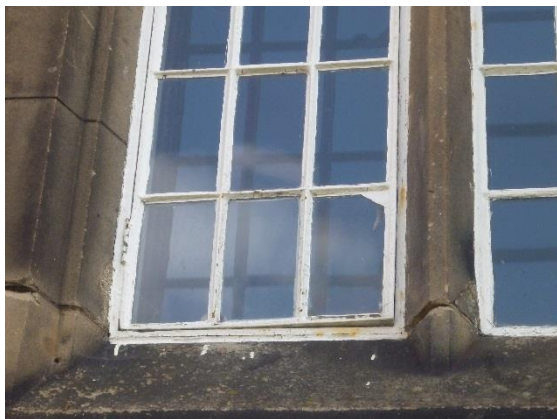
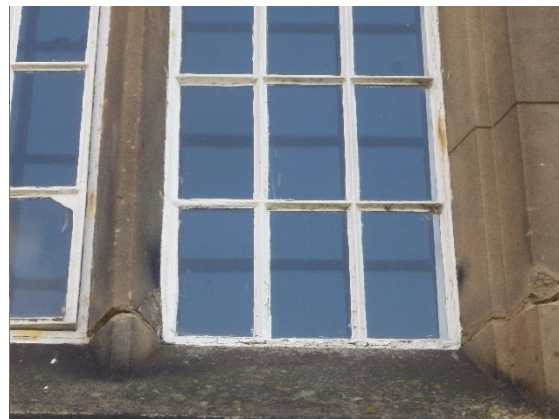
Ref: FFW18

Cast iron window set in stone. LH opening casement and RH fixed glazing. Opening casement shows signs of being openable as overpainting seems to be less evident, casement edge clear and casement partly open as image. Perimeter of fixed casement and opening casement showing slight signs of corrosion breaking through the failing paint covering.

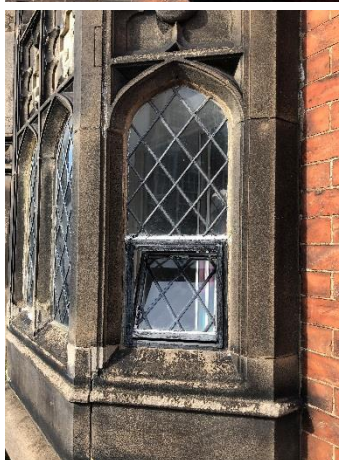
Bottom hung inward opening metal casement.

Stone Damage At corners of bay base.

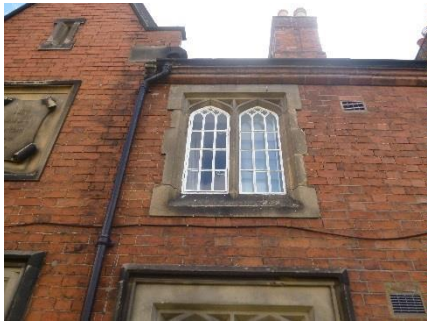
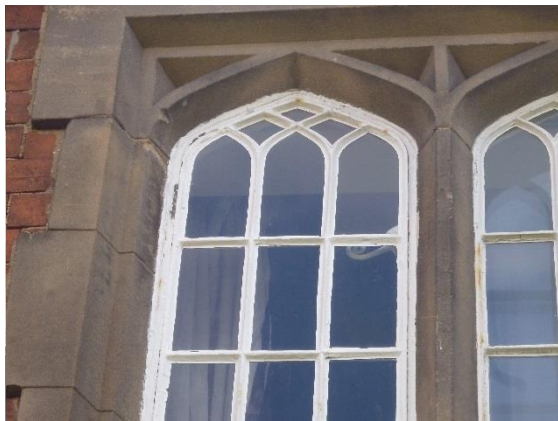
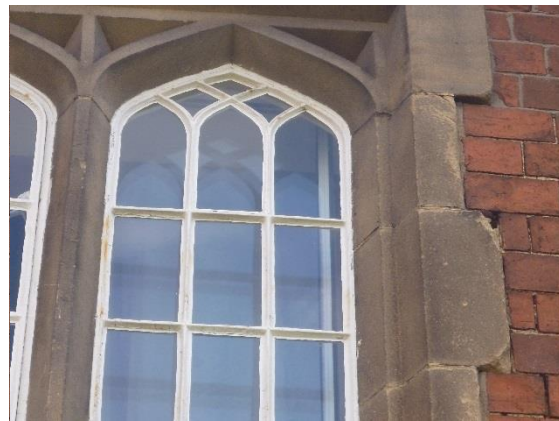
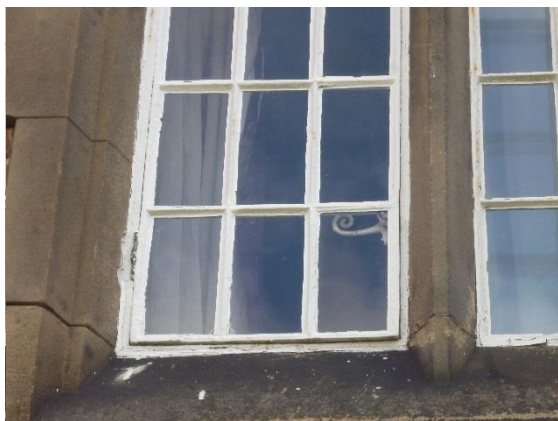
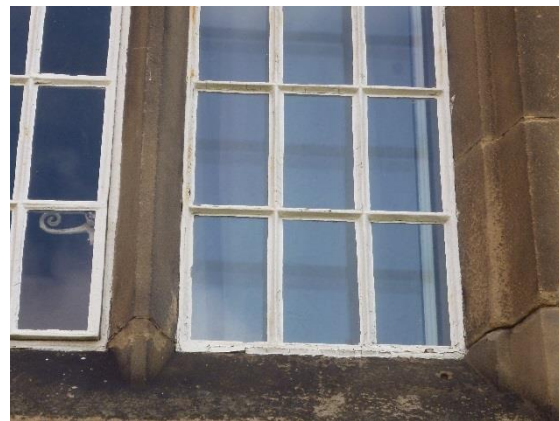
(Type B)

Cast iron window set in stone. LH opening casement and RH fixed glazing. Opening casement shows signs of being openable as overpainting seems to be less evident, casement edge clear and casement partly open as image. Perimeter of fixed casement and opening casement showing minimal signs of corrosion breaking through the failing paint covering.

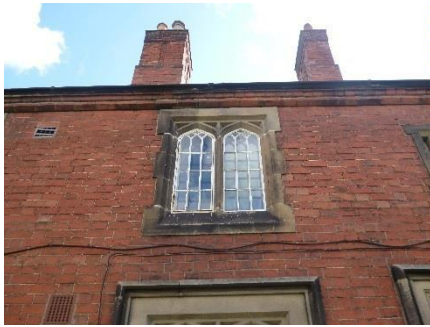
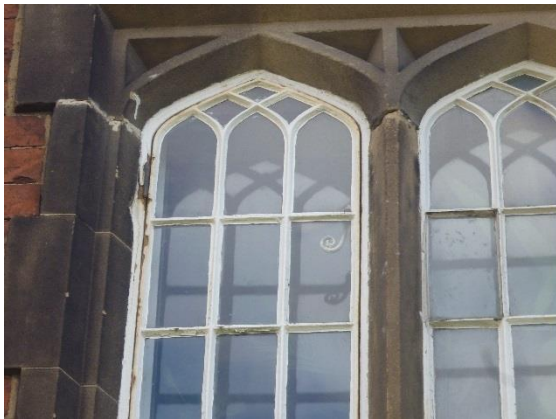
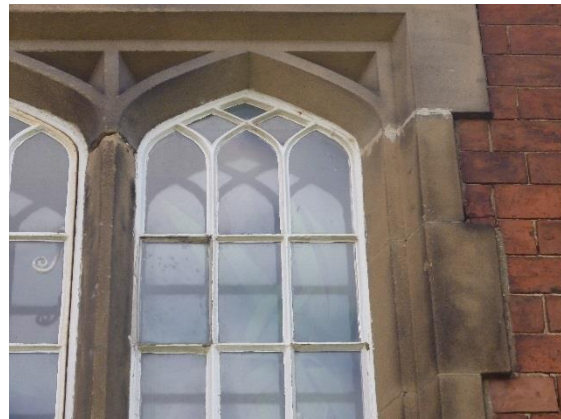
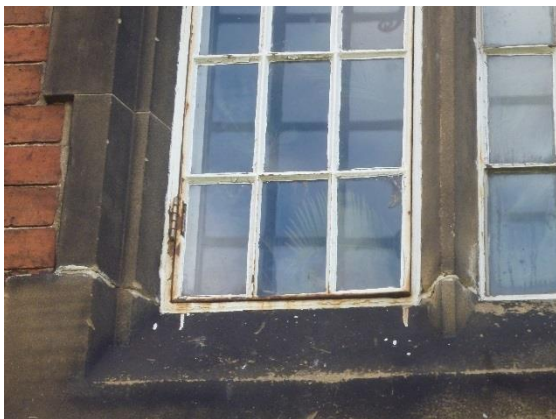
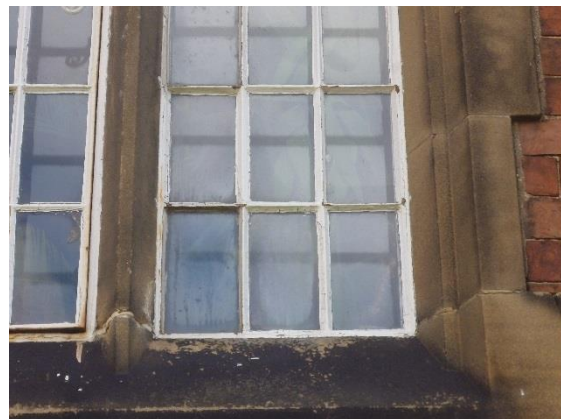
Ref: FFW20

Cast iron window set in stone. LH opening casement and RH fixed glazing. Opening casement shows signs of being openable as overpainting seems to be less evident, casement edge clear with heavy corrosion on the bottom edge and casement partly open as image.

Perimeter of fixed casement and opening casement showing heavy signs of corrosion breaking through the failing paint covering. Head of stone mullion section requires repointing and dressing.

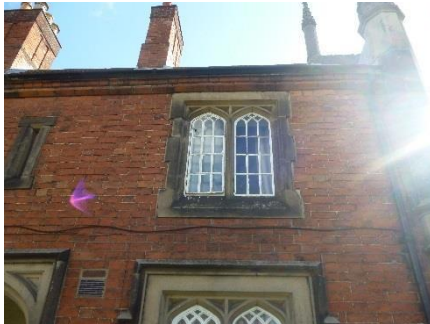
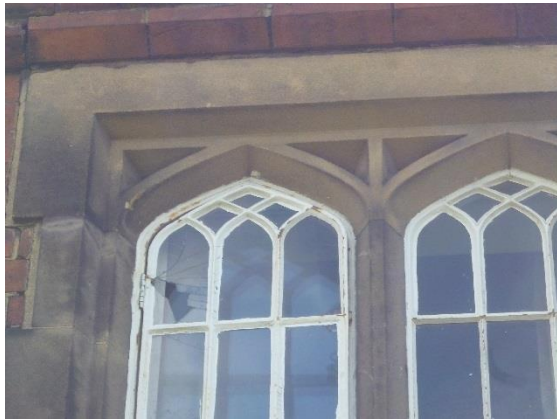
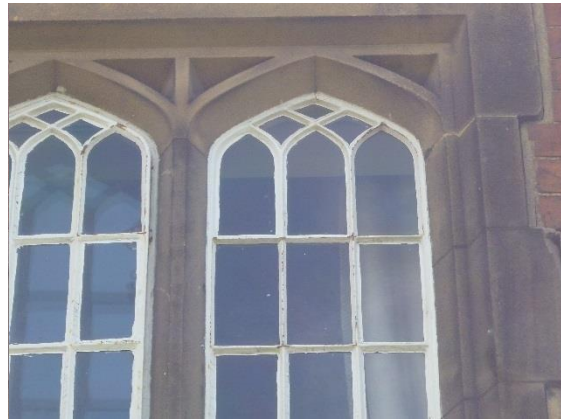
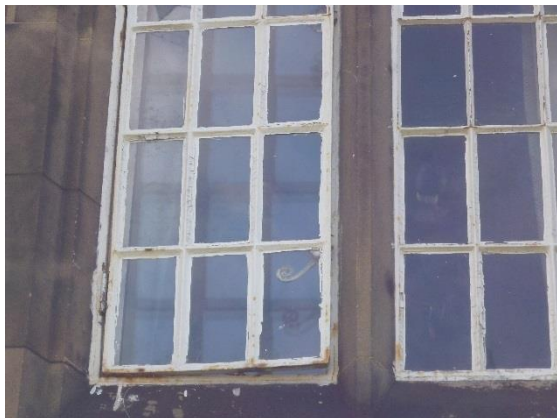
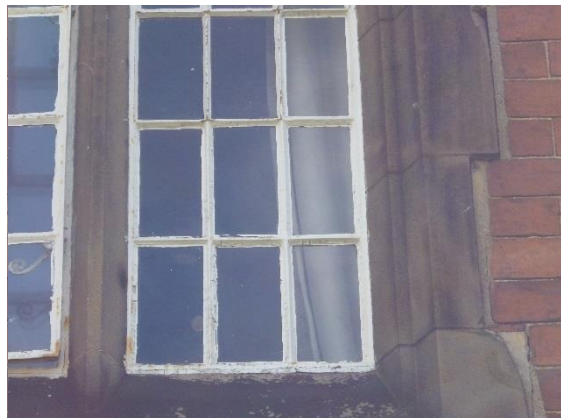
Ref: FFW21  
(Type B)

Cast iron window set in stone. LH opening casement and RH fixed glazing. Opening casement shows signs of being openable as overpainting seems to be less evident, casement edge clear with heavy corrosion on the bottom edge and casement partly open as image. Perimeter of fixed casement and opening casement showing heavy signs of corrosion breaking through the failing paint covering.

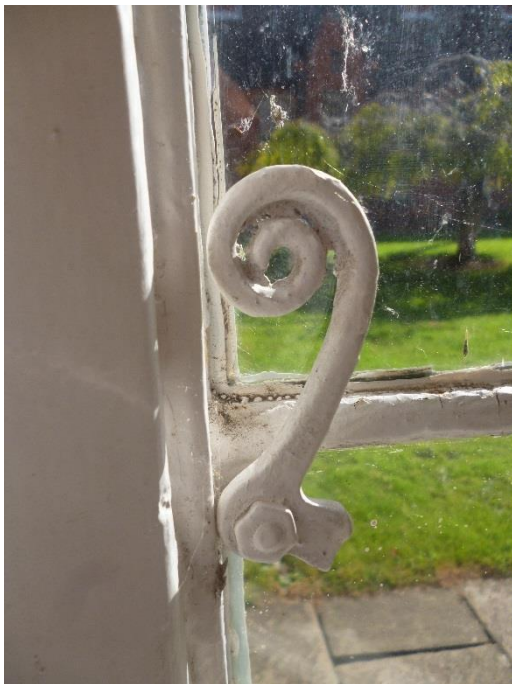
Iron thumb & pivot window stay catch.
