Project:  
**Proposed Conservation Works to  
Spalding War Memorial  
Ayscoughfee Hall Gardens  
Church Gate  
Spalding  
PE11 2RA**

Drawing Title:  
**Roof Finishes Plan as existing  
identifying works required**

**LBC APPLICATION ISSUE**

| <b>A1660-13</b> | <b>T1</b> |

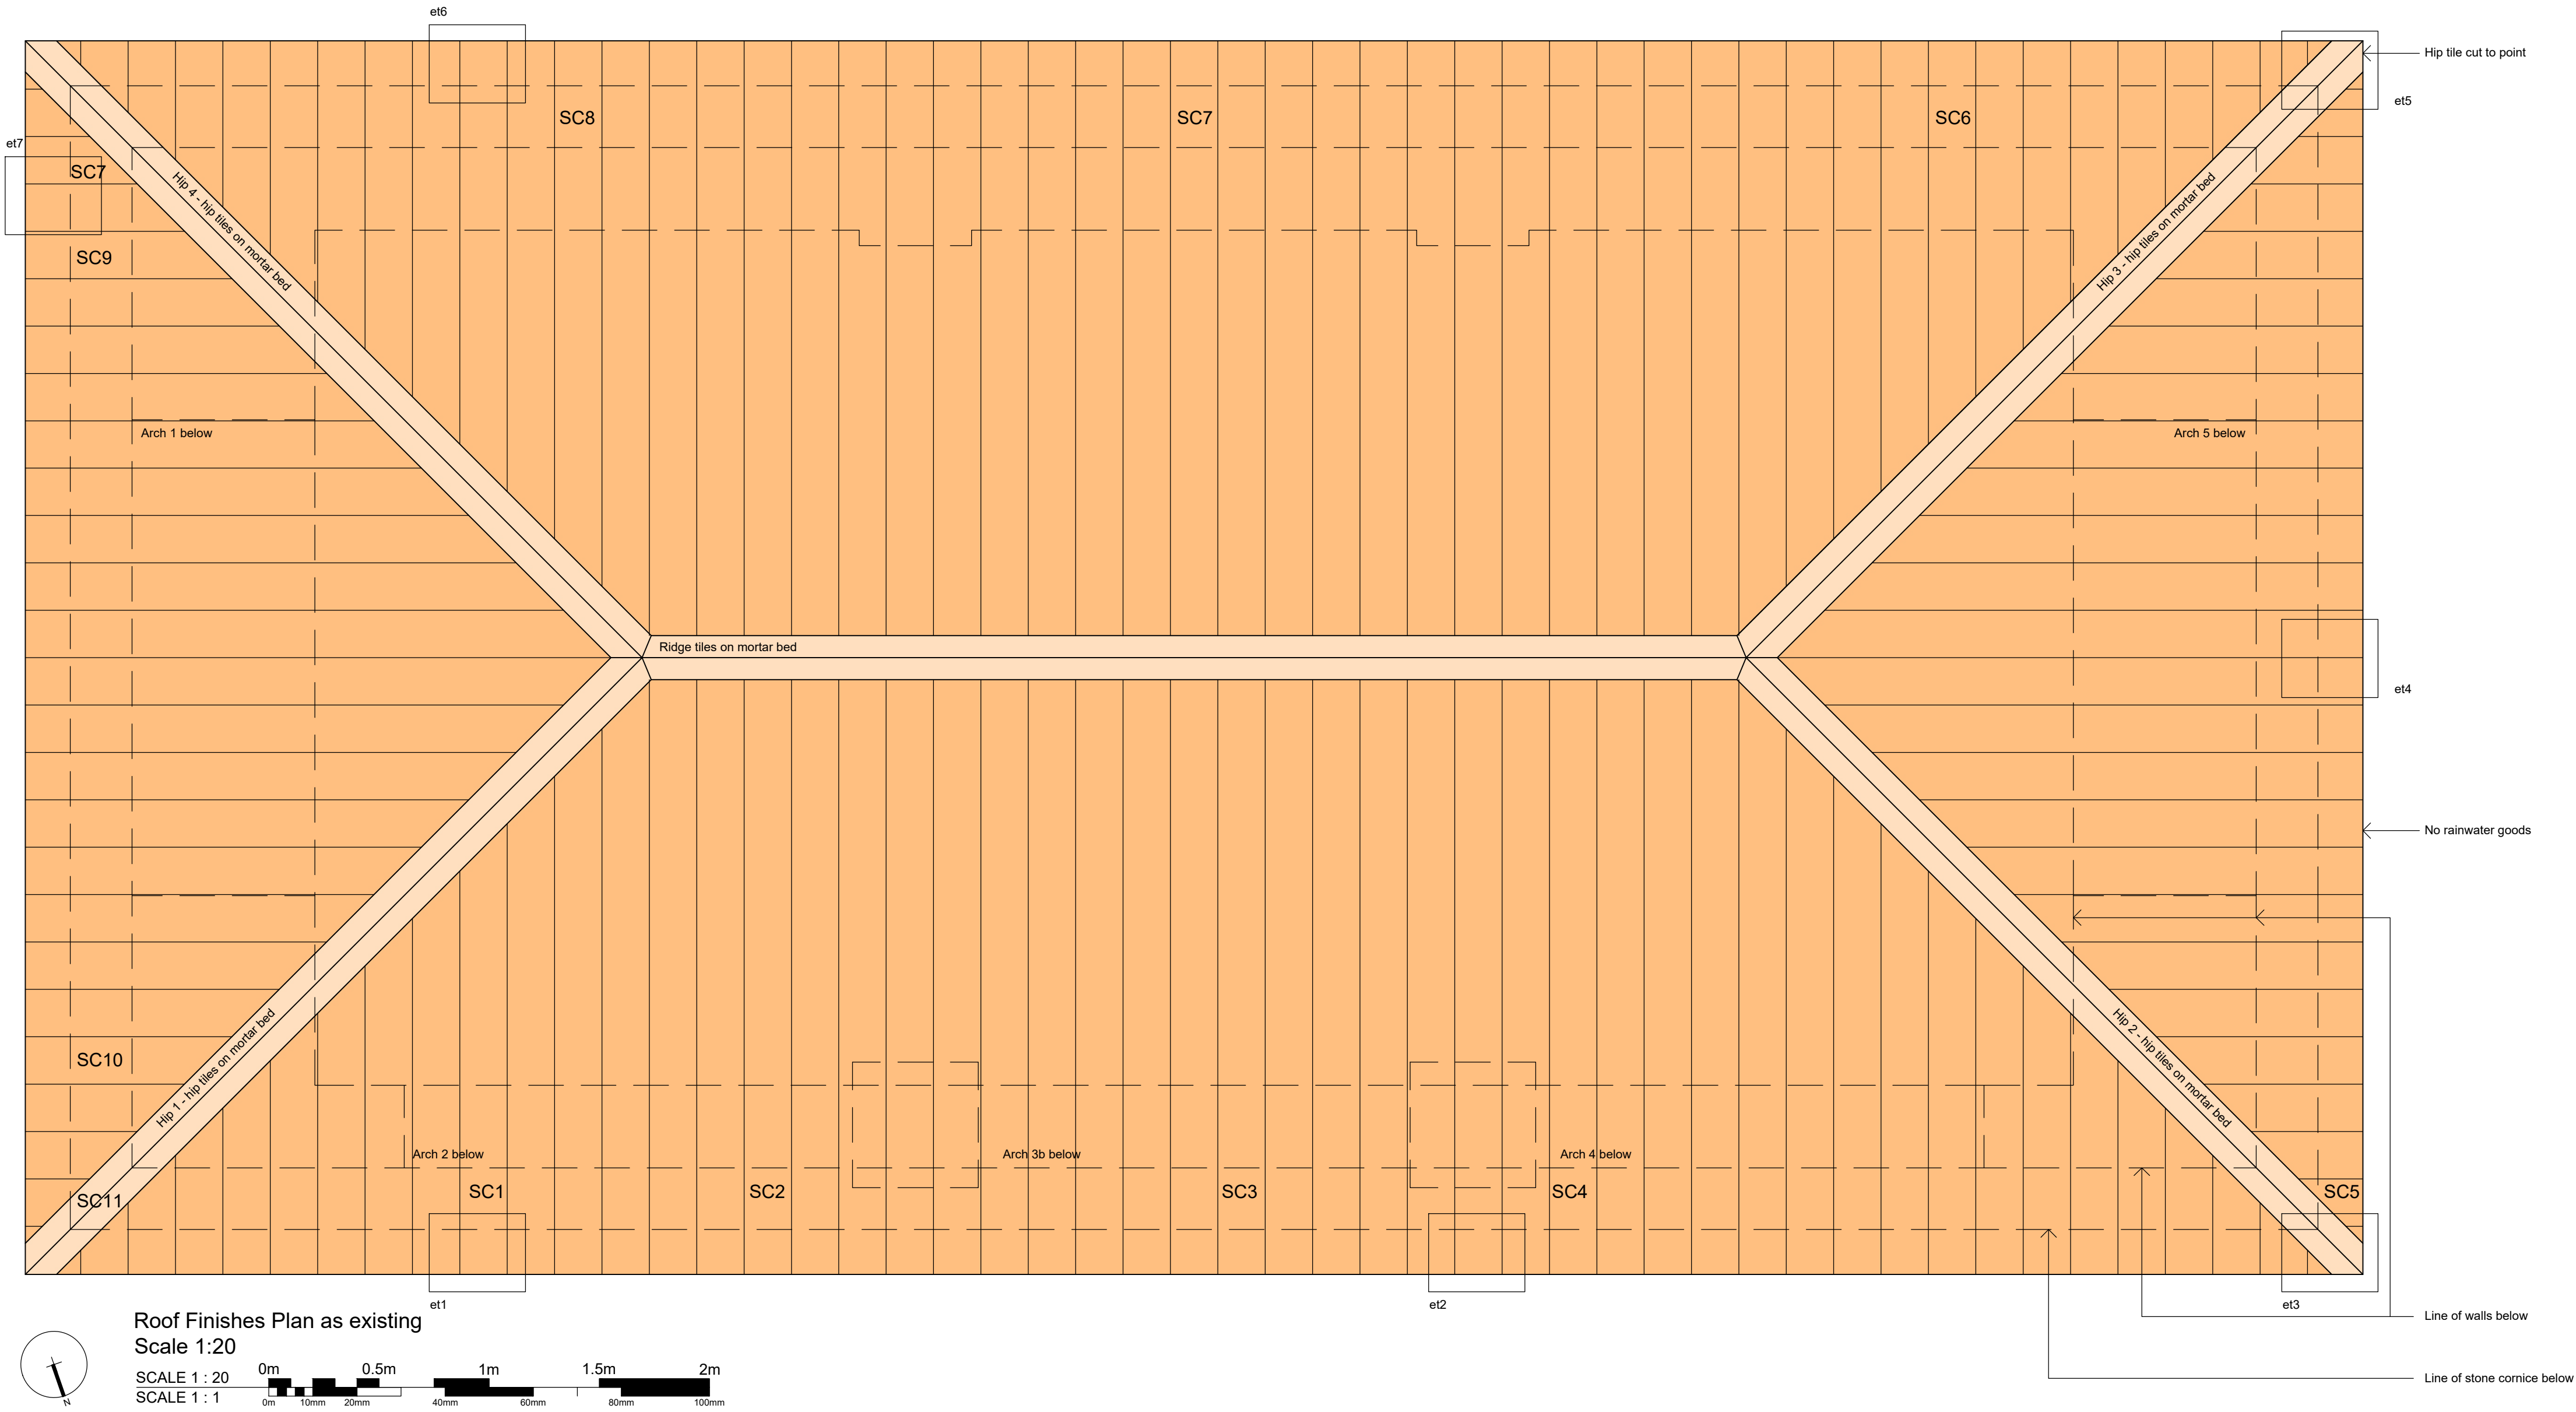
- et1 -  
1no. broken tile in lowest course above crack in cornice.
- et2 -  
2no. broken tiles in lowest course above crack in cornice.
- et3 -  
5no. previously badly repaired tiles at north-west corner of roof, in lowest 2 courses. New to be installed with 45° join to match remaining corners.
- et4 -  
1no. broken tile in lowest course above arch keystone on west elevation.
- et5 -  
1-2no. broken tiles in lowest course at south-west corner of roof.
- et6 -  
1no. broken tile in lowest course above crack in cornice.
- et7 -  
2no. dislodged tiles in lowest course above crack in cornice.

- SC1 -  
1no. vertical crack through full depth of cornice.
- SC2 -  
1no. diagonal crack through full depth of cornice.
- SC3 -  
1no. vertical crack through full depth of cornice.
- SC4 -  
1no. vertical and 1no. diagonal crack through full depth of cornice.
- SC5 -  
Eroded cornice corner piece to be rebuilt.
- SC6 -  
1no. diagonal crack through full depth of cornice.
- SC7 -  
1no. vertical crack through full depth of cornice.
- SC8 -  
1no. diagonal crack through top section of cornice.
- SC9 -  
1no. diagonal crack through full depth of cornice.
- SC10 -  
1no. diagonal crack through full depth of cornice.
- SC11 -  
Eroded cornice corner piece to be rebuilt.

Repair to be undertaken to damage / missing eaves tiles (et) by removal and replacement with new to match, of plain tiles in the following locations:

Repairs to be undertaken to repairable cracks and eroded stone (sc) in stone cornice in locations as indicated on plan and described below.
