# Heritage Impact Assessment

Proposed works to North Gates (at the end of The Chestnut Avenue),  
Ayscoughfee Hall Museum and Gardens, Church Gate, Spalding, Lincolnshire

June 2022

A1572NG– HIA rev P01

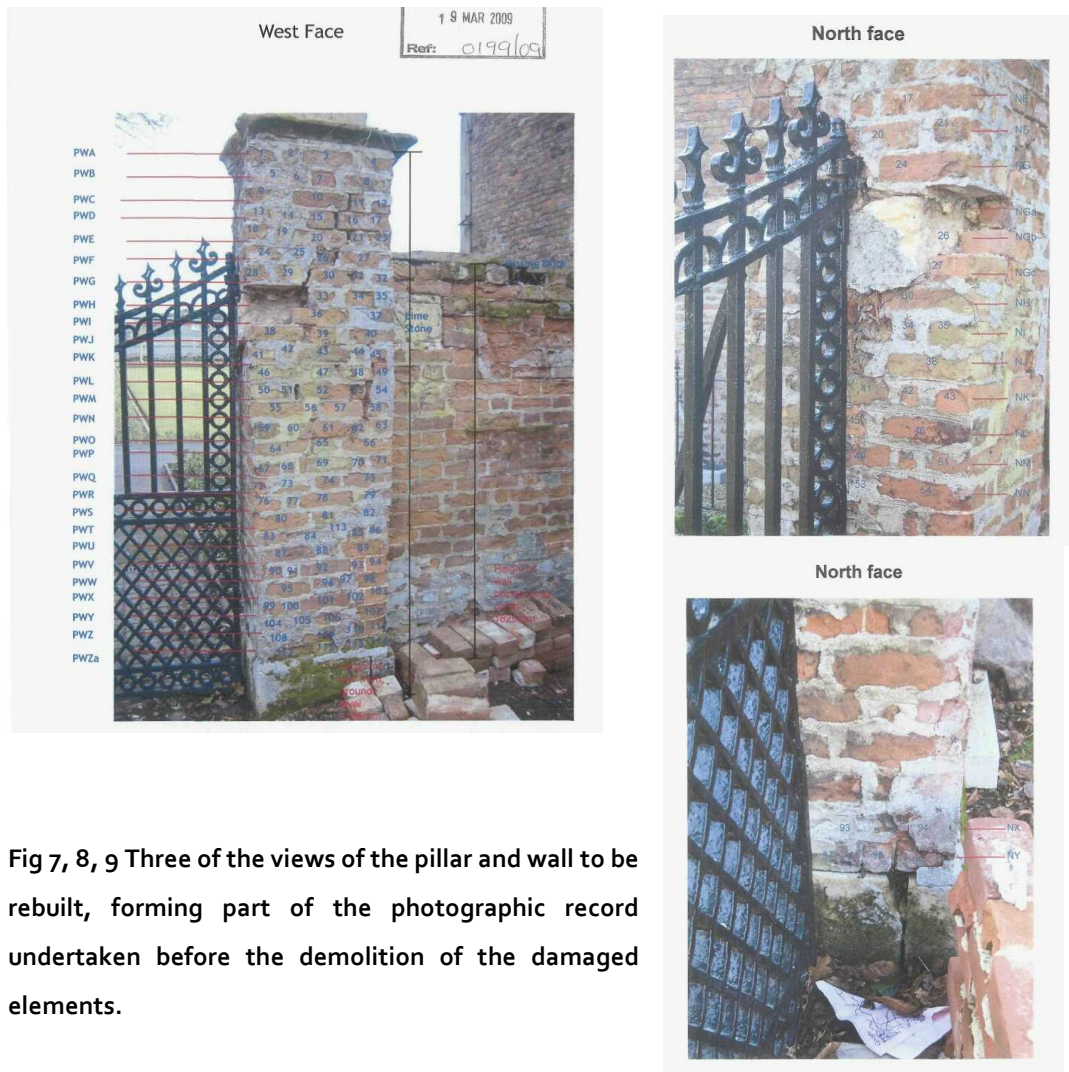
Fig 7, 8, 9 Three of the views of the pillar and wall to be rebuilt, forming part of the photographic record undertaken before the demolition of the damaged elements.
