Protected Species Survey  
Land and Buildings at Millfield Nurseries  
Spalding Common  
South Holland  
Lincolnshire  
NGR TF23416 20081

Report prepared by:  
Christopher Barker CEnv  
Licensed Bat Consultant

| | Report ref:<br><b>P1033/ 0216/ 01 v2</b> | |

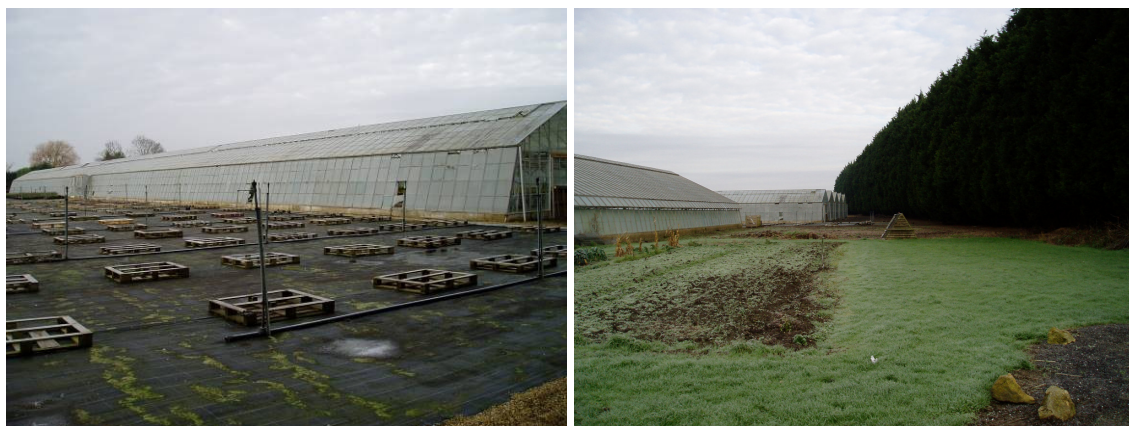
The land surrounding the glasshouses and other buildings around the site surveyed is predominantly concrete hard standing, covered nursery stock areas as shown in the photograph below or compacted ground used for access and storage of equipment. The only areas of semi-natural land are thin strips of grassland and bare soil along the boundaries of the site. These areas were inspected and no indication of any burrows, tracks or trails suggesting the presence of significant wildlife was found.

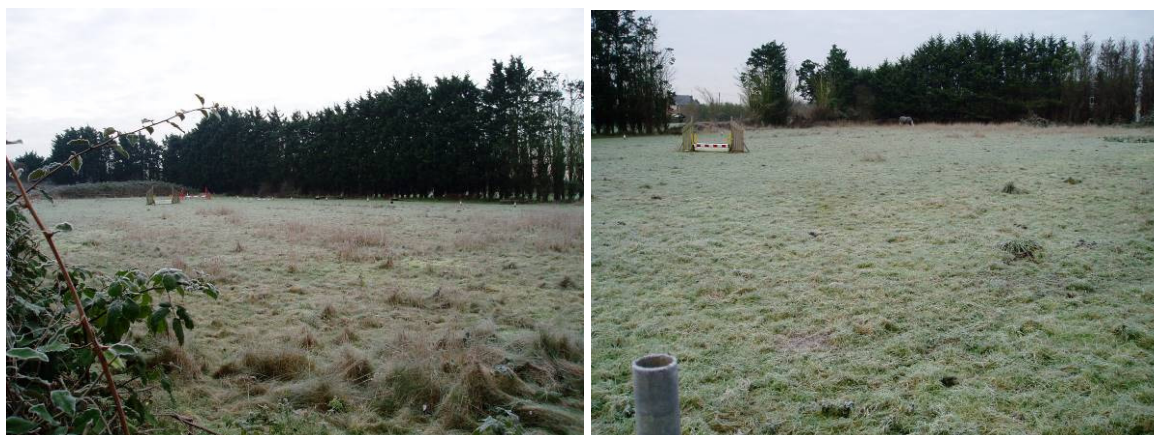
The land lying along the southern side of the survey area adjacent to the residential house and garden comprises a field of intensively grazed semi-improved grassland used as a paddock and exercise area for horses. The field is occupied by uniform grazing sward that is very short and cropped with limited diversity. The boundaries of the field are fenced with wire fencing / sheep netting. The uniform character and quality of this sward is reasonably good and indicates a managed field with moderate fertility and regular grazing to maintain this.

Area grazed by horses

Grazing / exercise area for horses

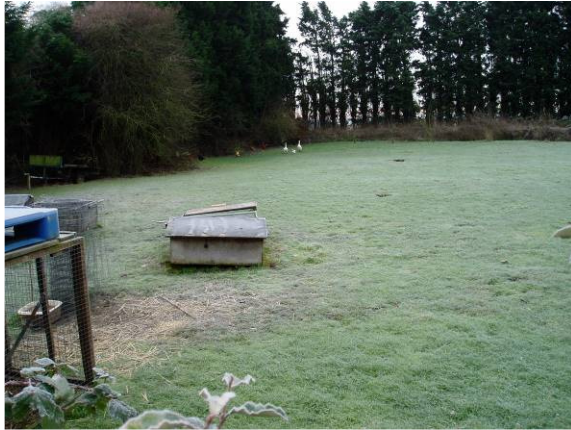
At the eastern end adjacent to the house and garden one part of the field has been segregated and contains chickens and geese.

Chicken / geese area.
