# Water Lane Nurseries, Low Road, Spalding

## Structural Condition Survey

### Barn A

July 2024

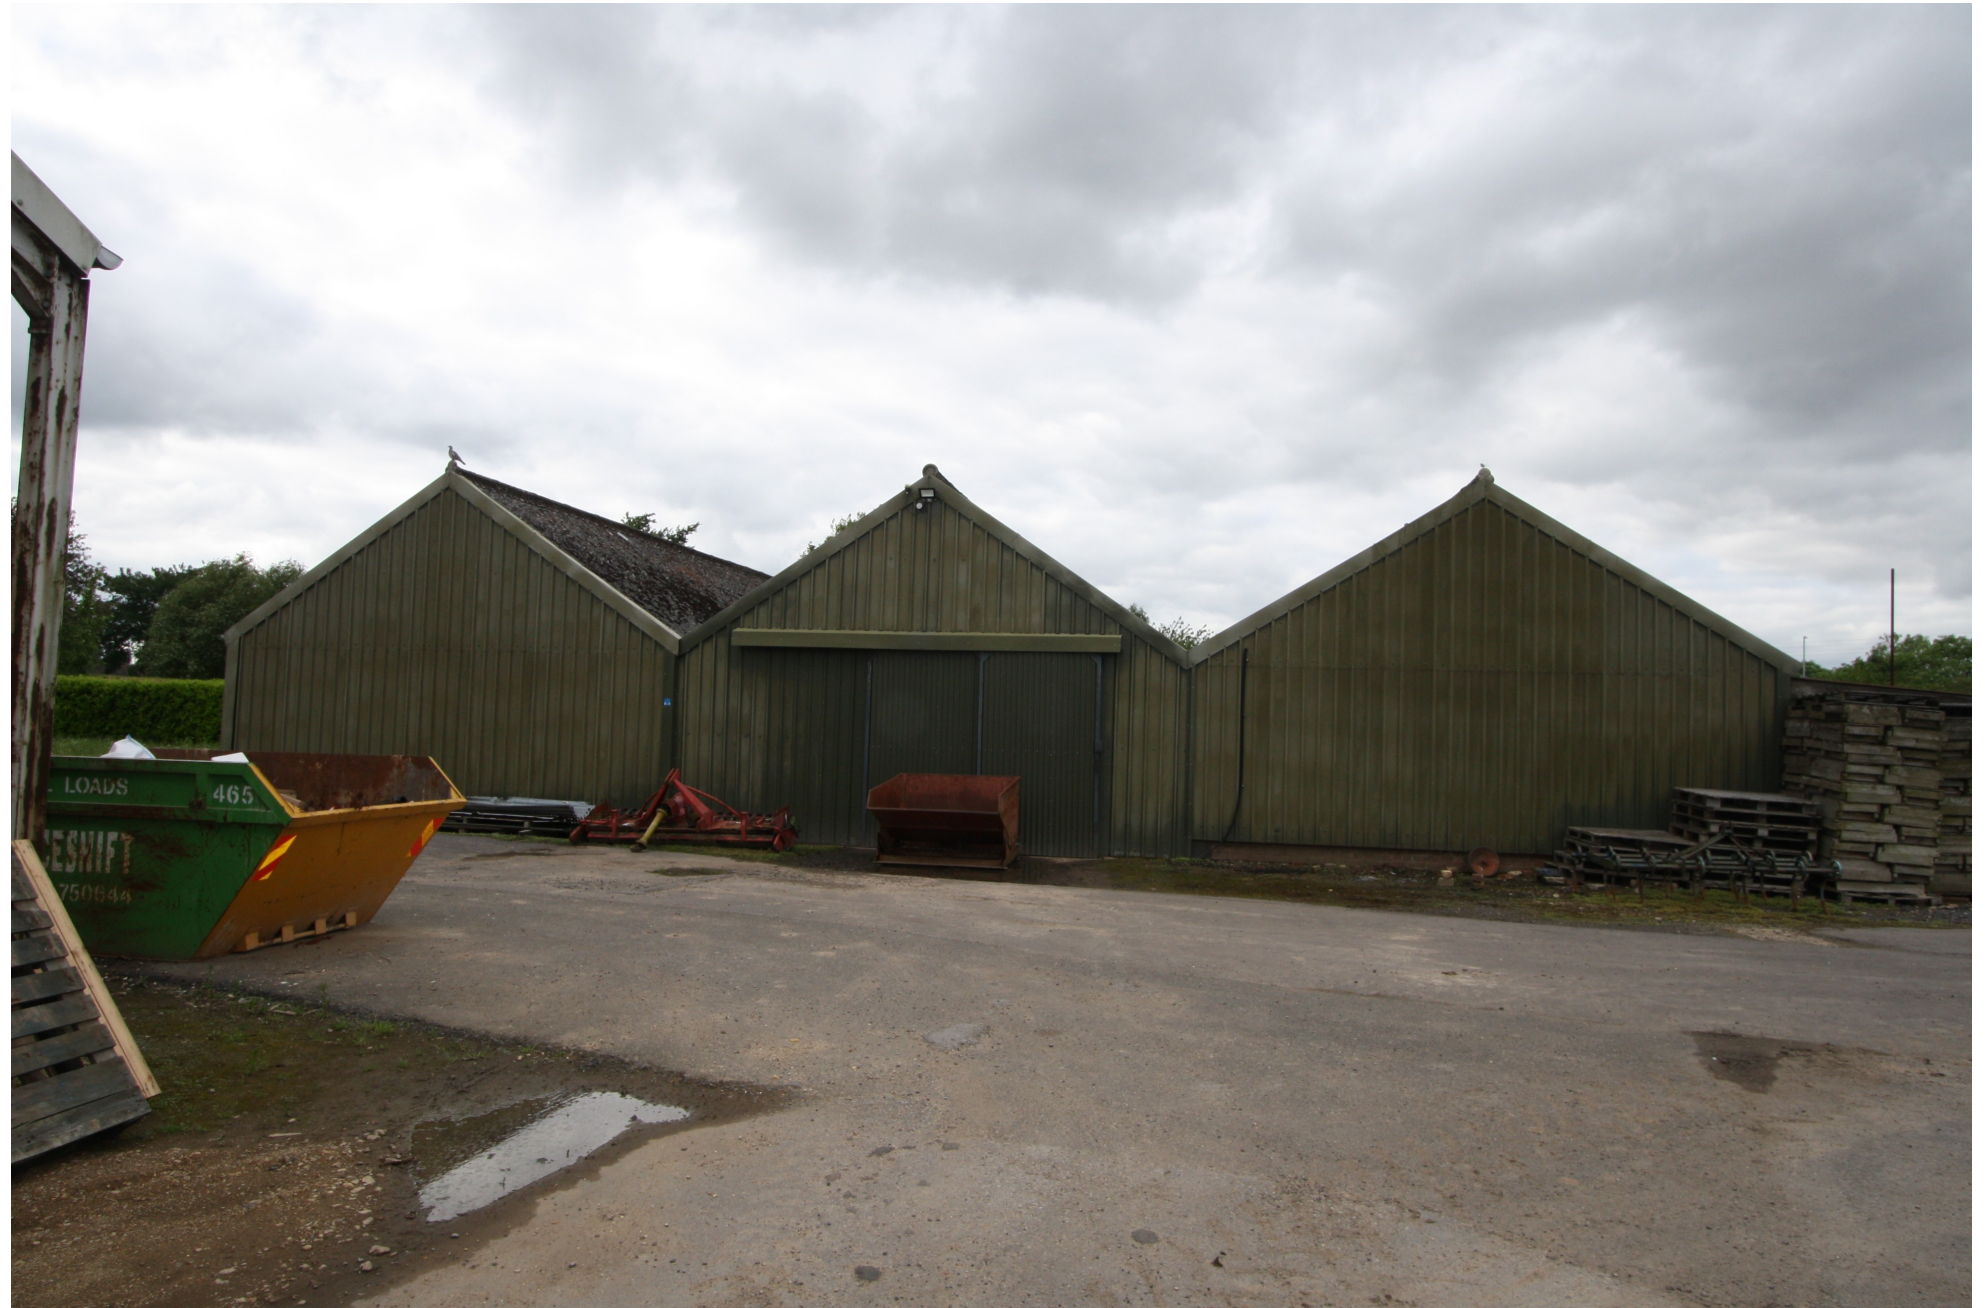
The building is in two distinct parts. The main barn is a steel framed building with cladding previously used for agricultural equipment and machinery storage. To the side of the main barn is a lean-to type structure used as a covered area for storage of equipment.

The exact date of construction is unknown. As far as Studio 11 Architecture are aware, this building is not listed under the Planning (Listed Buildings and Conservation Areas) Act 1990 and is currently used for the ad-hoc storage of machinery.
