# Water Lane Nurseries, Low Road, Spalding

## Structural Condition Survey

### Barn B

**Project:** Demolition of existing barns/ green-house and the erection of 9 dwellings on land at Water Lane Nurseries, Low Road, Spalding

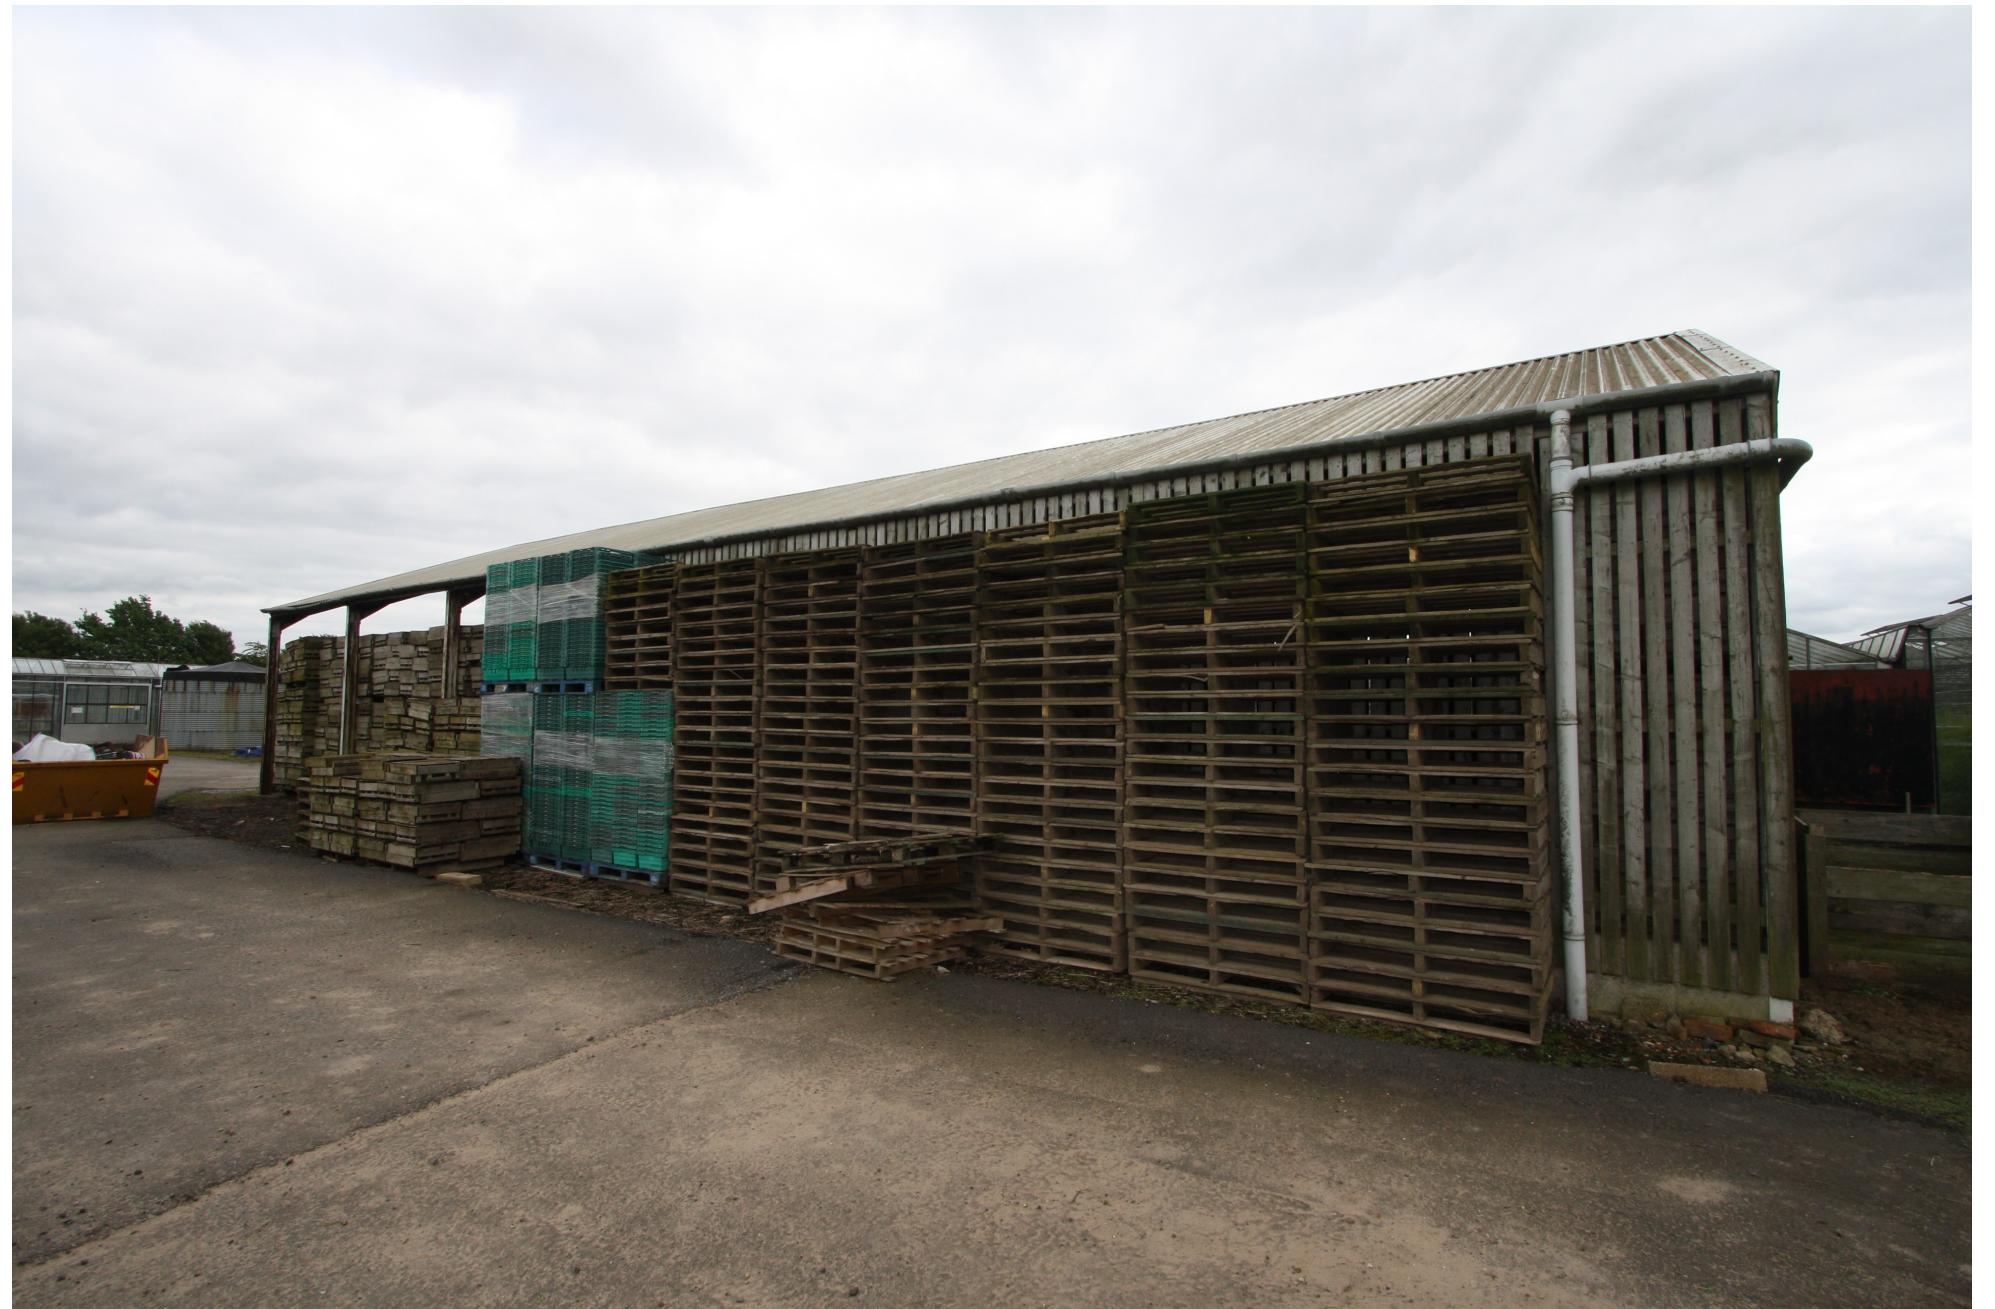
The building is very simple in form. The barn is a steel framed building with cladding previously used for agricultural storage.

The exact date of construction is unknown. As far as Studio 11 Architecture are aware, this building is not listed under the Planning (Listed Buildings and Conservation Areas) Act 1990 and is currently used for the ad-hoc storage of machinery.
