**Ayscoughfee Hall  
Spalding  
Lincolnshire**

**Report on the condition and proposed rebuilding  
of the Mary Ann Johnson Fountain**

**February 2022**

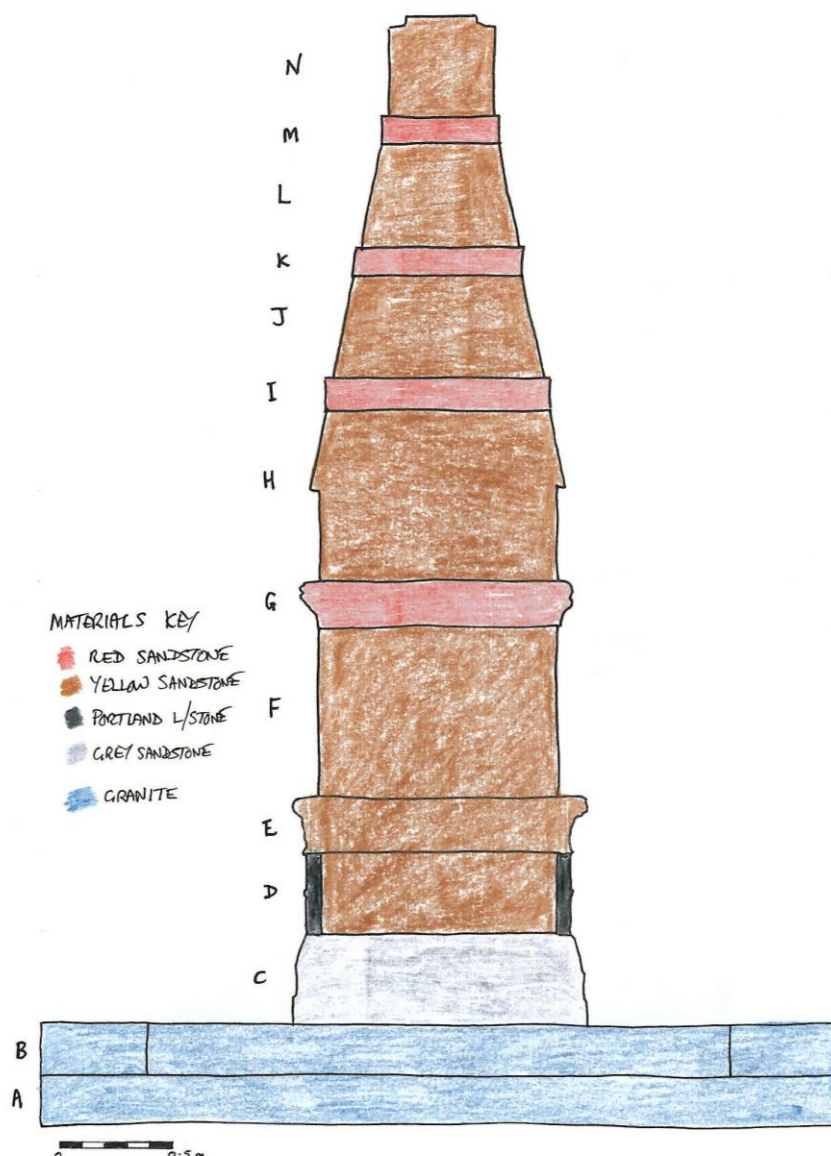
*Plate 2: Sketch reconstruction of the Fountain showing set out and materials of the various stages*

The fountain comprises 15 or 16 courses of stone with a metal cross on top. The layout is shown in the drawing below (plate 2), omitting the top course or two of stone and the cross, neither of which were present in the store. I think, looking at the photo of the Fountain prior to dismantling (plate 1 on the front page) there are probably two missing stone courses, firstly a red sandstone course about 125mm thick with one roundel on each side; then some kind of arched finial stone, maybe 300mm high. The cross looks from the colour photo to have been brass (it has green corrosion) but we know the holding down rod was iron.

A variety of materials have been used. There is a grey granite, a grey sandstone, a yellow sandstone, a fine-grained red sandstone, a limestone (for the column shafts) which looks to me like Portland stone, and then of course the copper pipework.

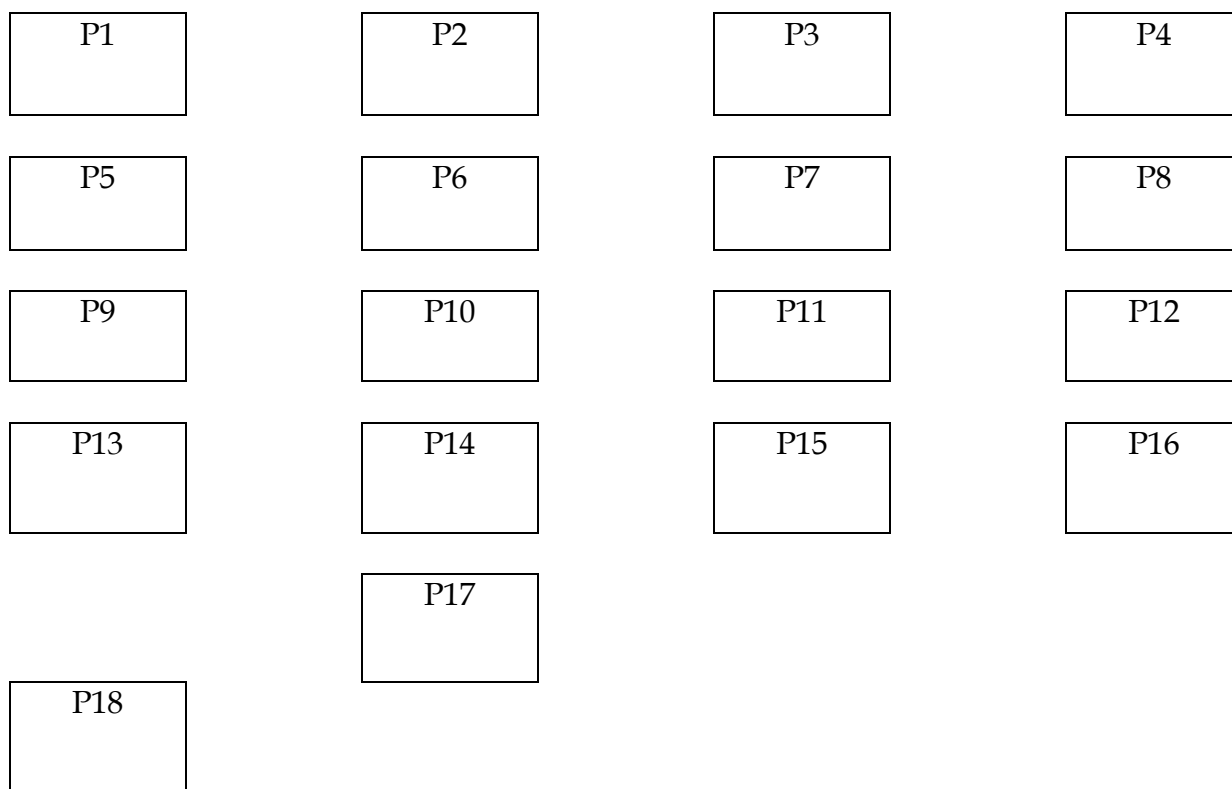
*Rear wall of Store*

The dismantled elements are stored with on pallets or on supports to keep them off the ground. The layout at the time of the survey was as shown below, with a total of 18 'pallets' numbered P1 to P18:

Course A was on 'pallets' P2, P6, P7 (two stones), P9, P10, and P14 (two stones).

Course B was on 'pallets' P1 (two quadrants), P5 (the four straights), P6 (one quadrant) and P9 (one quadrant).

Courses C and D are both on P18 except for the column shafts which are on P7. P18 has collapsed under the weight. The Course C stone, which is an unidentified grey sandstone not used elsewhere on the fountain, is in quite poor condition with a

spalling and disaggregating surface. There is a crack, probably going all the way through, on one side, perhaps a stress fracture from when the pallet collapsed. The two courses, and the 'door' on course D, are cemented together. Course D is potentially very weak at the corners of the octagon due to the thinning of the stone where there are hollows for the columns, and with the separate access stone. It is generally okay but is very dirty, and on one side a weak bed in the stone has started to weather. This last is not actually much of a problem but more a matter of note. There is lots of cement around the access stone.
