Project:  
**Ayscoughfee Hall Museum & Gardens  
Church Gate, Spalding, PE11 2RA**

**Proposed rebuild of damaged gate  
pillar (north pillar of east gates - Love  
Lane).**

Drawing Title:  
**Plans and elevations as proposed**

| <b>A1572-61</b> | <b>P1</b> |

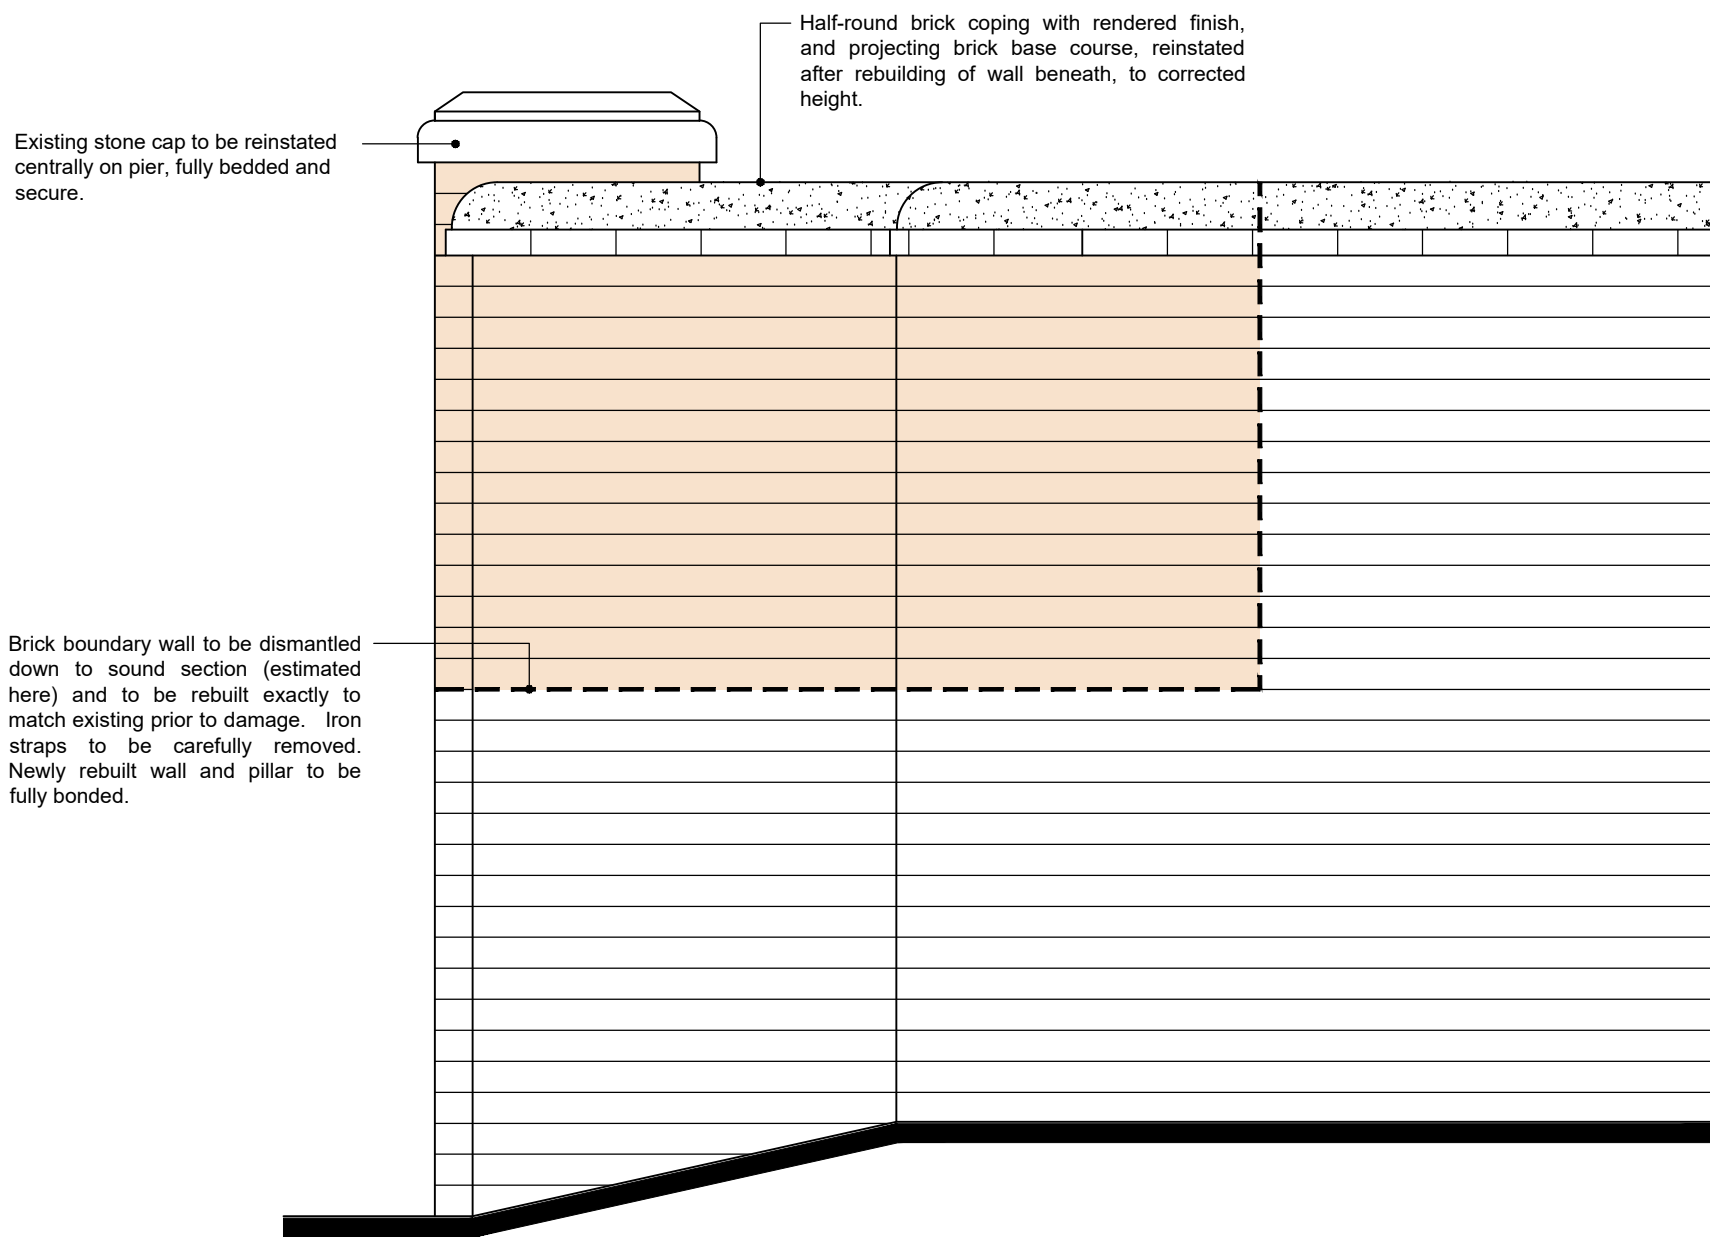
East elevation of north pillar and abutting wall  
Scale 1:20

The existing brick gate pillar to the north of the southern Love Lane opening, suffered impact damage in 2023 when stuck by a vehicle. The hinge stone on the west face of the pillar has cracked and parted vertically, through the line of the hinge plate. This stone has rotated anti-clockwise on plan such that it projects beyond the brickwork beneath by circa 50mm. The brickwork beneath the hinge stone has cracked vertically through at least 3 courses. The brickwork above the hinge stone (again on the west face) has been displaced to the north, such that it overhangs the north face of the pillar by circa 50mm, for a height of 9 courses. On the south face, the west section of the hinge stone has been shifted to the west, and a significant gap has opened up between the two components of the hinge stone, rising through 2 courses before reducing to a single crack. The impact also appears to have resulted in a number of smaller cracks throughout the pillar and into the adjoining boundary wall. In summary, the main elements of damage of the impact to the brickwork appear to be as follows:

1. Fracture and displacement of the west hinge stone.
2. Rotation of the upper section of the gate pillar.
3. General cracking throughout the pillar and into the abutting wall.

Beyond this, immediately north of the pillar there are a number of iron straps set within the bed-joints of the brickwork, continuing around the wall splay on plan, and set at various heights. This mortar cover on the ironwork has eroded away on the upper 3 straps, exposing the iron to the elements. This has resulted in the iron corroding, expanding significantly in the process. Consequently, the brickwork above has been lifted. It is suspected that there may be a total of 7 iron straps, though only 3 are visible.

The damage is to be addressed by undertaking the following works:

5. Careful removal and disposal of the 3 corroded iron straps.
6. Investigation of the wall at lower level to establish whether further iron straps exist. Should this be the case then the works are to include the dismantling of further brickwork and the removal of all iron straps.
