# Ground Gas Verification Report

## Public Open Space, Wygate Park, Spalding

**BRD241183-OR14-A**

**November 2020**

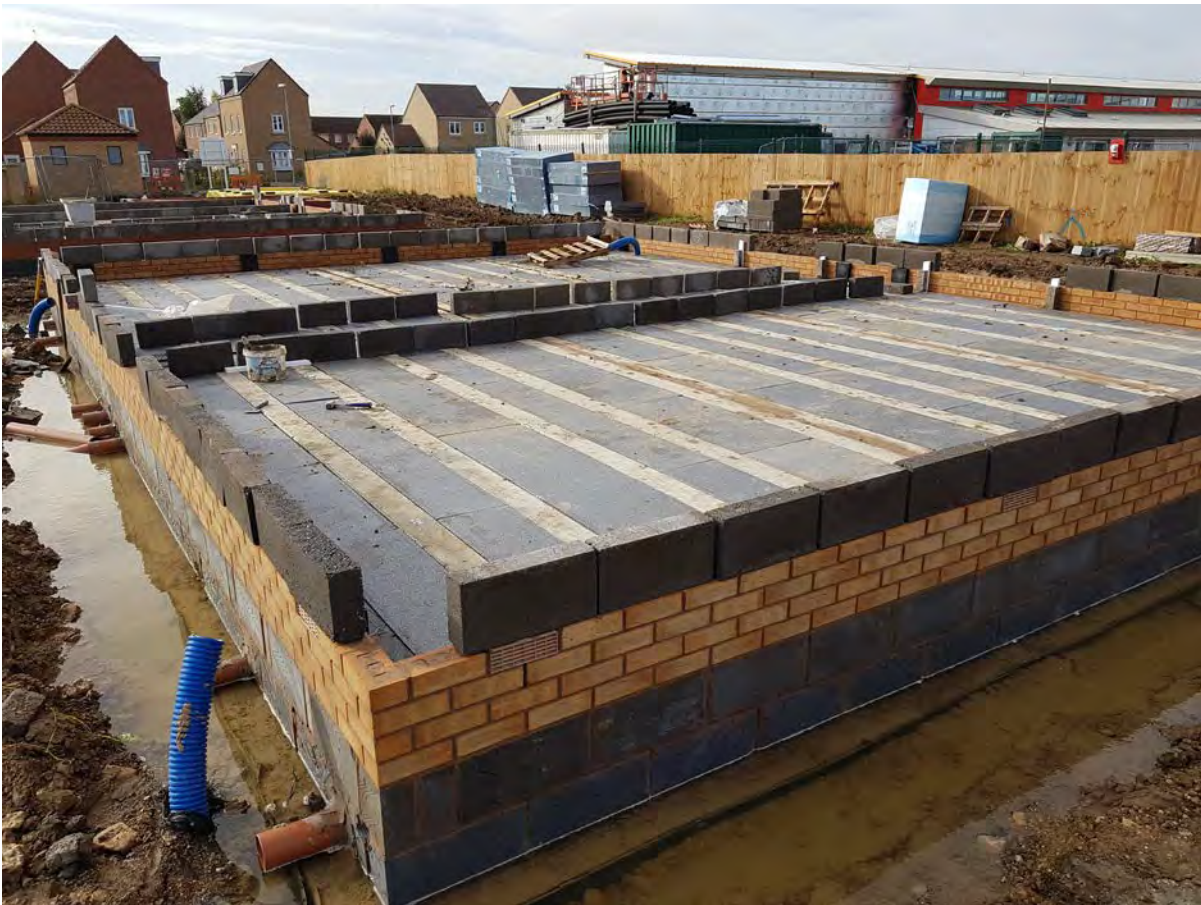
**Photo 6** – Plots 908/909 showing air bricks and periscopic vents. Thick layer of final insulation yet to be laid upon which the membrane will be fitted. Not plot 904 in distance with yellow membrane.

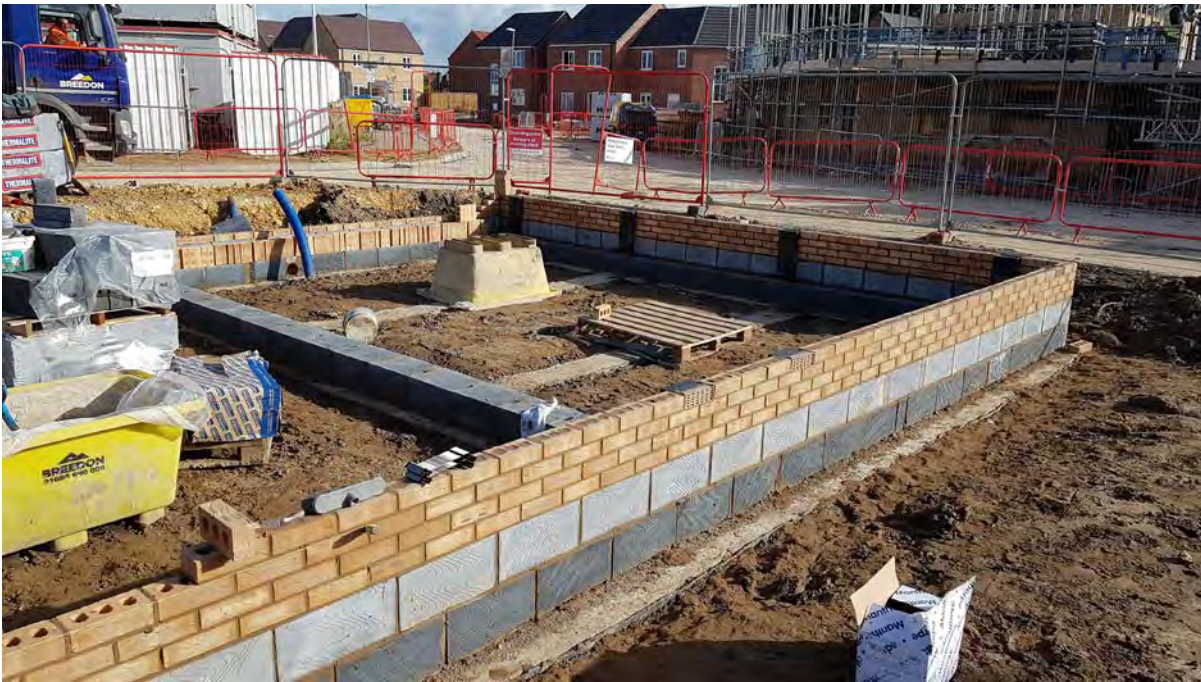
**Photo 8** – Plots 901 to 903 under construction showing air bricks and void.

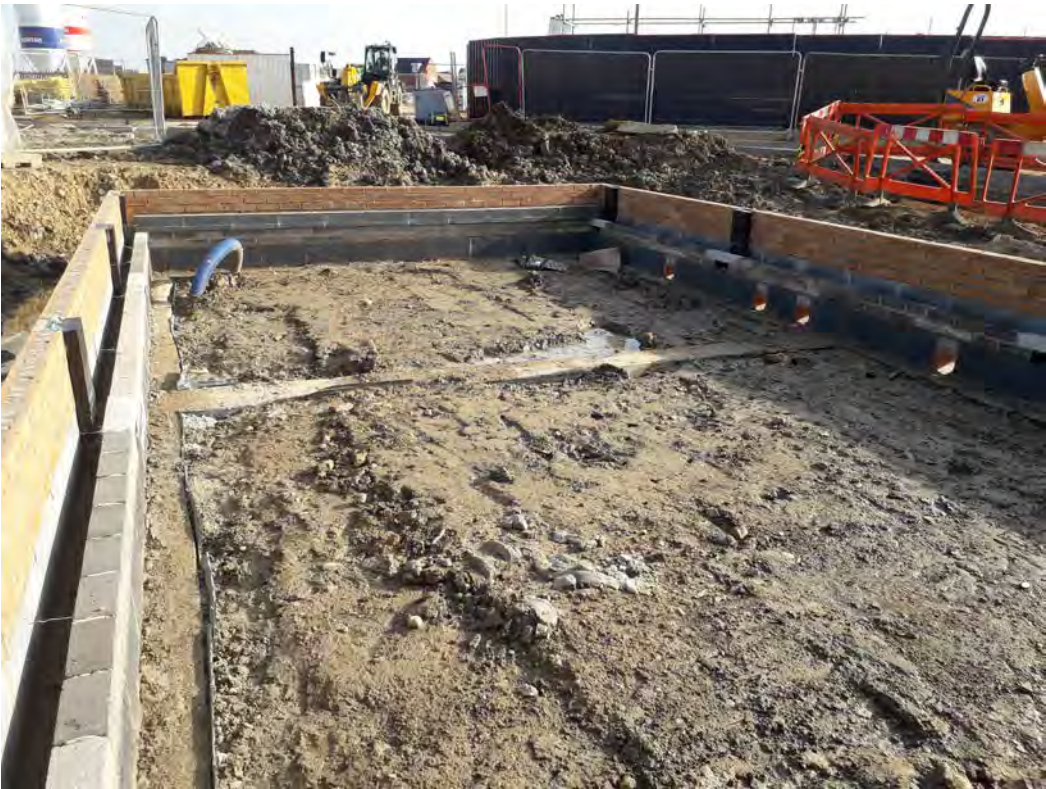
**Photo 6** – Close up of interior of Plot 920 showing void and periscopic ducts.

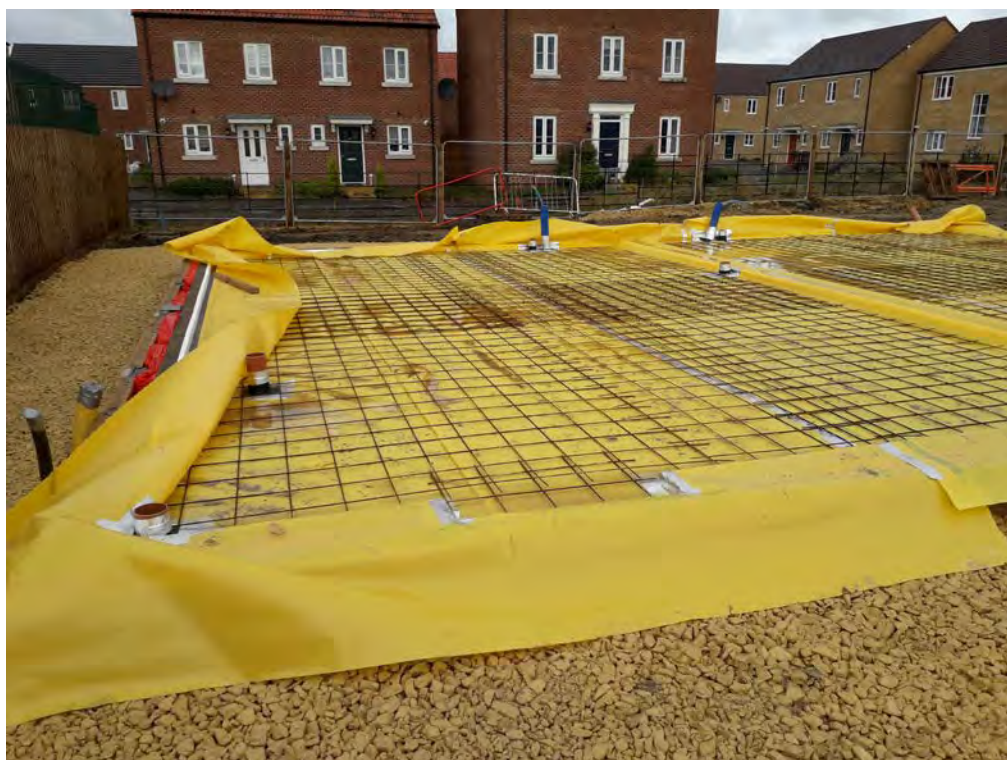
**Photo 1** – General view across Plot 910/911.

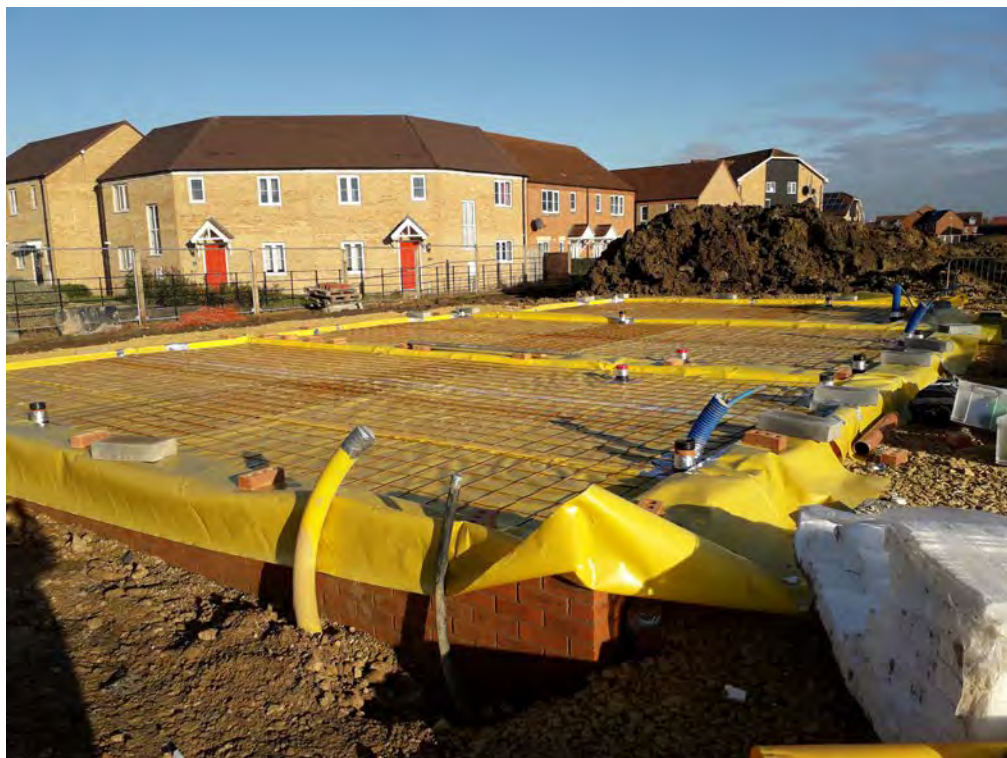
**Photo 1** – General view across Plot 912/913/914.

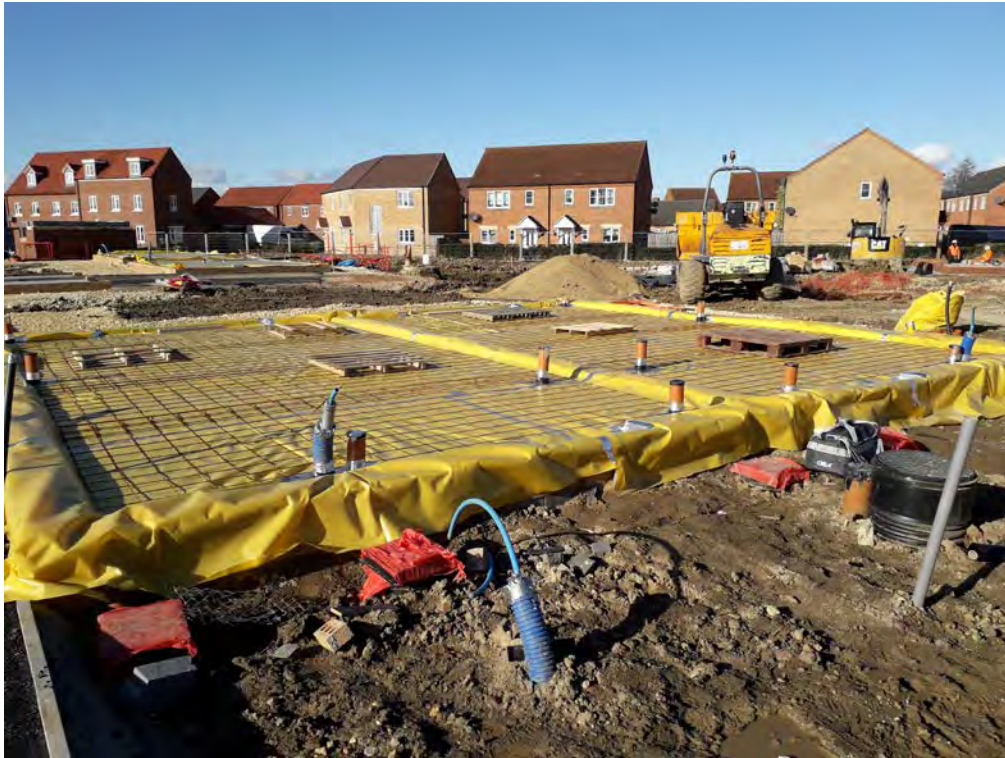
**Photo 1** – General view across Plot 921/922.

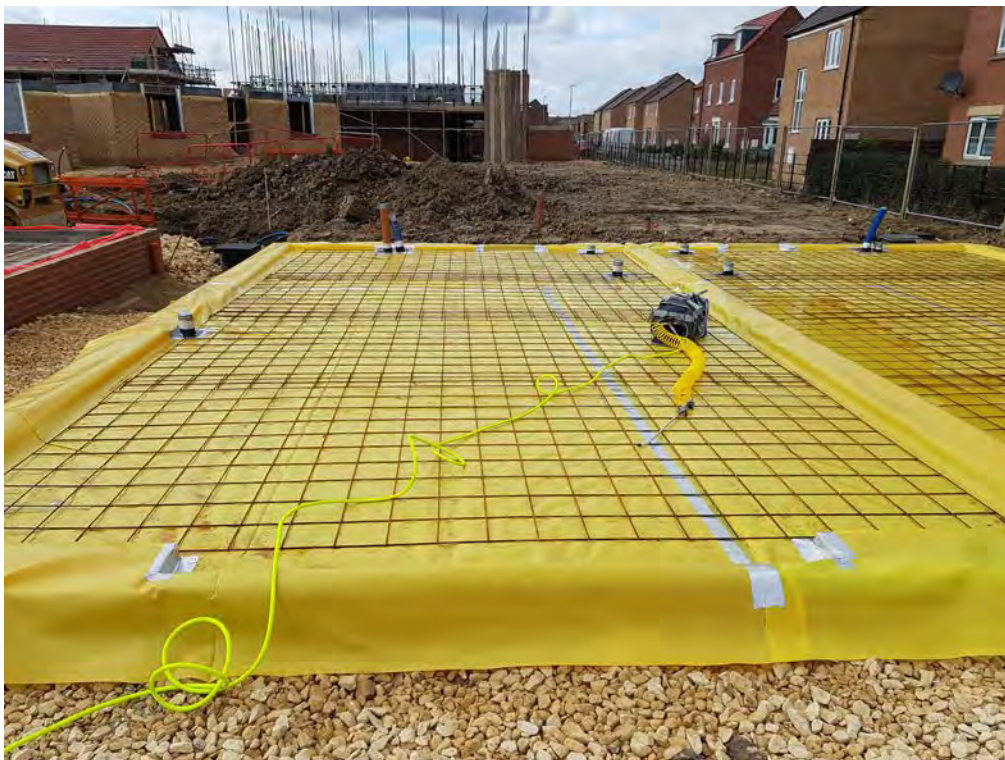
**Photo 1** – General view across Plot 924/925.

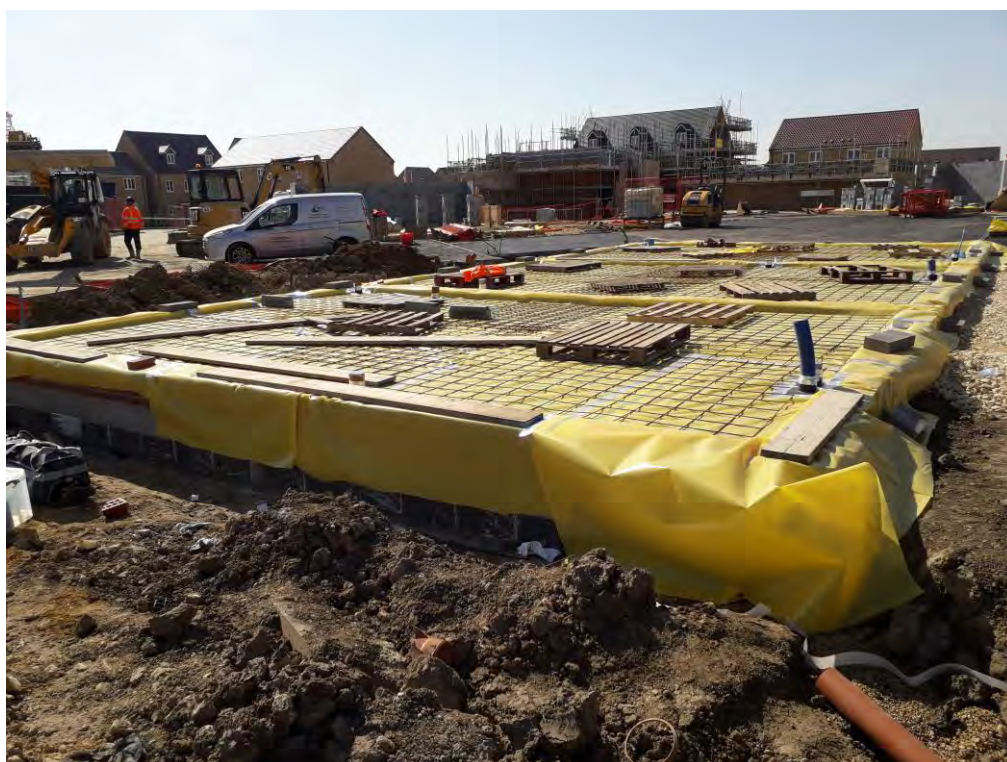
**Photo 1** - General view across Plot 927/928/929.

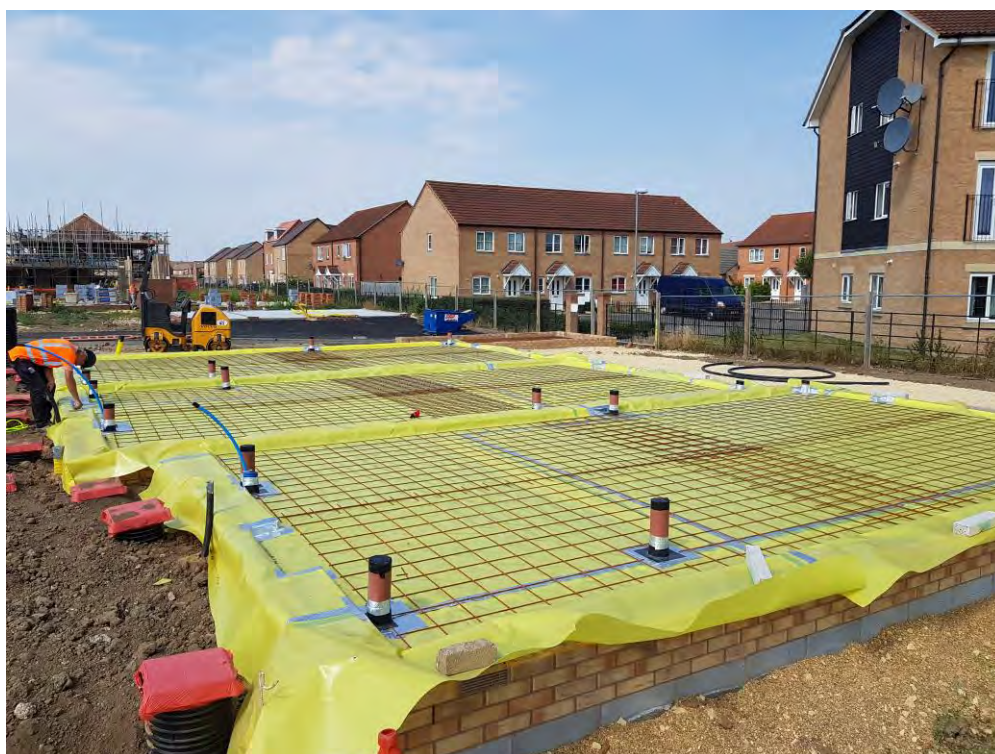
**Photo 1** - General view across Plot 930/931/932.
