# Historic Building Record

*The Coach House, Avenue Farm House, Sutton Bridge.*

A programme of historic building recording was undertaken prior to the renovation and conversion of an outbuilding at Avenue Farm House, Avenue Farm Road, Sutton Bridge, Lincolnshire.

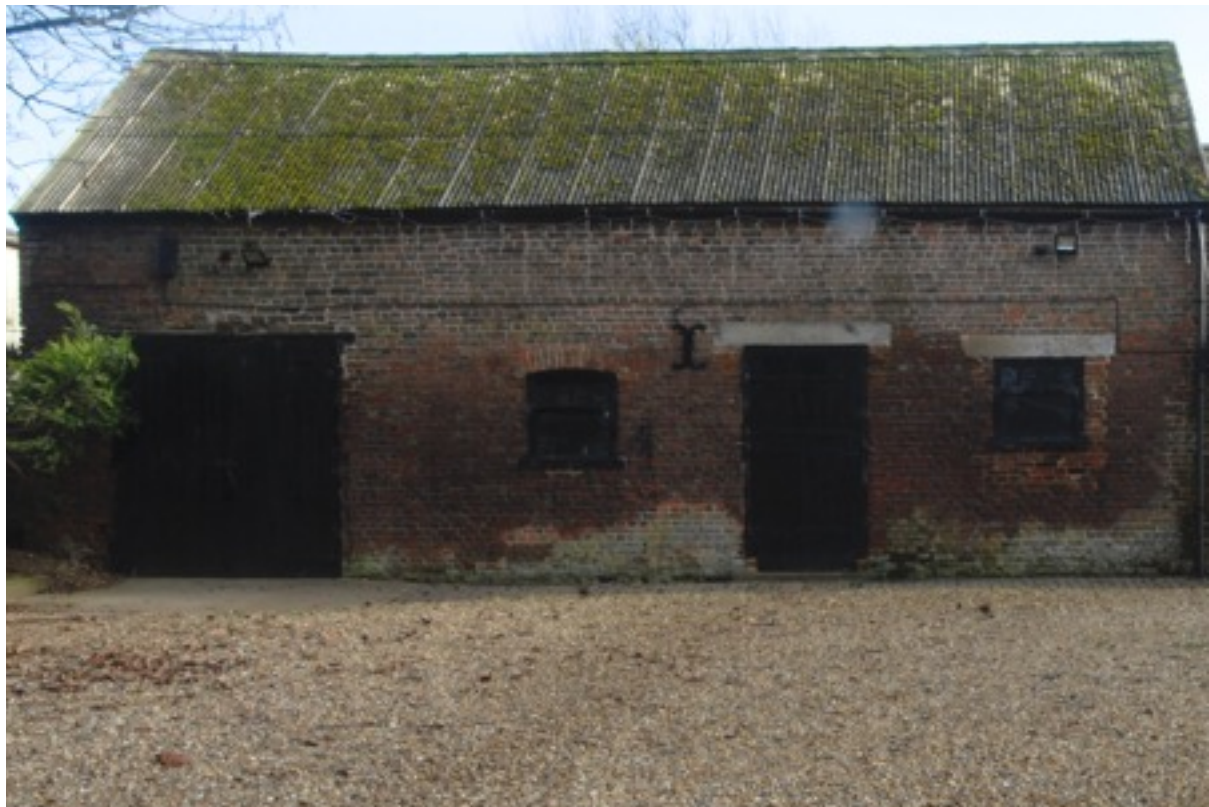
The building as it exists today is the remains of a complex of farm buildings some of which are now no longer part of the property. There have been numerous alterations to the building over the years, evident from the mix of both old and modern materials, most notably the temporary roof structure at the rear (Plate 9 - refer to plastic roof). Repairs around the windows demonstrate the use of mixed materials when being repointed, original lime mortars being mixed with more modern cement and sand mixes.

Plate 5 - West Elevation (Front)

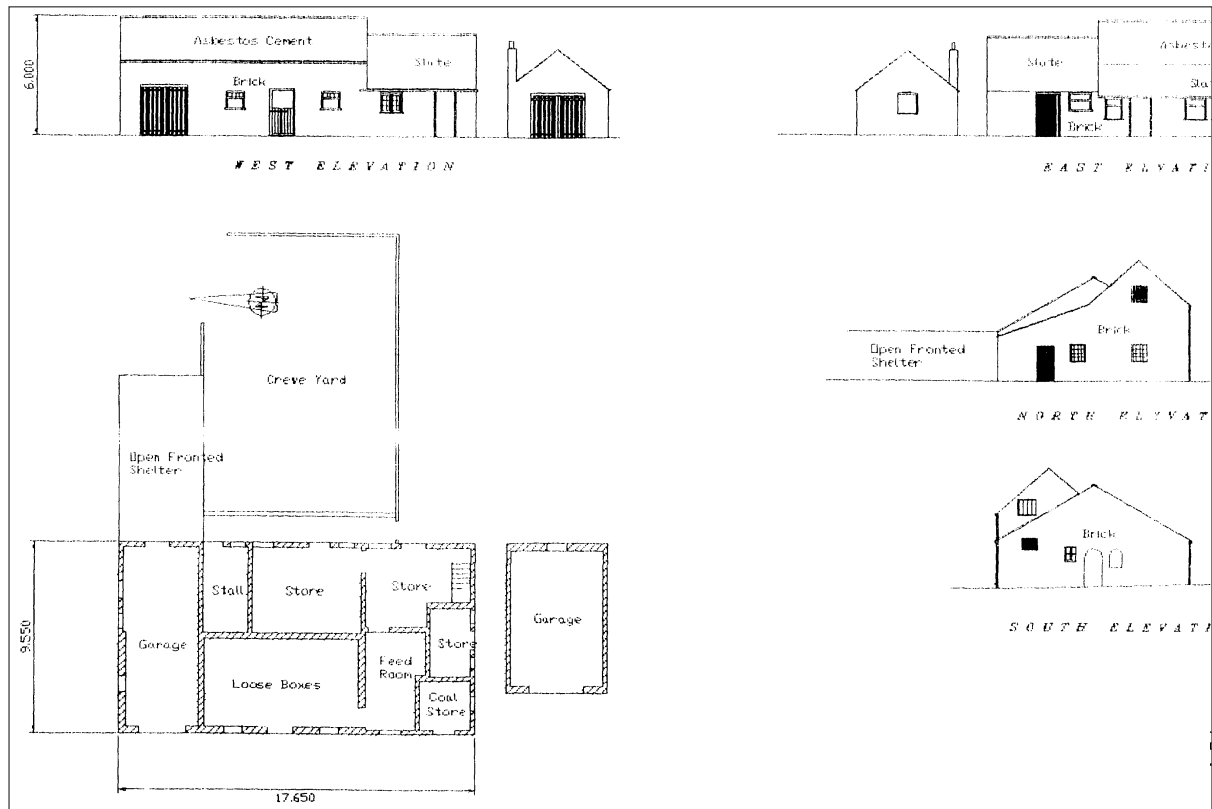
There are variations in the brick bond but the majority of the original brickwork in in English Bond. It is clear from the layout noted in the site plan (Plate 8), the original use of the building was to house cattle. The pitch of the largest roof is shallow and is covered by corrugated asbestos cement sheets. The pitch of the smaller roof is wider but roofed in a more modern slate instead. The open fronted shelter is no longer present. The eastern

**Plate 8 - Layout as recorded in 1991**

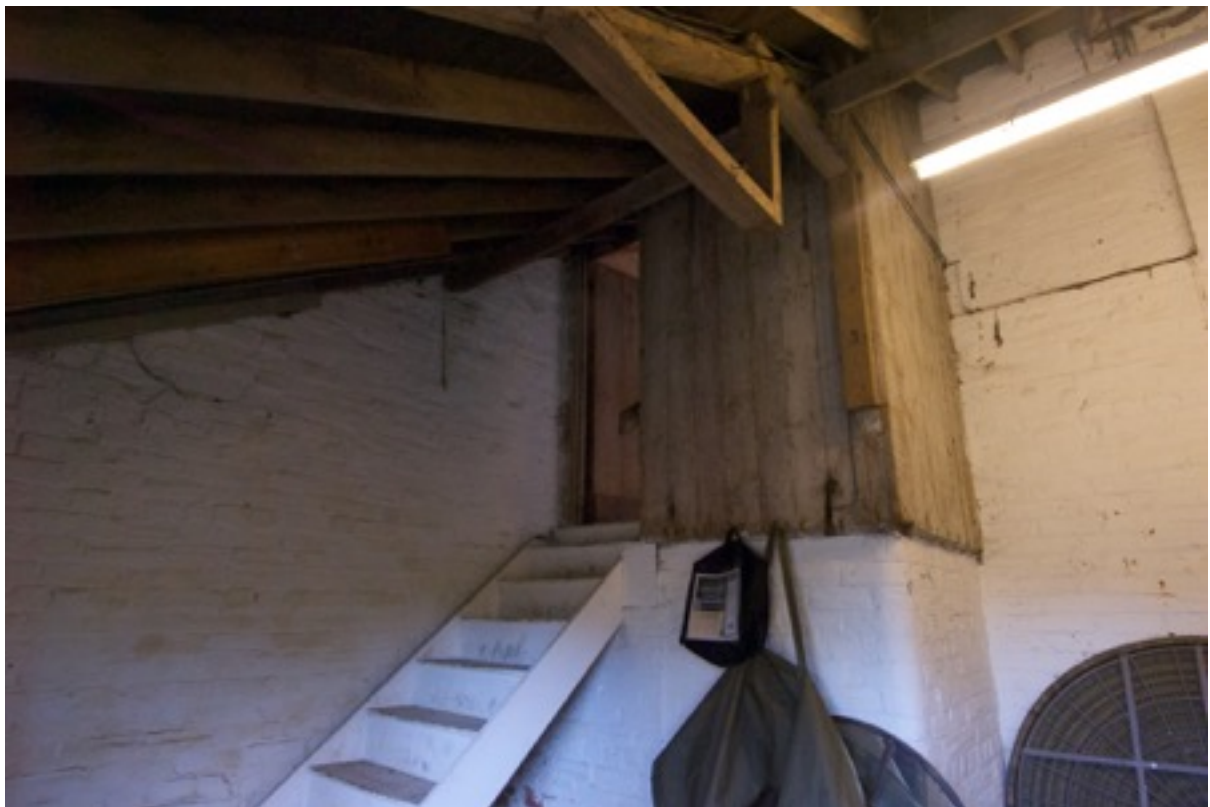
Presented again in a 1 brick depth English Garden Wall Bond but repairs are more difficult to determine with the walls being completely whitewashed. Originally used as a store for hay, steps lead up to a room occupying the loft space.

**Plate 15 - Steps leading to raised area.**

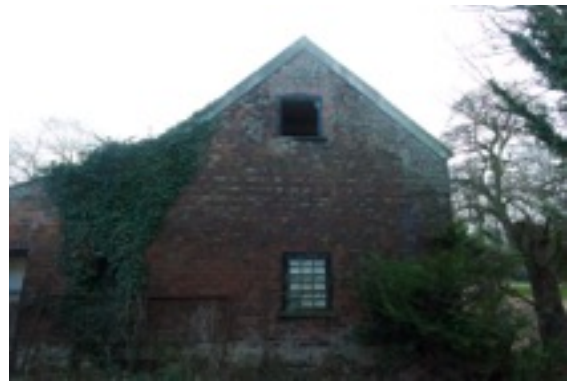
**Plate 19 - Northern elevation.**

Walls are 8” thick and the timber doors whilst old are not original, approximately fifty years old. Again as with the rest of the building repairs have been done over different ages of the building evidenced by the multiple uses of different brick types and pointing materials / techniques. It is housed under the shallower pitch roof of the two roofs of the building.
