# Parsonage Farm Parsonage Lane Spalding Lincolnshire

*Historic Building Recording*

CA Project: MK0012  
CA Report: MK0012\_1

March 2019

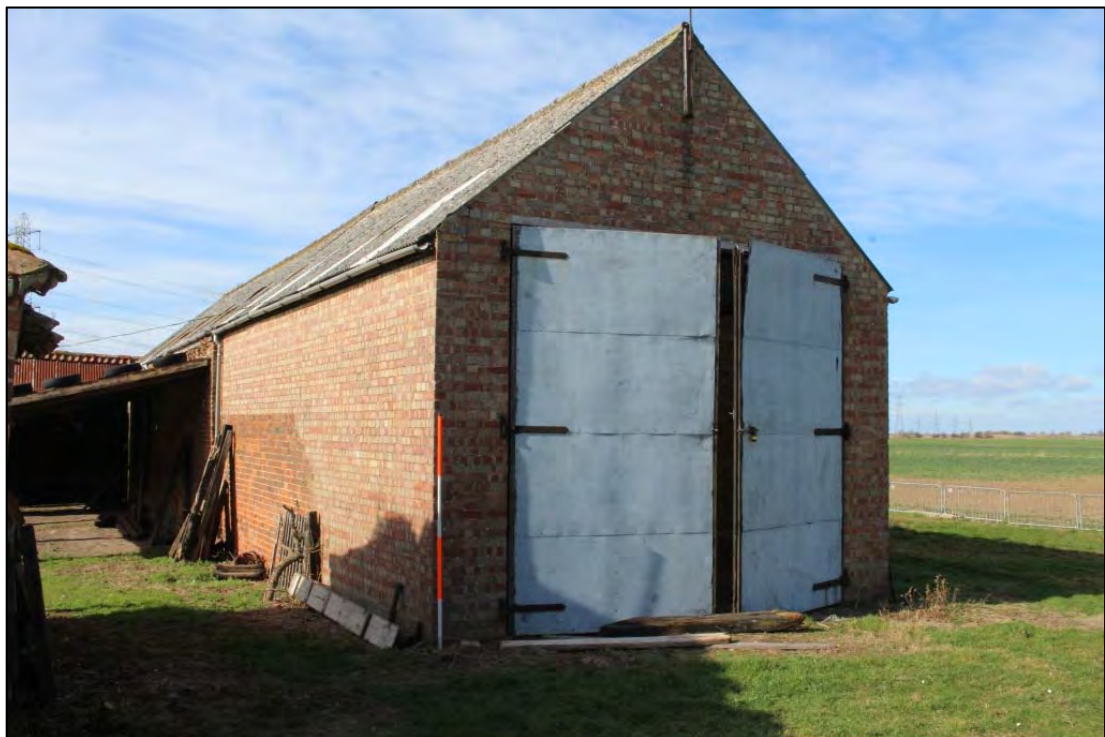
- 4.2. Building A (Photo 1) comprises a brick barn structure, incorporating a corrugated metal roof and three functioning openings, all doorways. The barn is the largest building in the farmstead complex, measuring approximately 28m in length and 6m wide. The footprint of the barn can be identified on the 1888 OS map (Fig. 3) and coincides with the earliest cartographic record of the farmstead, suggesting that the barn was one of the original buildings. Despite this, the barn appears to have undergone substantial alteration and repair, much of which is evident in the internal brick elevations and the roof structure.

Photo 1: Overview of Building A, viewed from the south-east

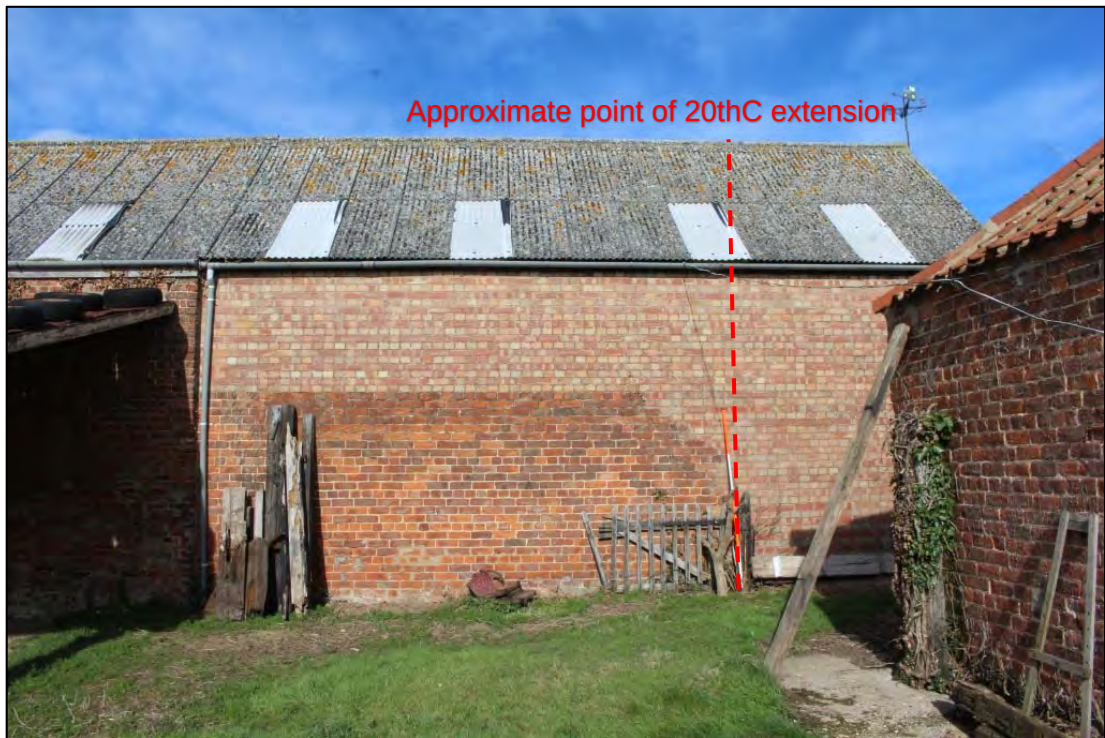
- 
- 4.3. The eastern extent of the barn (Photo 2) incorporates the extension to the barn identified in paragraph 3.8 and is evidenced by the 20th-century brickwork. The extension was first evident on the 1976 OS map and is identifiable where the remnants of 19th-century brickwork terminate. Internally, the extension is clearly visible (Photo 3). A pair of modern steel doors are fitted within the eastern elevation of the extended barn (Photo 1, above).

Photo 2: Overview of north-eastern extent of Building A

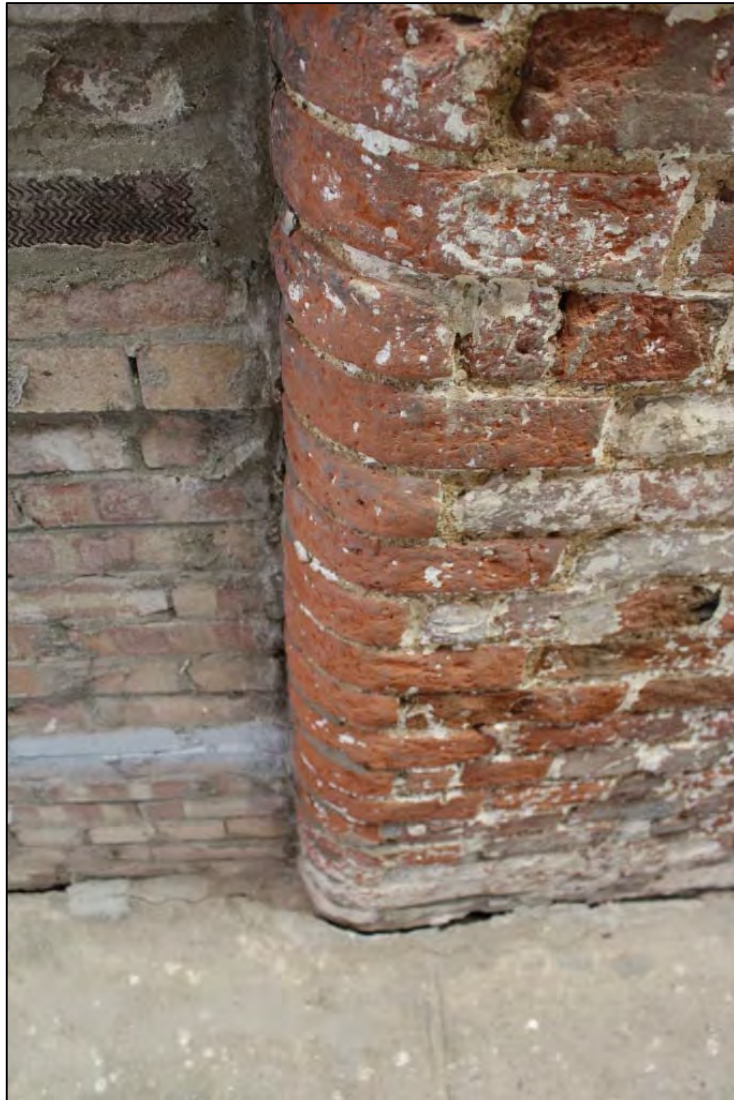
Photo 8: Detail of bullnose bricks to the blocked-up opening

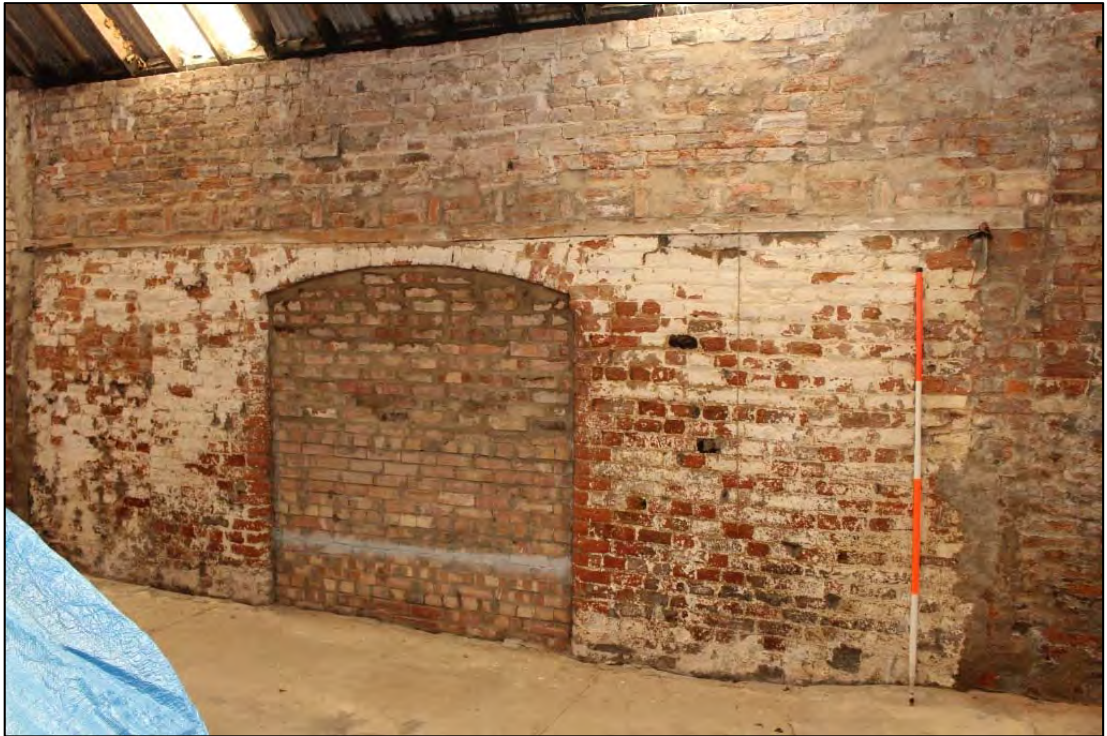
the barn (Photo 9). An extant, machine cut timber remains within the wall, immediately beneath the slots (Photo 10) but this cuts across the top of the brick arch, suggesting that a first floor was inserted as a later alteration. Evidence for the existence of a first floor is replicated on the northern elevation, however the brickwork has been repaired in a way that does not evidence the incorporation of slots for timber joists (Photo 11).

Photo 9: Internal view of southern elevation incorporating segmental arch opening and possible slots for first floor joists

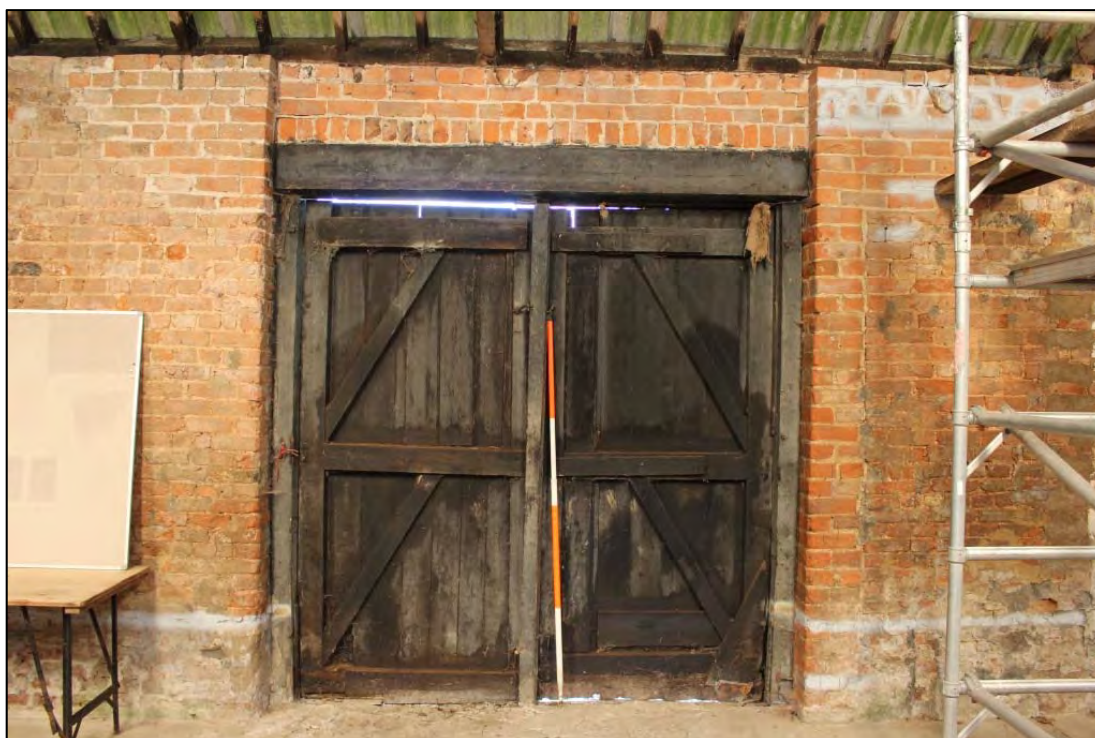
- 4.6. The barn incorporates a pair of timber ledged and braced double doors in the northern elevation (Photo 12) that date to the 19th-century/early 20th-century. The brickwork above and to the northern extent of the doors has been renewed in the past, suggesting that the extant doors may be later replacements for earlier doors. To the southern elevation of the barn, directly opposite the double doors, is a single width door with extensive brickwork alterations to the immediate south (Photo 13). The extent of the brick infill suggests that the opening may have originally been wider and could have been used in conjunction with the extant double doors as part of a threshing process. Some conjecture remains as to the doors true purpose however, as their relatively small dimensions, combined with their aspect onto a small courtyard and the raised floor level of the barn compared with the courtyard are all possible reasons why the barn may not have been used for threshing.

Photo 12: Overview of double timber doors within the northern elevation

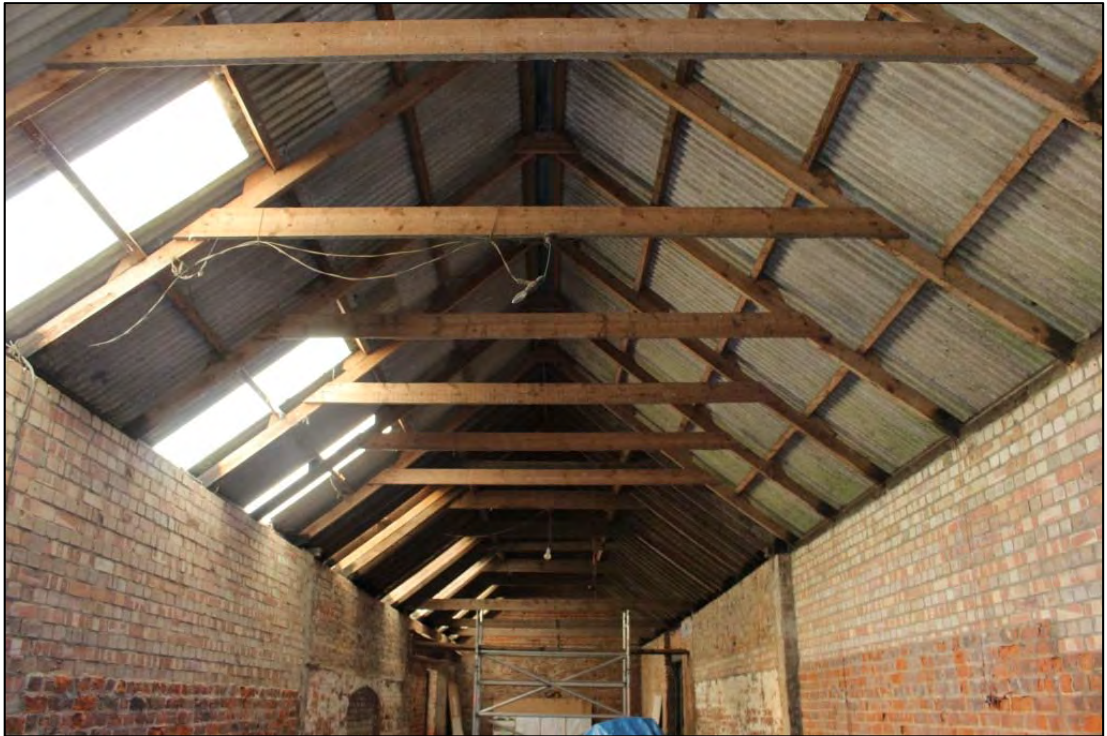
- 4.8. The roof of the barn is a simple construction using slender, rafters and collars which appears to be machine-cut and date to the 20th-century (Photo 15). The configuration of the roof changes slightly where the possible earlier extension commences (Photo 16), suggesting that the roof structure was constructed in two separate phases. The corrugated sheeting appears to have been applied relatively recently, in one phase for the entire roof. It is likely that the original roof covering would have comprised clay pantiles, as can be found on Buildings B, C, E and F.

Photo 15: Overview of roof structure, looking west

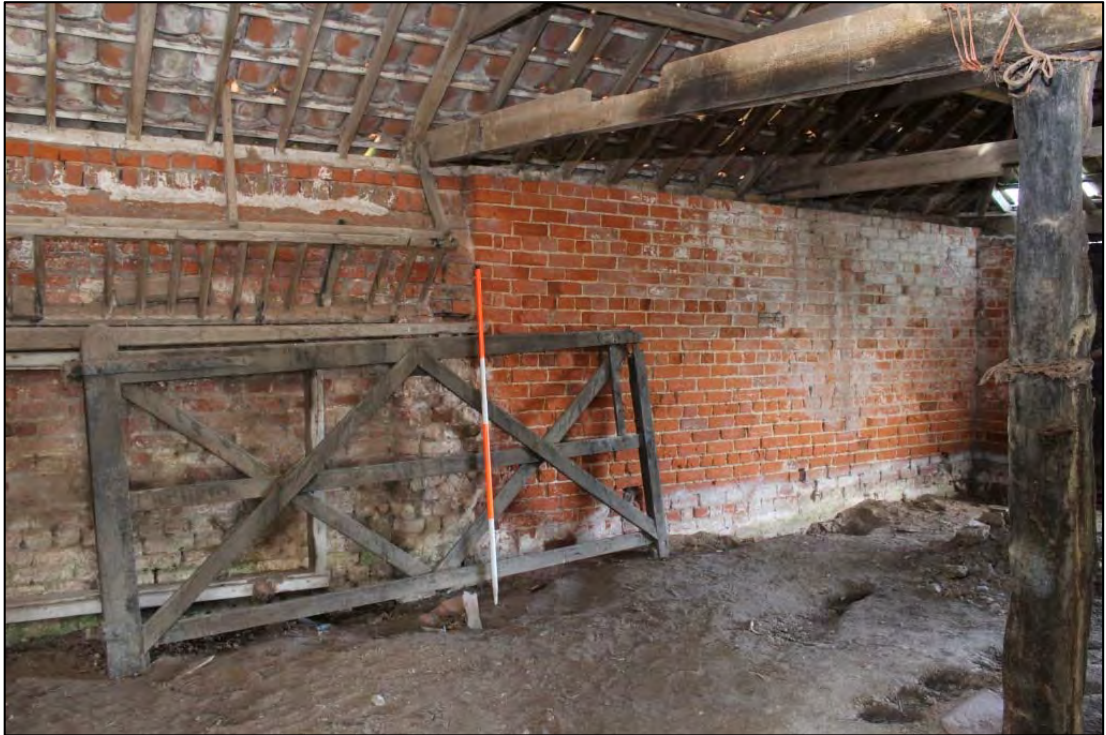
terminates in a buttress or pilaster at its northern extent, which tapers into the wall as it rises, whilst the northernmost extent of the wall appears less weathered and is abutted to the same buttress at its southern extent by use of a butt joint (Photos 19 and 20). To the southern extent of the western elevation is a timber hay rack (Photo 21) of a form suggestive of cattle feeding.

Photo 19: Overview of western elevation within Building B

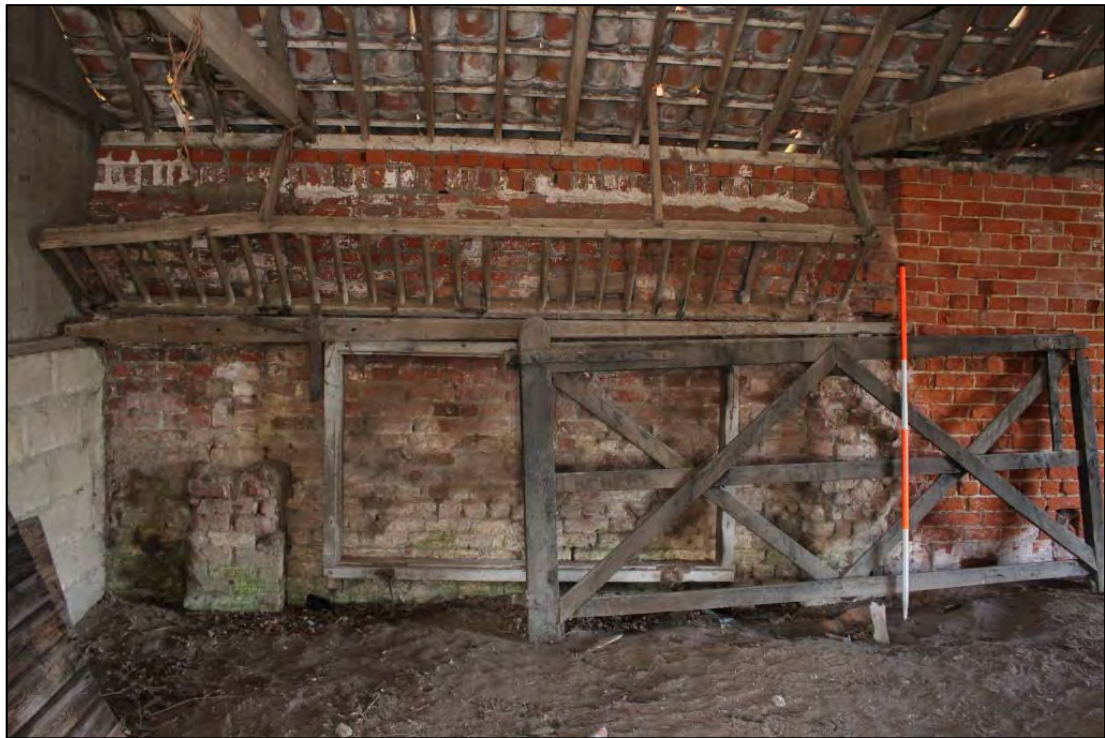
Photo 21: Overview of southern extent of western elevation within Building B

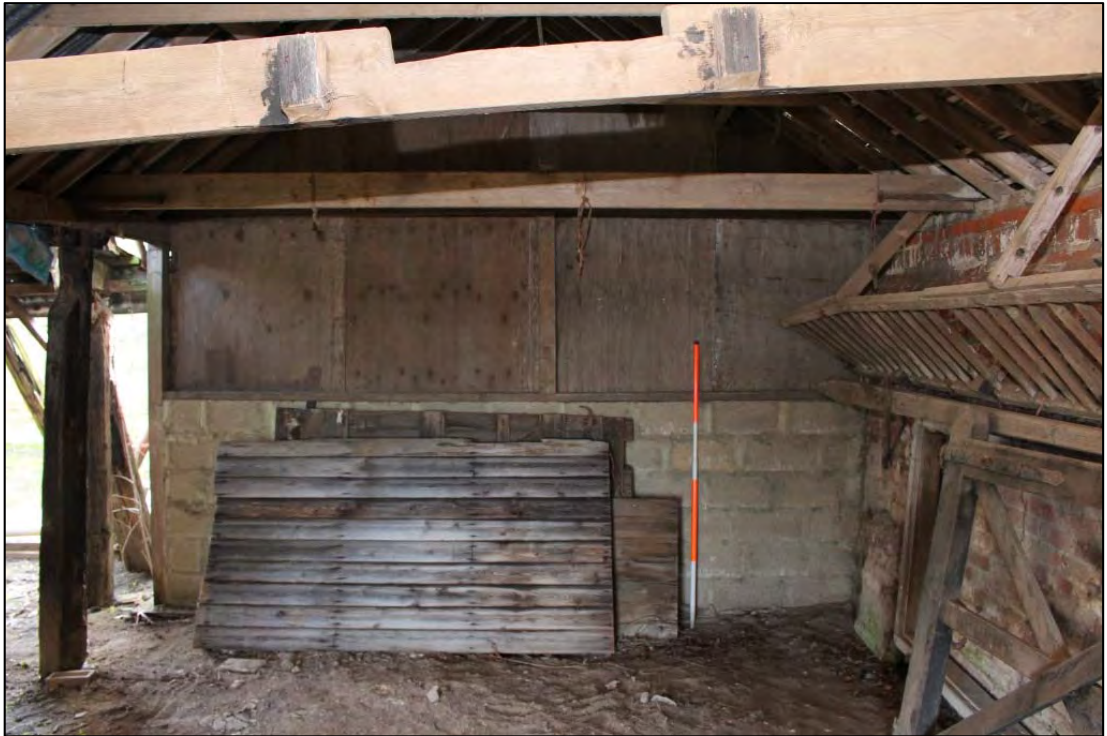
- 4.12. The southern extent of Building B is partitioned from Building C via a 20th-century block and timber wall (Photo 22), suggesting that Buildings B and C once formed one building. The blockwork continues to form the eastern elevation of Building C (Photo 18, above) which had since been converted into stabling for horses (Photo 23), however cartographic evidence shows that Buildings B and C were once open fronted, facing into the courtyard (see Figs. 3 and 4). Assuming that the northern extent of Building B was once possibly sectioned off as part of Building A, the remainder of Buildings B and C would have probably functioned as a shelter shed for cattle. These buildings were enclosed on three sides whilst incorporating an open side for cattle to enter. Cattle were not tethered and there were no stall divisions, the building was merely designed to shelter cattle from the worst of the weather (Brunskill 1982). Shelter sheds would have incorporated a hayrack to the rear wall, as evidenced in Photo 21, above. The degree of alteration to Buildings A and B precludes a confident conclusion as to the exact relationship between the two buildings, however it is possible that there would have been a separate access directly to fields from the shelter shed in the same location of the existing access to Building B, at its northern extent. This would assume that there was a subdivision at the western extent of Building A between livestock and crop storage/threshing to allow for the movement of the livestock.

Photo 22: Overview of southern extent of Building B showing block and timber division from Building C

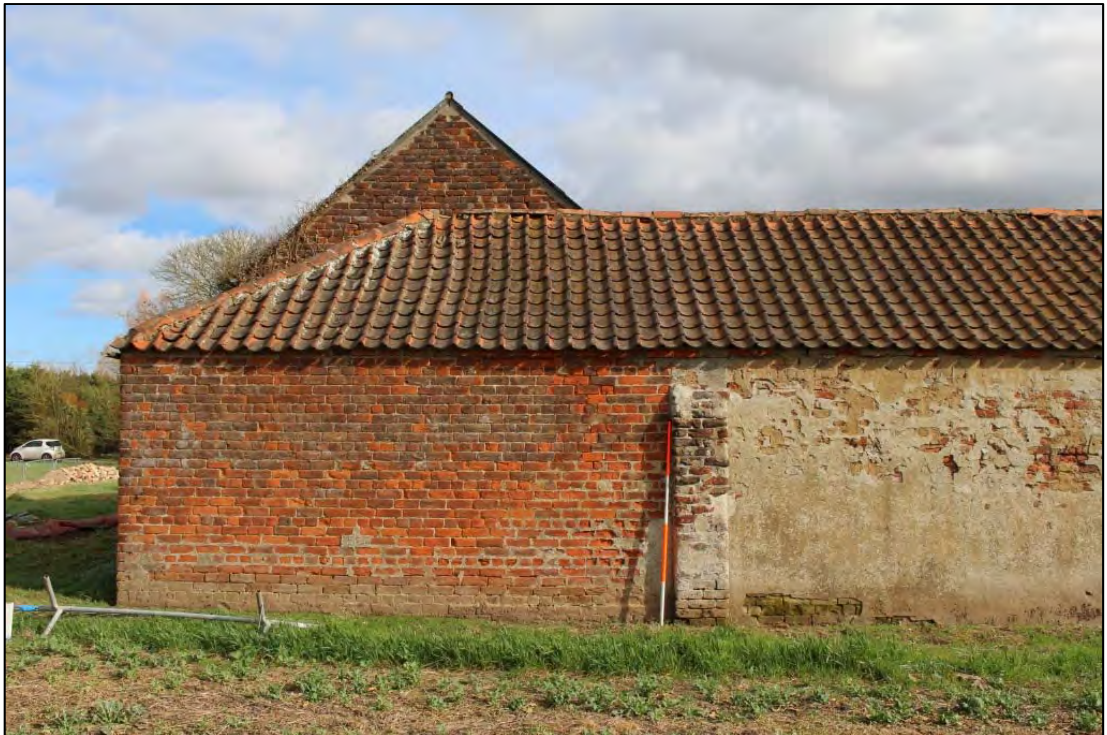
- 4.13. Externally, the buttress separating the two phases of the western elevation is apparent and provides a clear visual distinction between the two sides of the building (Photo 24). Photo 24 and Fig. 5 also show that the position of the buttress is

Photo 24: Overview of western elevation of Building B

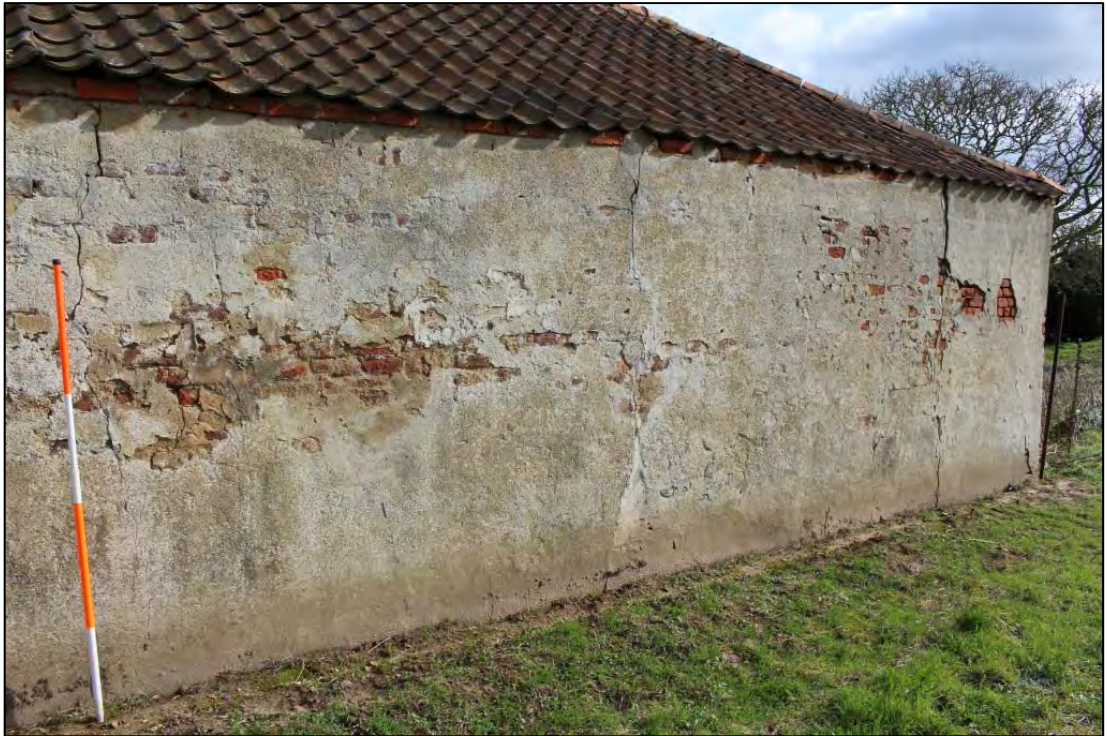
approximately in line with the southern elevation of Building A, perhaps adding weight to the theory that the northern extent of Building B was once part of Building A, as suggested in cartographic evidence. This is further corroborated by 19th-century alterations, including the later wall to the north-western extent of Building B which hint towards a significant reconfiguration of the buildings at this part of the farmstead. The southern extent of the western elevation (Photo 25) retains cement render to the majority of the elevation. This appears to have caused damage to the brickwork beneath, likely through the trapping of moisture (Photo 26).

Photo 25: Overview of the southern extent of the western elevation

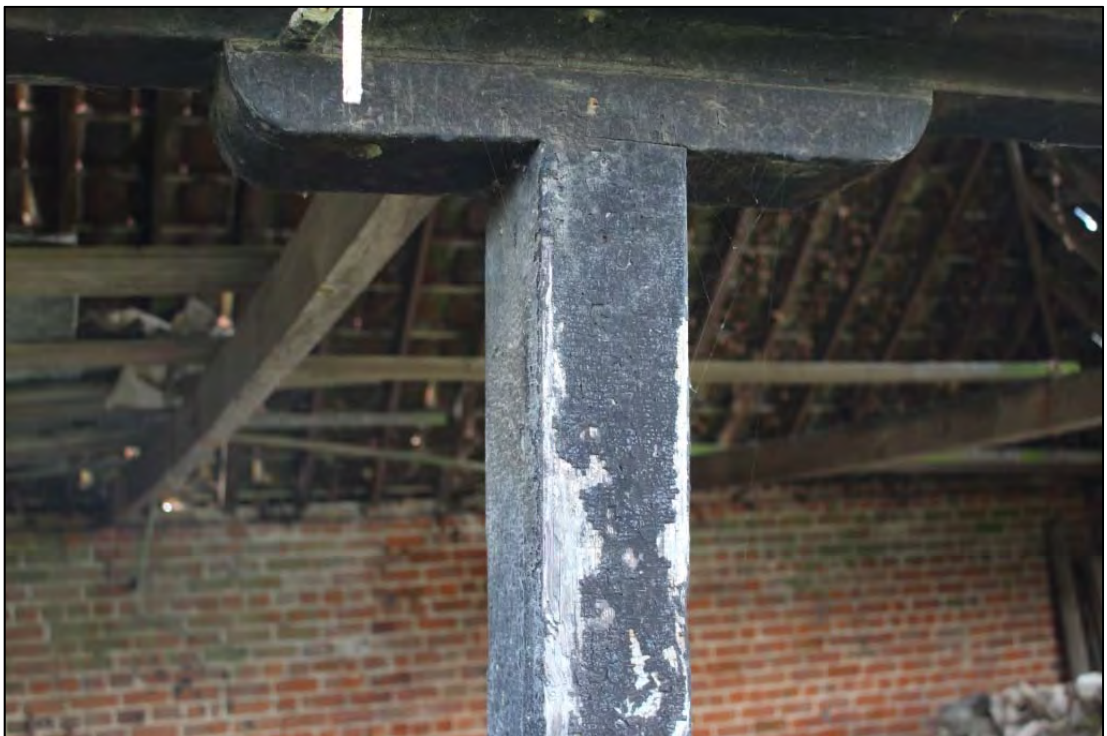
Photo 31: Post and pad arrangement to the open side of Building E

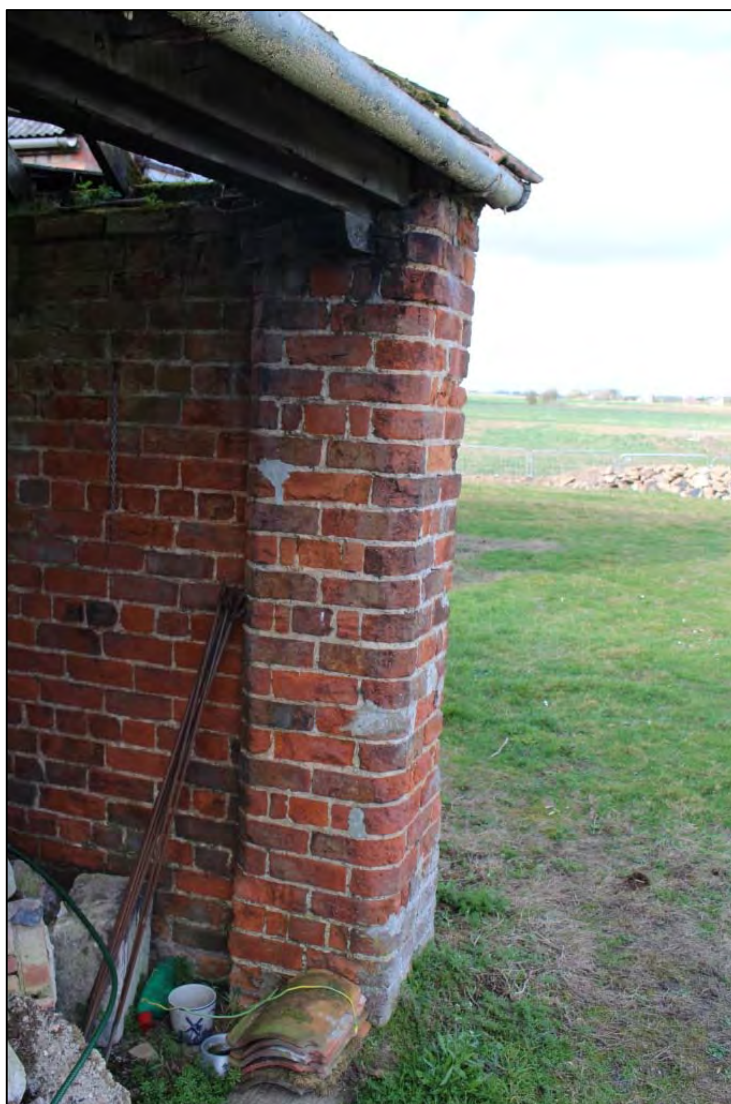
Photo 32: Chamfered brickwork to the northern extent of the eastern elevation

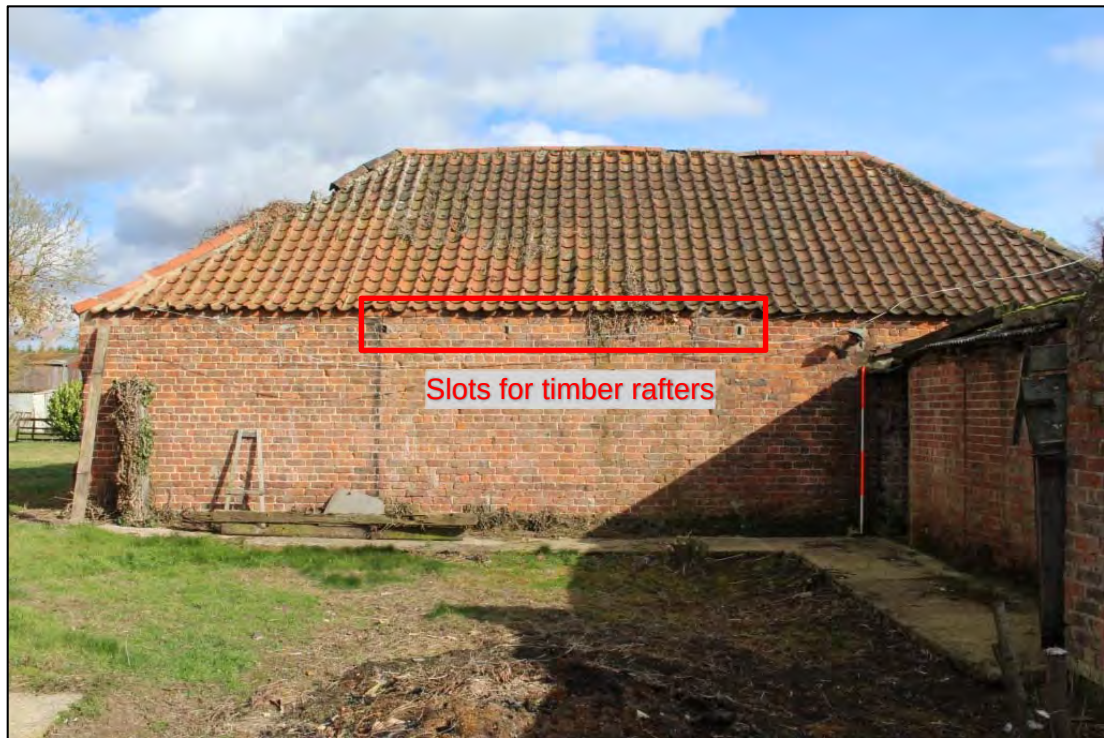
wall (Photo 36) which probably accommodated rafters for a lean-to structure within the courtyard, no longer extant.

Photo 36: Overview of western elevation of Building E

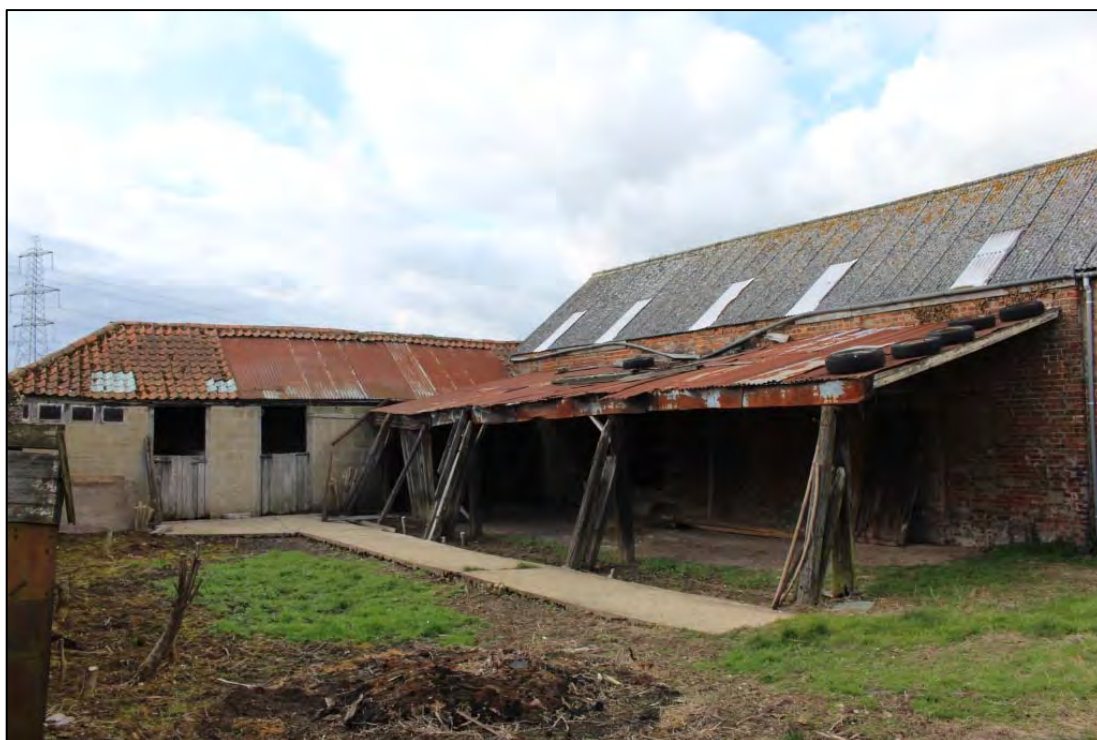
- 4.19. Situated to the north-western extent of the courtyard, Building G (Photo 37) abuts the southern elevation of Building A and comprises a rectangular lean-to structure supported on four, regularly spaced railway sleepers set vertically in the ground with further sleepers acting as braces. The building exhibits characteristics of a covered yard, however the execution is very crude and utilitarian, suggesting that it was erected at low cost and was perhaps not envisaged as a permanent structure. The orientation and size of a structure in this position is first evident on the 1976 OS map, suggesting that Building G was erected no earlier than 1931.

Photo 37: Overview of Building G, looking north-west

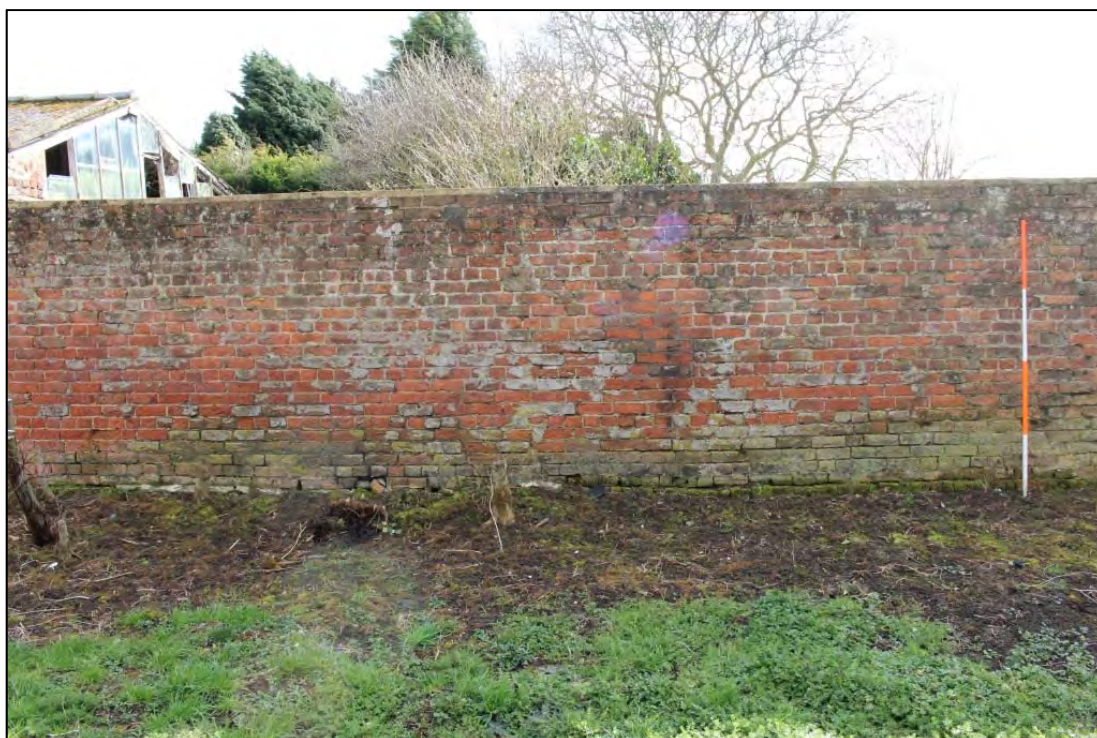
- 4.20. Enclosing the courtyard to the southern extent is a brick wall (Photo 38), approximately 2.2m tall, which extends from the south-eastern corner of Building C to the north-western corner of Building D. The wall comprises red brick, laid predominantly in English Bond and capped in cement. Whilst the northern elevation of the wall is plain, the southern elevation incorporates a series of chamfered buttresses or pilasters, probably included for decoration rather than structural stability. The westernmost buttress, situated where the wall has transitioned to the southern elevation of Building C (Photo 39), tapers into the wall at the top (Photo 40). The three easternmost buttresses also incorporate brick chamfer detail but terminate abruptly at the top of the wall without tapering (Photo 41). This suggests that the wall may have once been taller and was reduced in height in the past, possibly due to damage or stability issues. A large, angled buttress (Photo 42) disrupts the rhythm of the chamfered buttresses and was almost certainly installed at a later date to address a structural deficiency within the wall.

Photo 38: Overview of southern wall, looking south

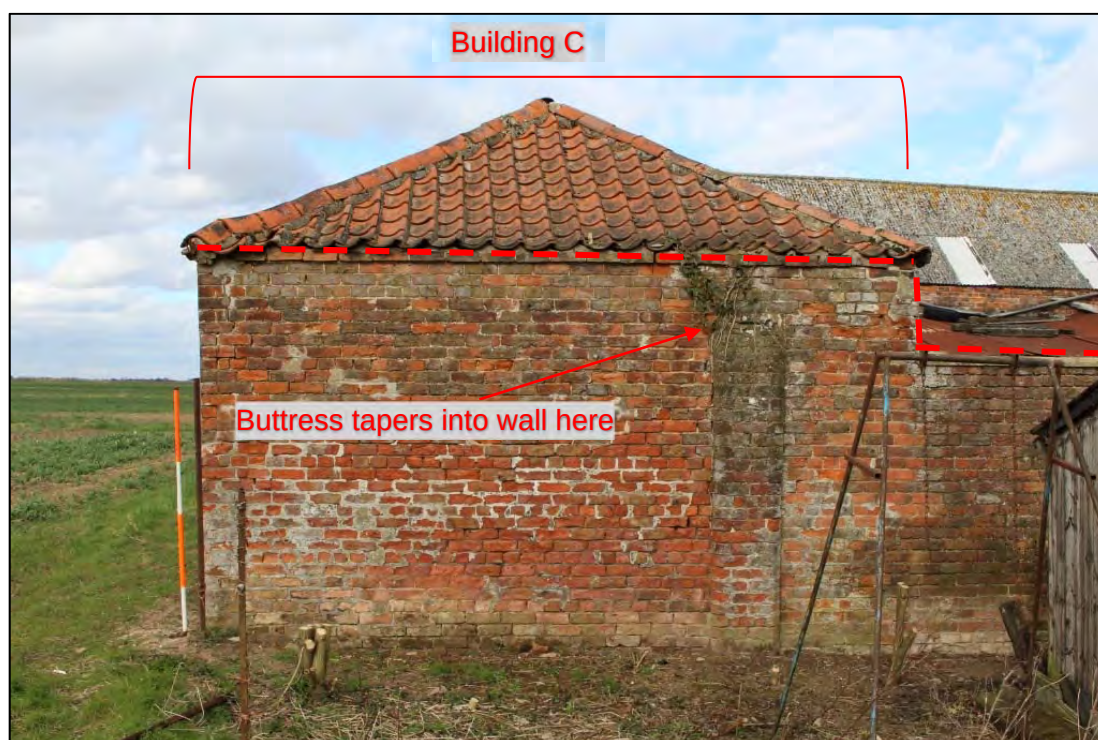
Photo 39: Western extent of southern wall, incorporating the southern elevation of Building C. Height of wall indicated by dashed line

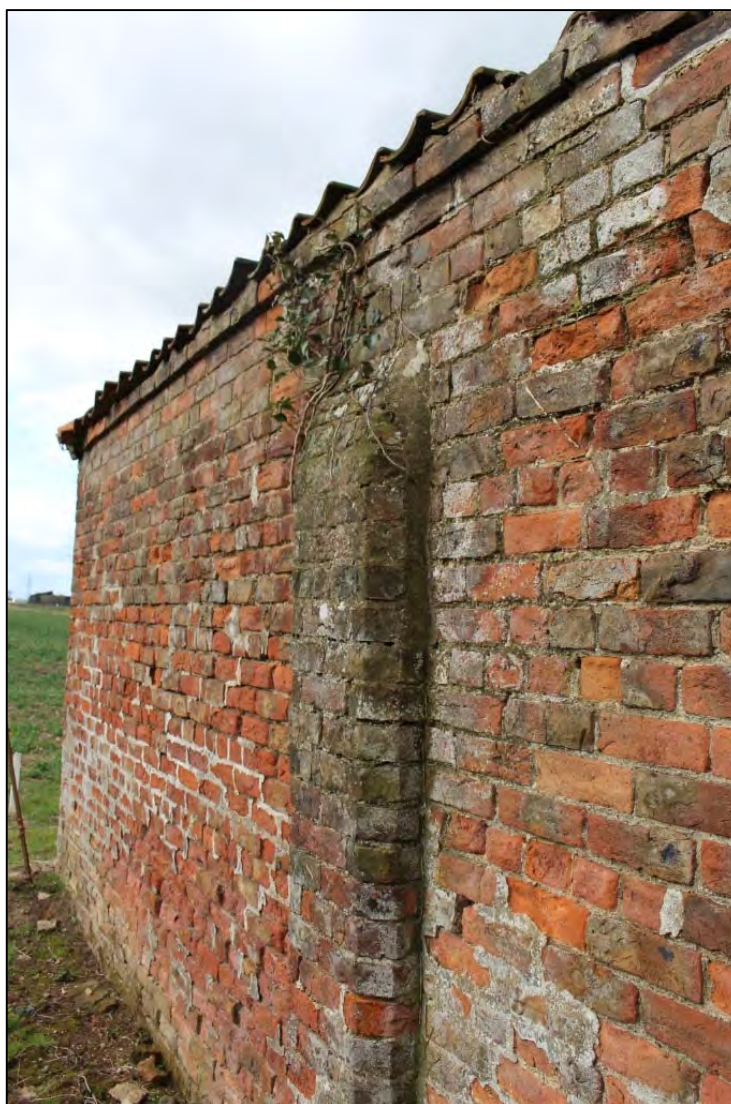
Photo 40: Detail of westernmost buttress to the southern elevation of Building C, note the decorative chamfering and taper

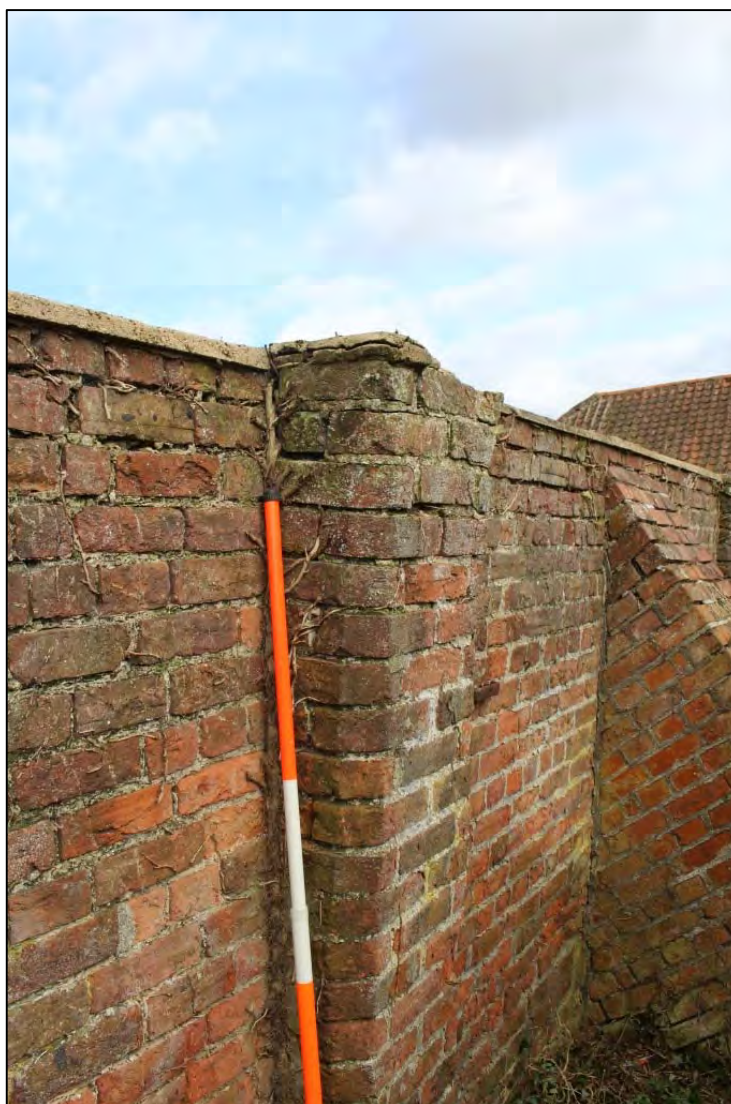
Photo 41: Detail of buttress within southern wall
