**Stage One Environmental Desk Study of 87, Moulton Chapel Road**

**Moulton Chapel, Spalding, Lincolnshire PE12 0XD**

Report number 20-02-02 Addendum

Date 28<sup>th</sup> April 2020

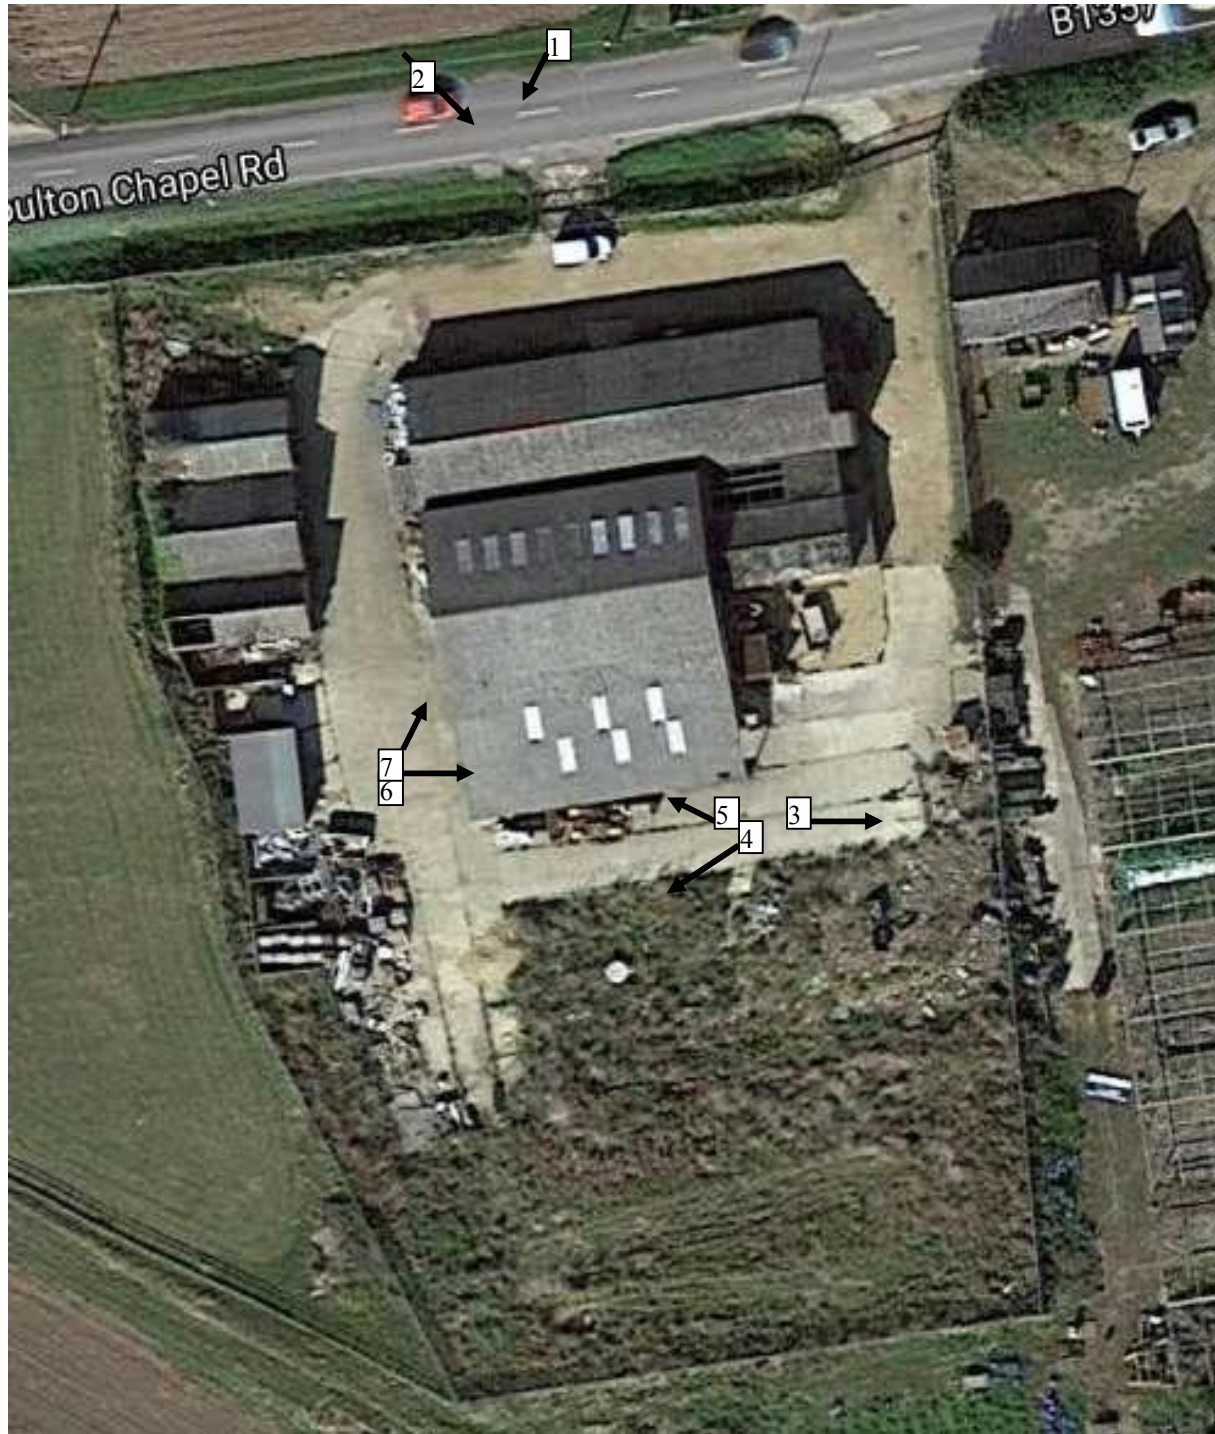
Figure 1 Location and direction of photos by photo number

The aerial photo with locations and directions of photographs are shown in figure 1. An extensive search on Google and Bing did not identify any past history that could be useful. The OS maps of the area had only one large scale map that had any detail, that being 1:2,500 and dated 1975. It showed what was possibly a farmyard, but the buildings are not the same or in the same place. The other maps were all 1:10,000 and did not show anything. These were examined, but as there was no relevant information, this was not noted.
