# **Heritage Impact Assessment Design and Access Statement**

Broadgate House, 696 Broadgate, Weston, Lincolnshire, PE12 6JA

Broadgate House, 696 Broadgate, Weston, Lincolnshire, PE12 6JA  
MR AND MRS TEEUW

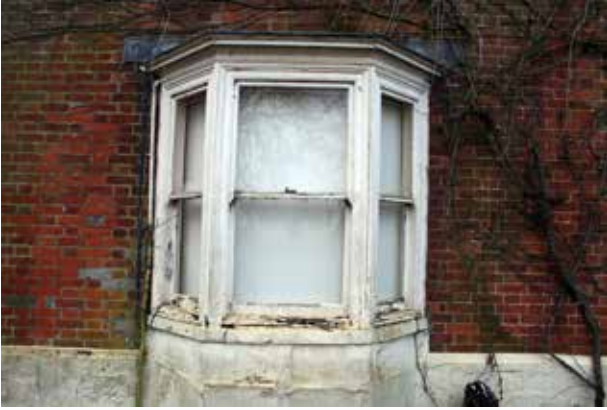
Figure A-2

The two bay windows are showing signs of decay but are possible to repair. **Figure A2-4**. The open porch at the front of the house is showing significant signs of rot and is at risk of collapse. The lead over the top is tired and allowing water ingress. We have a skilled joiner to repair the porch and replace the lead. **Figure A5-8**.

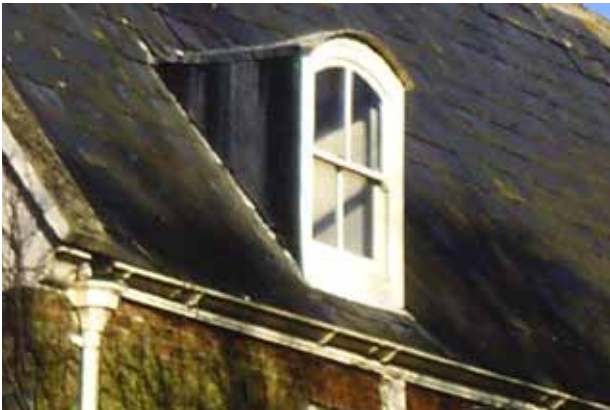
Figure A-11

The dormer windows on the second floor **Figure A9-10** are showing advanced decay and no longer close properly. They currently open by pivoting horizontally which is a worry as the top two bedrooms of the house are to be inhabited by small children. We have found an old slide photo of the property dating back to 1967 it shows that there were sliding sashes in these windows. **Figure A11**. Our intention is to replace these with sash windows of the correct design for the period. These would incorporate safety features. Please see the intended designs in **Figure A12**. We would also replace the leadwork.

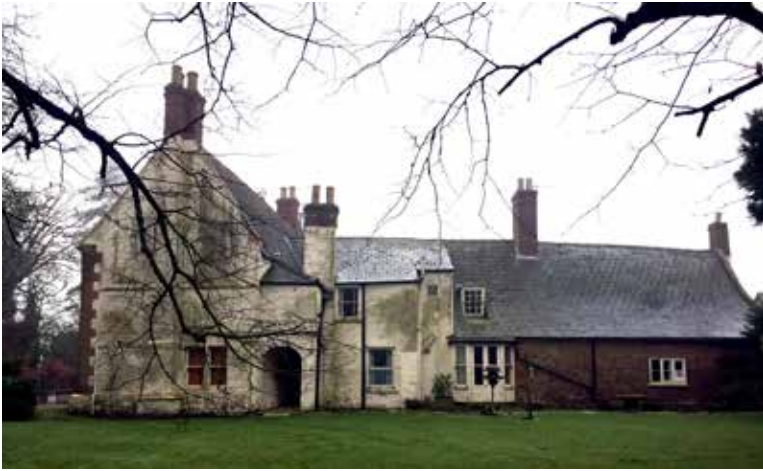
Figure C-1

For the south side of the property **Figure C1**. All of the windows will be repaired. The kitchen would benefit greatly in more light. Therefore we would like to introduce a small window in the same style as **Figure C2**. See **Figure C3** as a visual indication for placement and how this addition would look. Please see attached design **Figure C4** and **Figure E9** for the floor plan. For this addition to be considered in full, please refer to proposed changes within the kitchen. Currently there is a modern door at the rear of the property **Figure C5**. We are proposing to change this to a door in keeping with the property see design in **Figure C6**.

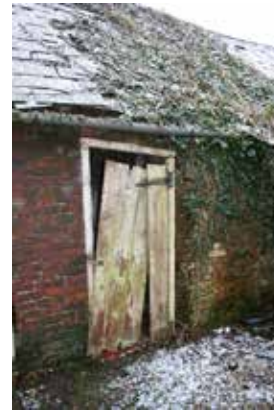
Figure D-2

The outbuildings that lead from the rear of the house are in a extremely dangerous condition and should only be accessed with caution. North side (garden) **Figure D1-4**. West side (back) **Figure D5-6**. South side (yard) **Figure D7-10**.

In order to save the buildings and make safe, it is essential that the roof slates are removed as soon as possible. This build is very close to collapse and as we have small young children and it can not be unleft. We will then rebuild the collapsed walls **Figure D2** and **Figure D1-5** using reclaimed bricks and a lime mortar. Where the brickwork has blown an example shown in **Figure D11** this will be repaired, the modern cement will be raked out and replaced by lime mortar.

The roof timbers will also be made sound and the slates can be reinstalled. Some of the roof slates are missing or damaged we will be replacing these with reclaimed slates. A sample can be provided if required.

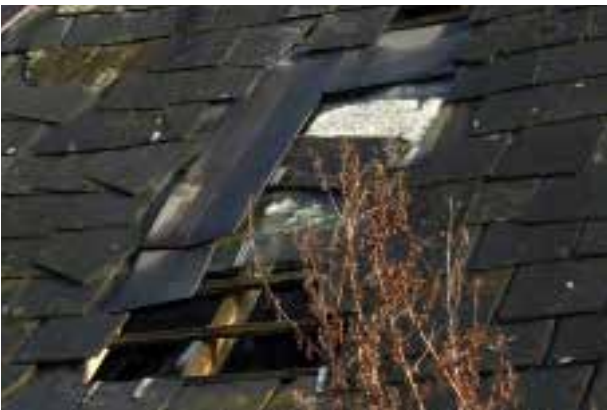
Figure D-13

**Figure D12-15** There is a garden room within the rear outbuildings that has glass sheets on the roof to allow in daylight. In the interest of safety, we intend to replace the glass with Conservation Rooflights **Figure D16**. Please see **Figure D17** for placement of these windows. The future use of this room will be for the enjoyment of the garden and entertaining. We intend to add a sink, a small number of kitchen units and a toilet.

**Figure D9** This window will be replaced with a window of the correct design. See **Figure D13**. Window **Figure D10** will be repaired.

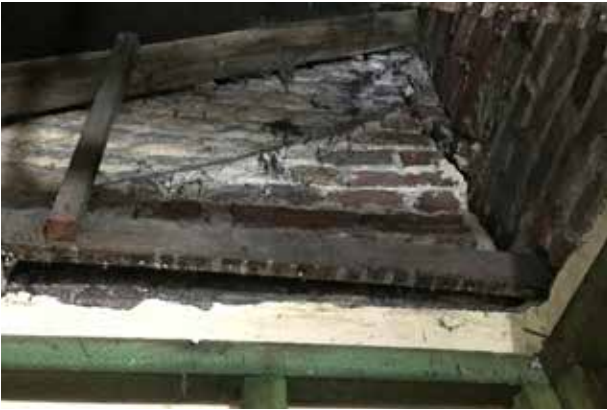
Figure E-1

After removing 1970's paneling in the pantry area it has revealed some interesting finds about the how the building has evolved over time. There are obvious signs that there were outbuildings attached to the building on that side. **Figure E1**. It is likely that Broadgate's distinctive roofline on it's Northside was not an original feature and more likely a later extension. The roof void is very beautiful addition so will be left exposed instead of being boxed in. **Figure E2-3**. The walls will be repaired and lime rendered.

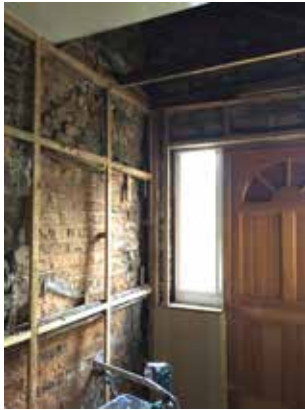
Figure E-4

It also reveals two areas of the side wall where there were openings. **Figure E4** is a doorway that has been filled in we recently found the door was still there when removing modern plasterboard on the other side. **Figure E5**. **Figure E6** was also revealed, all of these features will be retained and left exposed.

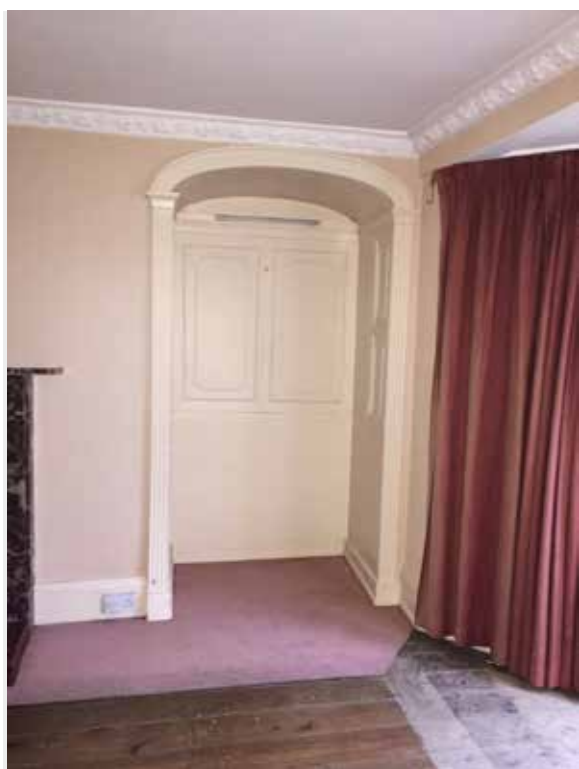
Figure E-17

We also propose to make an opening in **Wall B** in **Figure E9**. There is no concrete evidence pointing to this being an original opening but there are a few proof points to say that it may once have been. **Figure E17** shows how the alcove appears in the dining room. This alcove in is missing it's bottom back skirting board and the joins are not seamless. This may indicate that it was a later addition to the back.
