Hither Hold Farm, Further Old Gate  
Screening Assessment Photographs  
31.05.2022

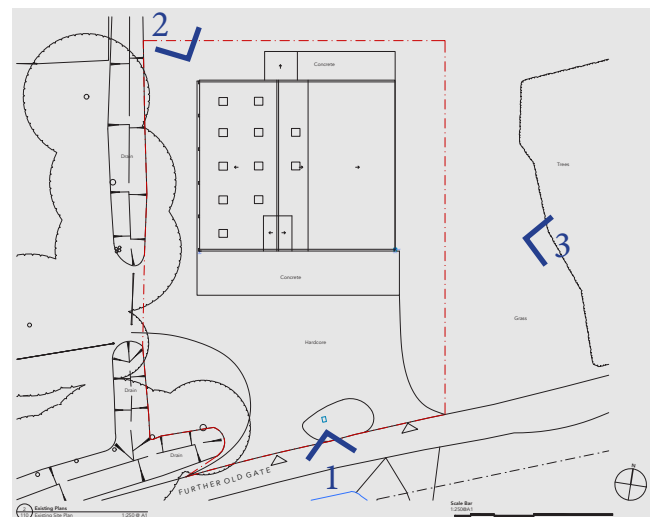
4.  
View to the side of the grain store looking south. Private drain runs along the right hand side, with tree clump on adjacent land to the other side of the drain formed of willow, oak and ash trees. Grassland meadow vegetation typical to the Lincolnshire agricultural lowlands seen in the foreground. Vegetation is consistent throughout the site and surrounding land, and is in good condition with no signs of distress or dieback.

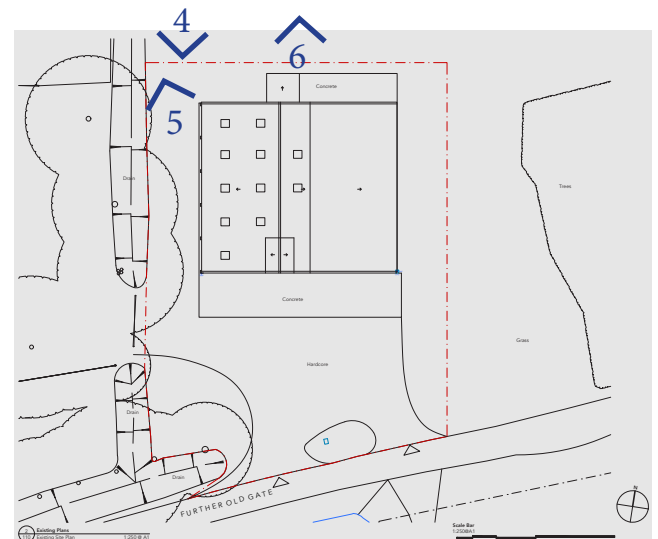
7.  
View of hardstanding to the front of the grain store, showing concrete formed of 4 slabs in good condition and clear of staining or cracks. Adjacent residential property visible beyond.
