Geotechnical &  
Environmental  
Consultants

Balmoral Way  
Holbeach

**Supplementary Ground Gas Assessment  
For  
Ashwood Homes**

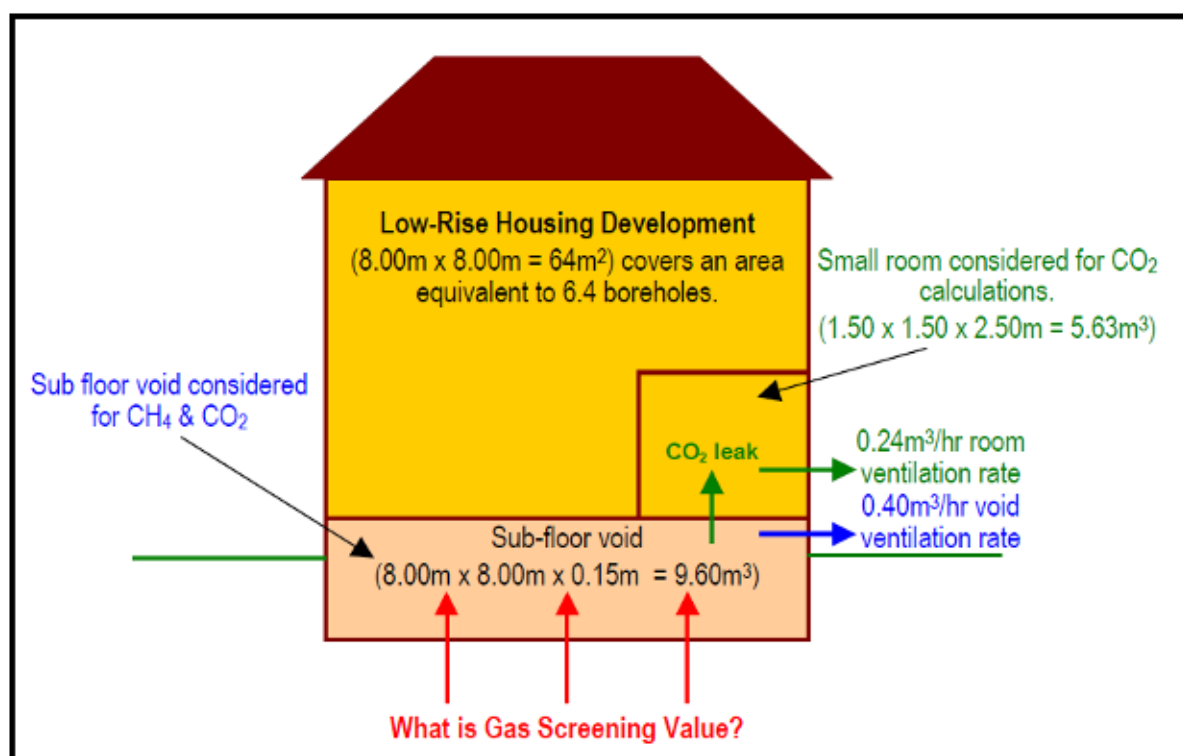
*'The model low-rise housing development is based upon a model low-rise house as shown in Figure 1. The property has a floor plan of 8.00m x 8.00m, giving a floor area of 64m<sup>2</sup>. Continuing the assumption that an individual 50mm internal diameter borehole relates to an approximate area of 10m<sup>2</sup> (proposed by Pecksen (1985) and further expanded by Ove Arup & Partners (1996)), this therefore, represents 6.4 boreholes for the floor plan of the house.'*

**Figure F1: Model Residential Property Developed for Calculating Maximum Permitted Equilibrium Gas Concentrations within the Sub-Floor Void**

The model low-rise house was given the minimum recommended sub-floor height of 0.15m as specified in the Building Regulations 'Approved Document C' (Department of the Environment and the Welsh Office, 2004 edition), which produces a sub-floor void space of 9.60m<sup>3</sup>. As a worst-case scenario, it was considered that the ventilation rate which the sub-floor void was subject to a complete volume change every 24 hours, which is considered to be highly conservative. The ventilation rate, therefore, is 9.60/24 = 0.40m<sup>3</sup>/hr.

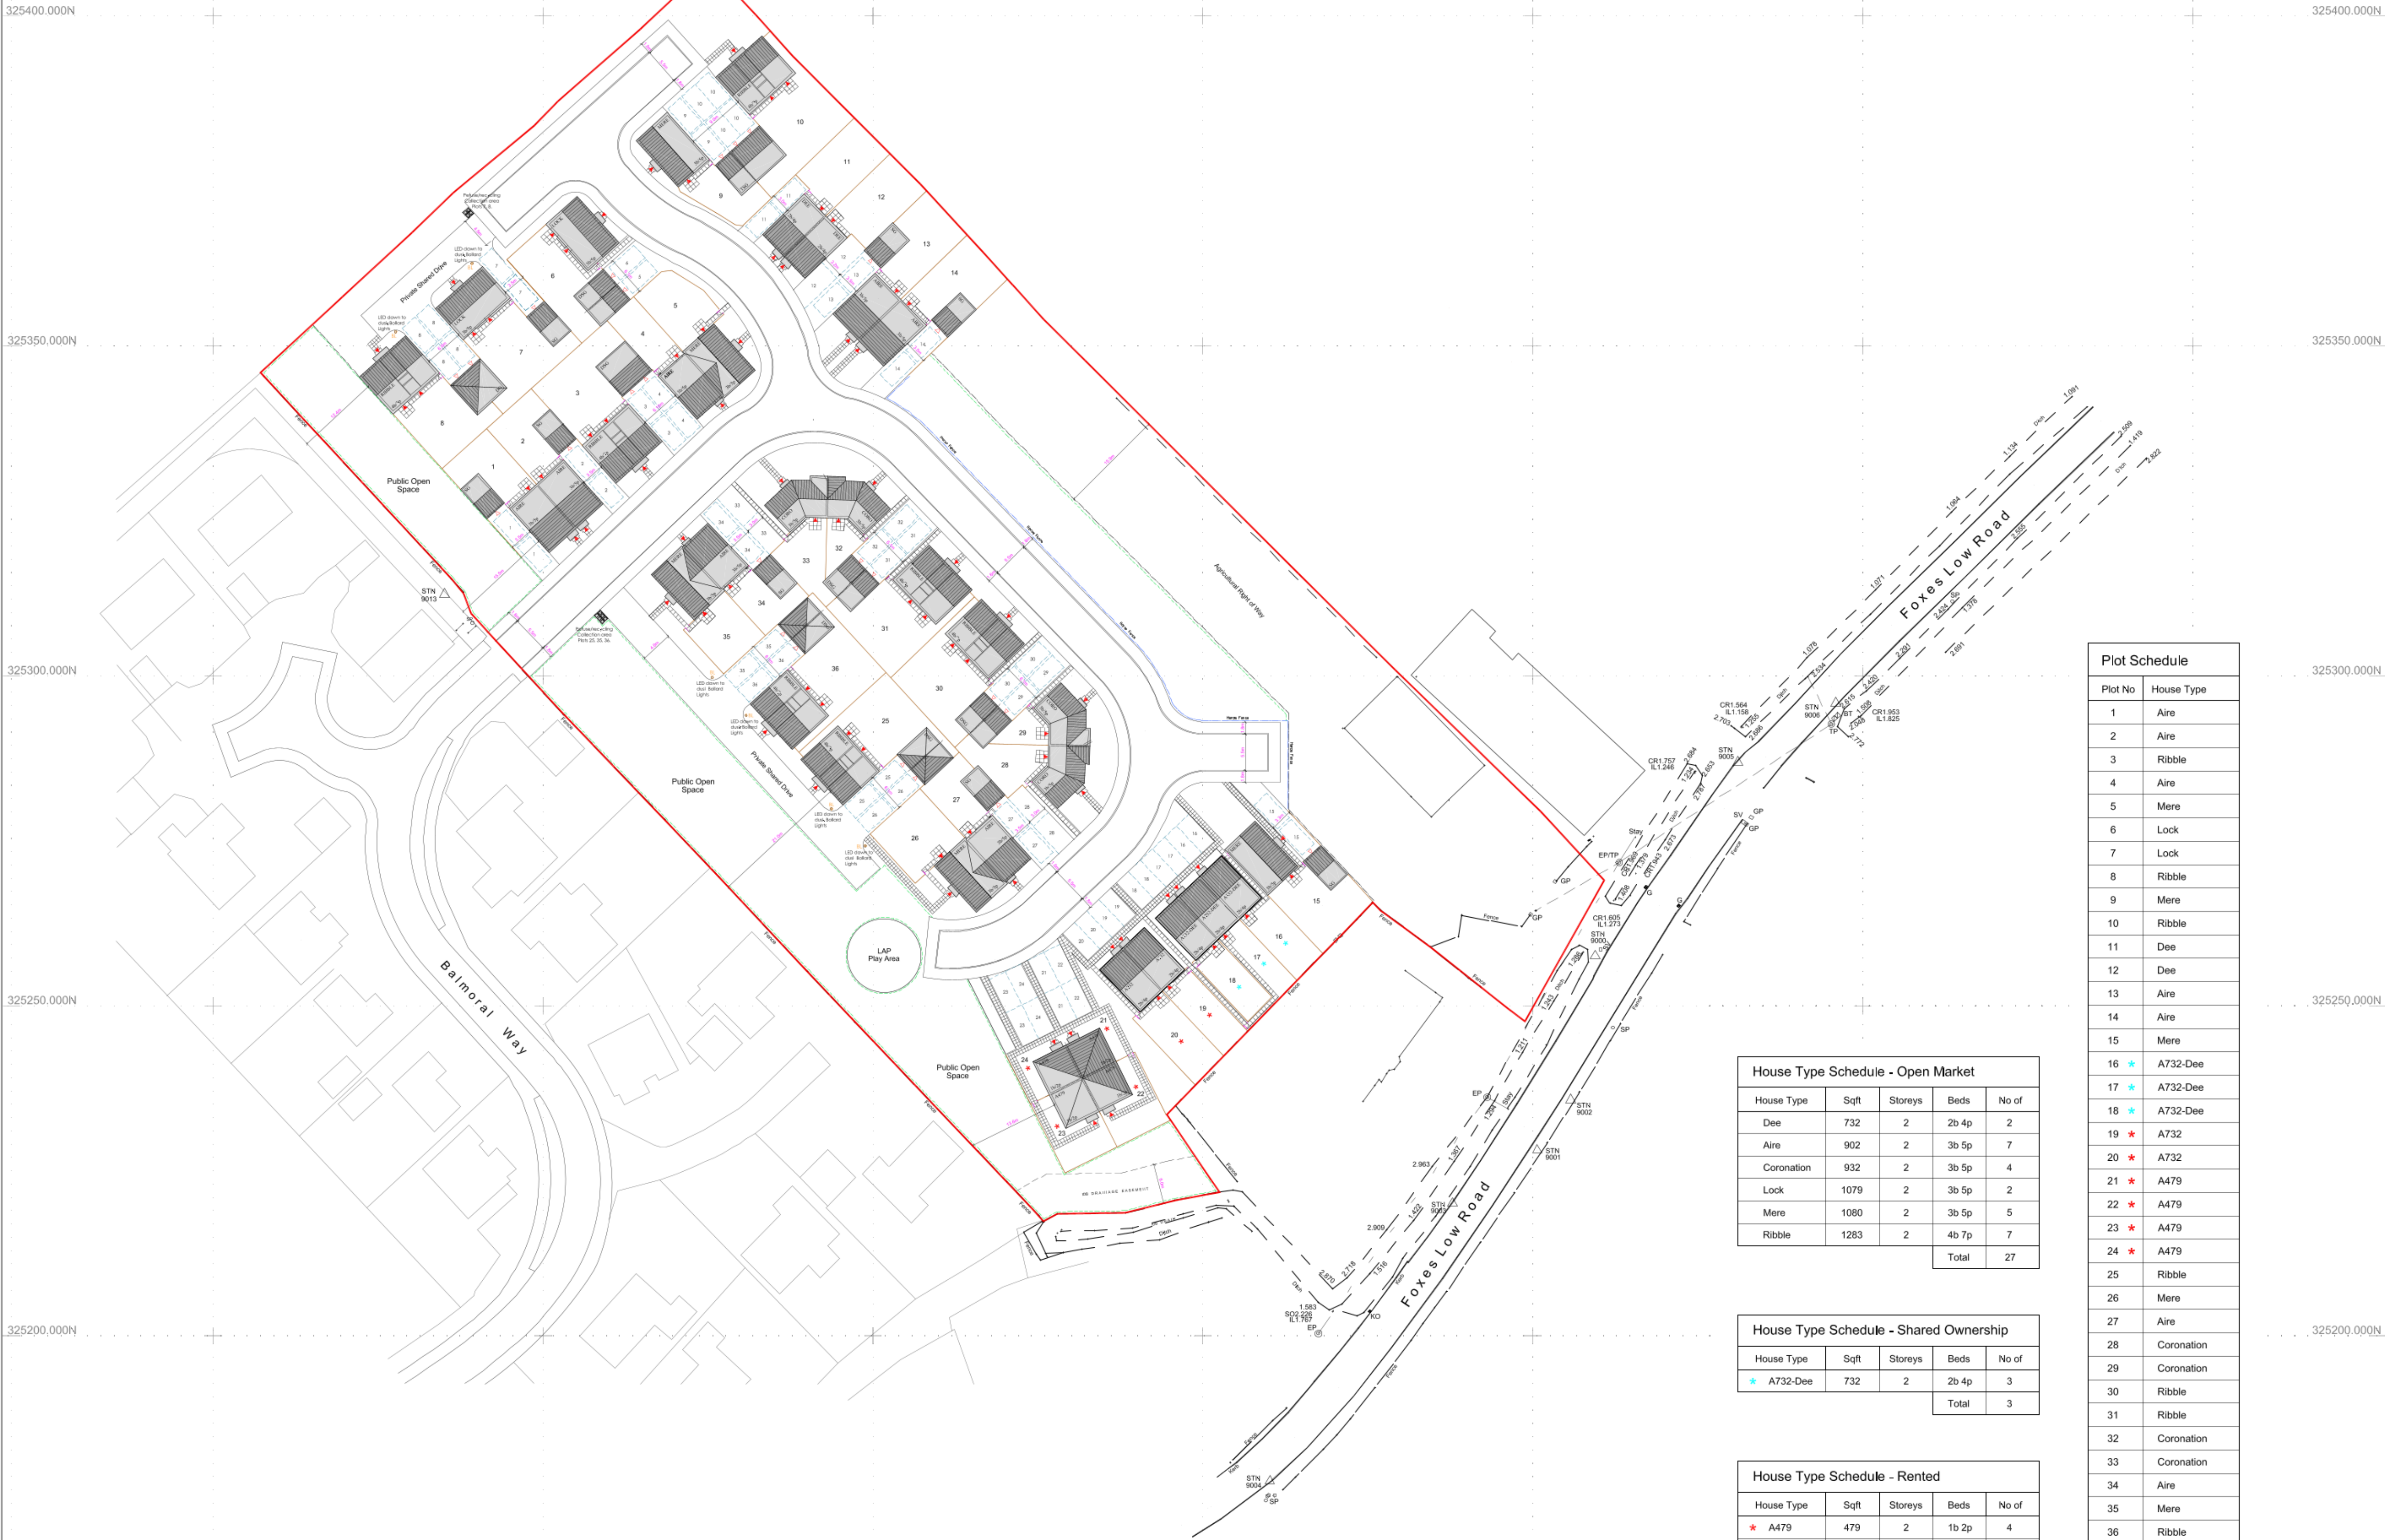
| A | 03.07.2019 | Single garage added to plots 1, 2, 13, 14, 27 and 34. |

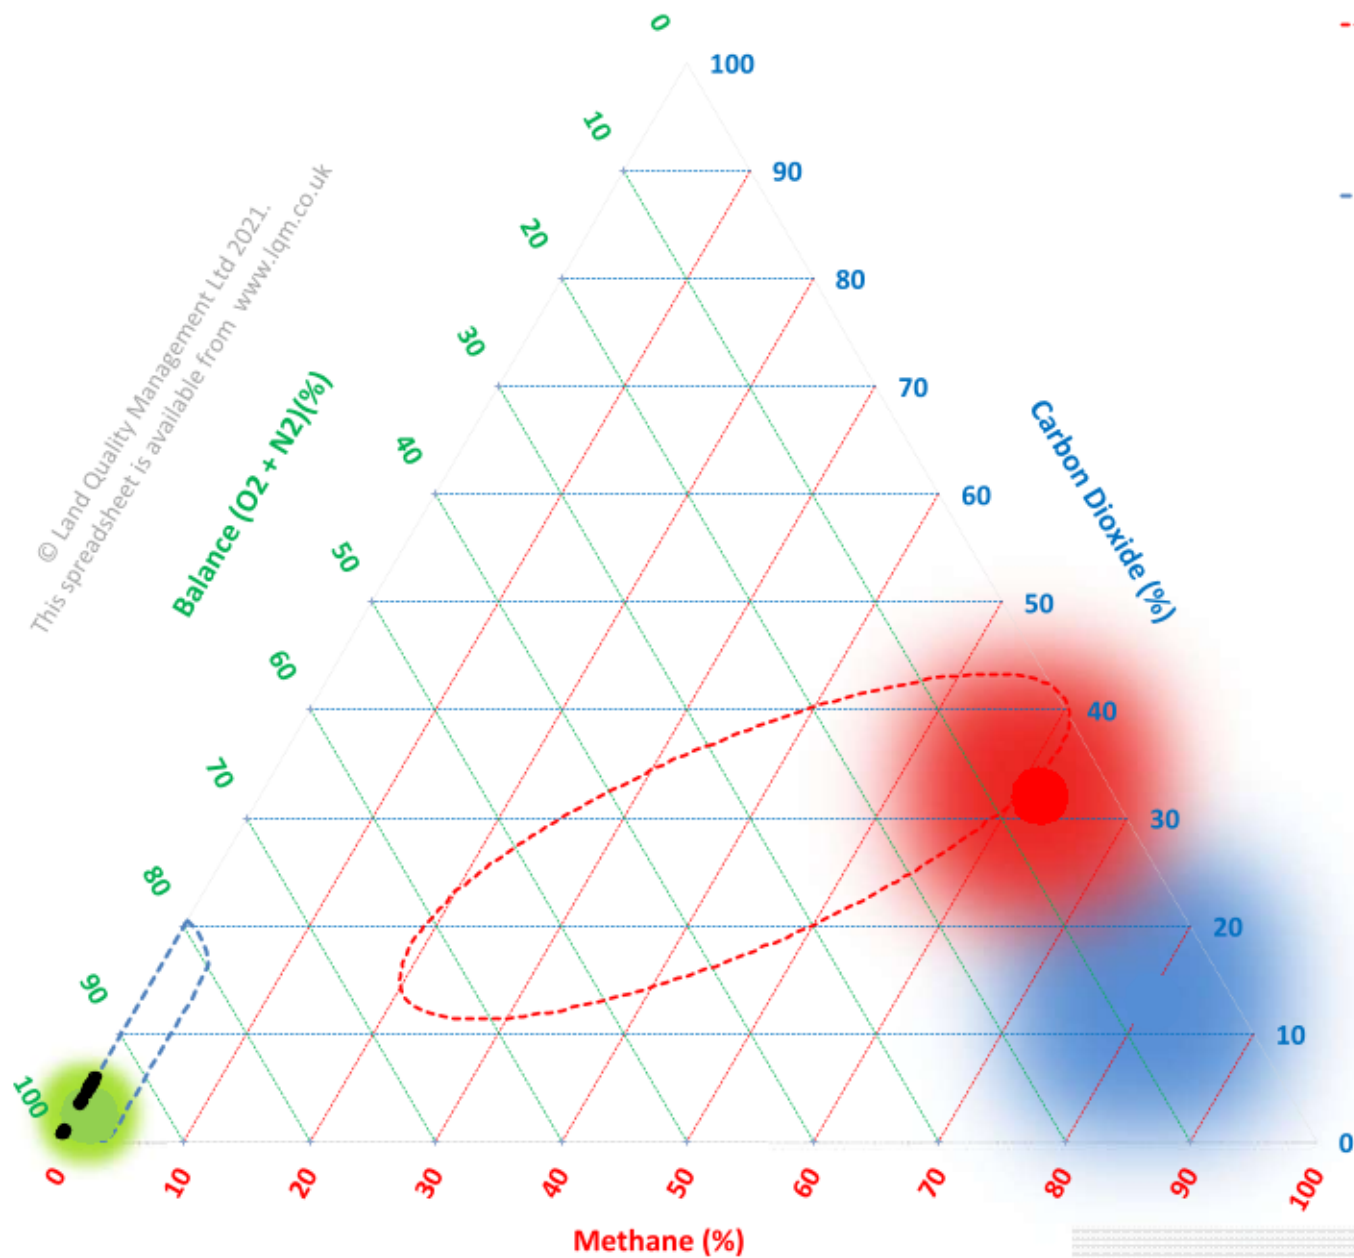
**APPENDIX IV**  
**Ground Gas Ternary Plot**

- Illustrative of landfill gas migration based on a source gas of 60%:40% CH<sub>4</sub>:CO<sub>2</sub> & assuming no chemical changes or oxidation of CH<sub>4</sub> (below 20% CH<sub>4</sub> and 13% CO<sub>2</sub> migration relationship becomes unclear)
- Indicative of microbial respiration of organic materials in soil (Zero methane and low flow)
- Indicative of ambient air (80% N<sub>2</sub>, 20% O<sub>2</sub>) with zero methane and carbon dioxide
- Indicative of geogenic gas
- Indicative of landfill gas
- Gas data
