Phase 2 Balmoral Way  
Holbeach

**Remediation Strategy & Verification Plan  
For  
Ashwood Homes**

**GeoDyne Limited**  
9 Brunel Parkway, Pride Park  
Derby DE4 8HR  
Tel: 01332 290 798 email: [info@geodyne.co.uk](mailto:info@geodyne.co.uk)

| Project No: D41012 | | Date: 28 <sup>th</sup> April 2023 | |

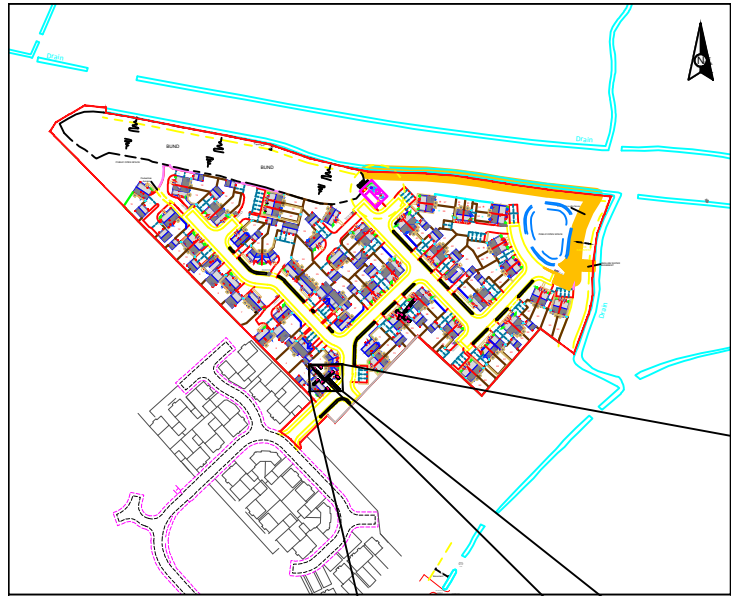
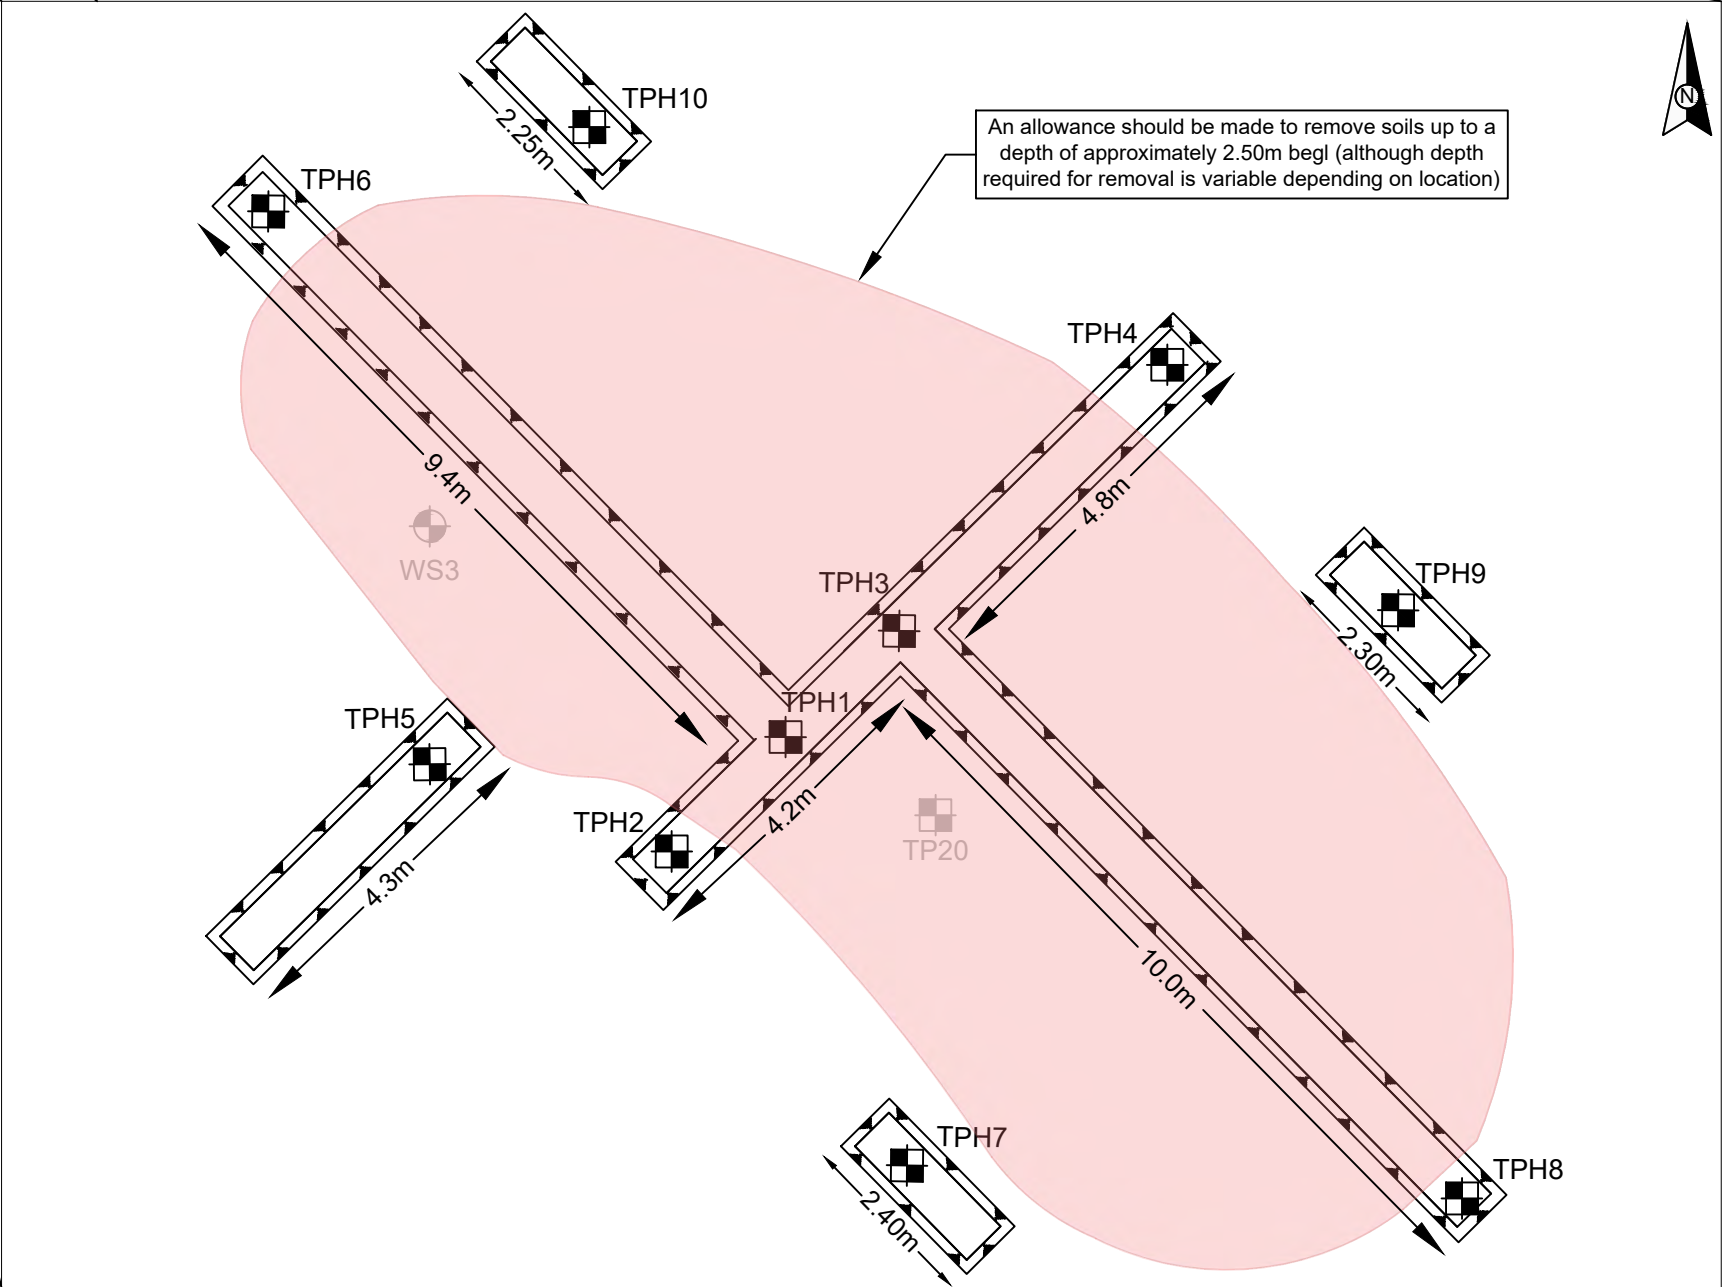
**Plan Showing Approximate Extent of Hydrocarbon Impacted Soils to be Remediated  
(Figure No. D41012/R4 Revision A)**

**KEY**

Window Sample Borehole (Advanced February 2021)

The soils were noted to exhibit generally slight hydrocarbon odours with some grey staining visible where hydrocarbon impaction was noted. Based on the observations made on site, it appeared that hydrocarbon impacted soils were encountered from near surface around the location of the former tanks and this had extended to depths of up to 2.30m below existing ground level (begl) locally. It was noted that the hydrocarbon impacted soils extended laterally from the tank area within a relatively restricted band at depths of around 1.50m to 2.00m begl (i.e. around where water would typically be encountered).
