GROUND FLOOR PLAN  
SCALE 1:50

FIRST FLOOR PLAN  
SCALE 1:50

SECOND FLOOR PLAN  
SCALE 1:50

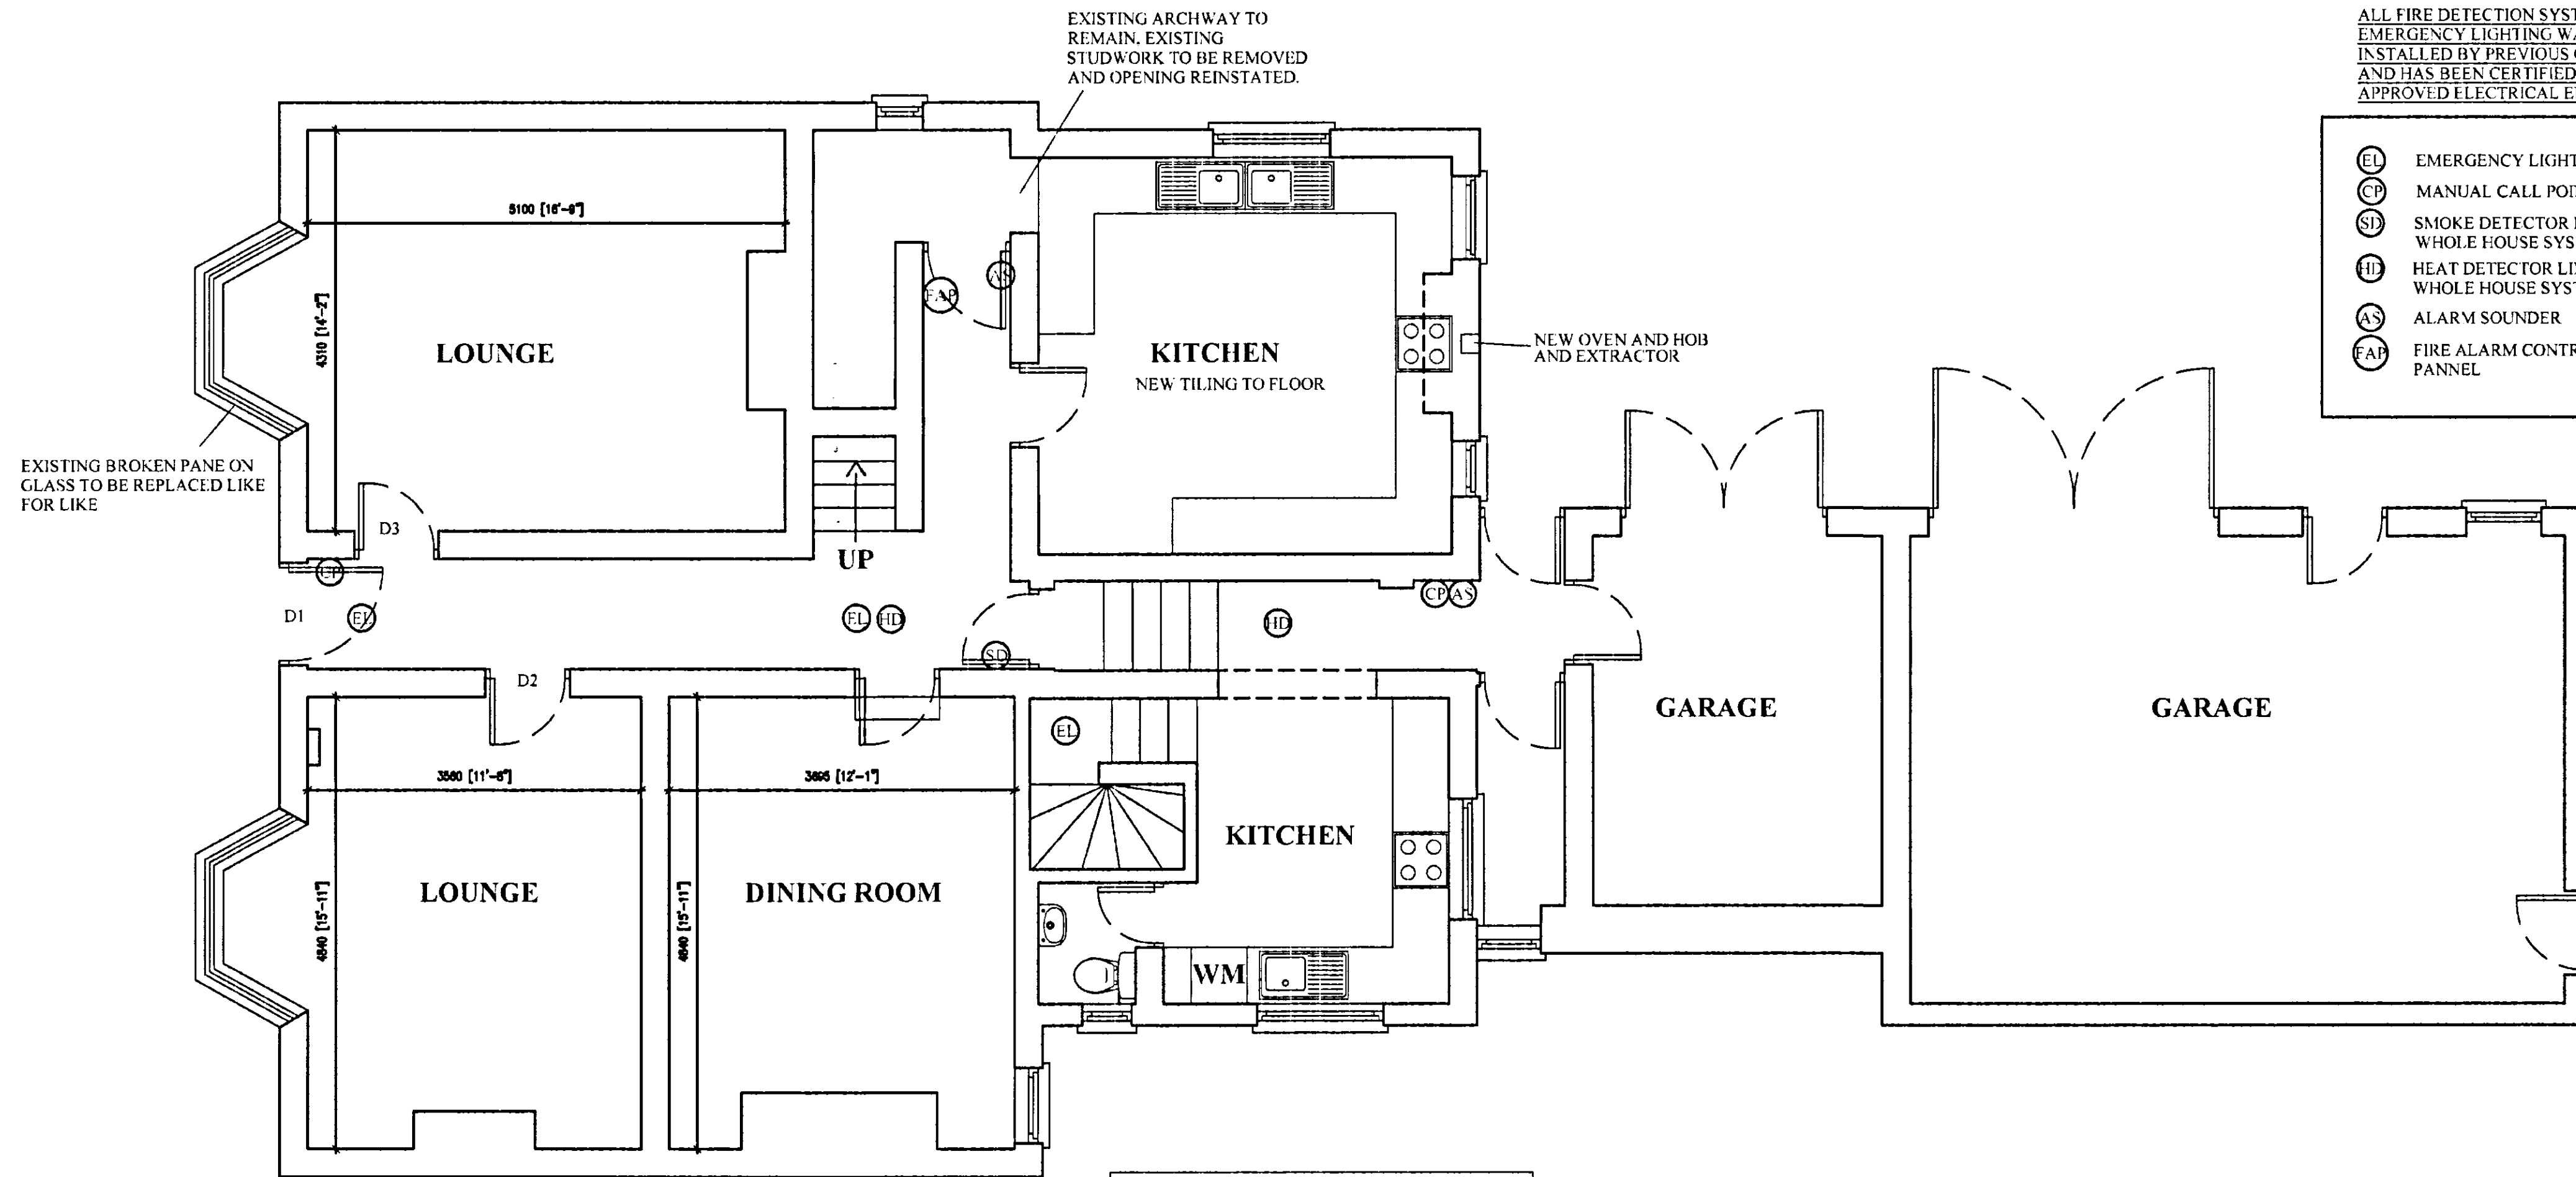
EXISTING ARCHWAY TO REMAIN. EXISTING STUDWORK TO BE REMOVED AND OPENING REINSTATED.

ALL FIRE DETECTION SYSTEM AND EMERGENCY LIGHTING WAS INSTALLED BY PREVIOUS OWNER AND HAS BEEN CERTIFIED BY APPROVED ELECTRICAL ENGINEER

- (EL) EMERGENCY LIGHTING
- (CP) MANUAL CALL POINT
- (SD) SMOKE DETECTOR LINKED TO WHOLE HOUSE SYSTEM
- (HD) HEAT DETECTOR LINKED TO WHOLE HOUSE SYSTEM
- (AS) ALARM SOUNDER
- (FAP) FIRE ALARM CONTROL PANNEL
