**PRELIMINARY STRUCTURAL REPORT**

**AGRICULTURAL BARN 2**

**LEAMLANDS FARM, LEAMLANDS LANE**

**DOCUMENT REF: SW 22-167-REP-01**

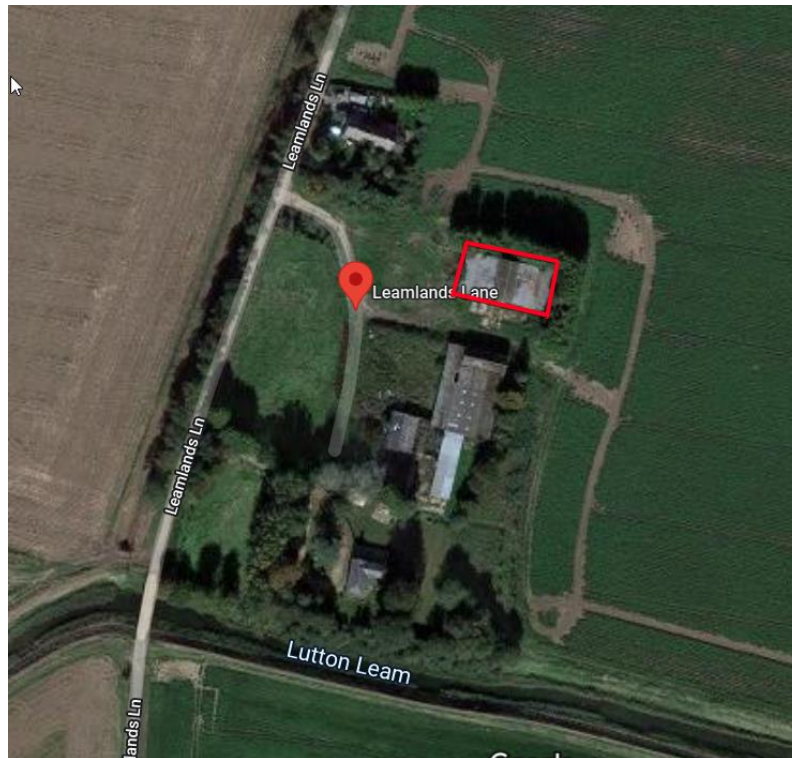
The site sits to the East of Leamlands Lane and the North of Lutton Leam. The barns sit to the North of the existing Dwelling, Leamlands Farm, Leamland Lane, Lutton Marsh PE12 9NS.

Site location plan, GR Merchant drawing 3775-21/01 is contained within Appendix A.

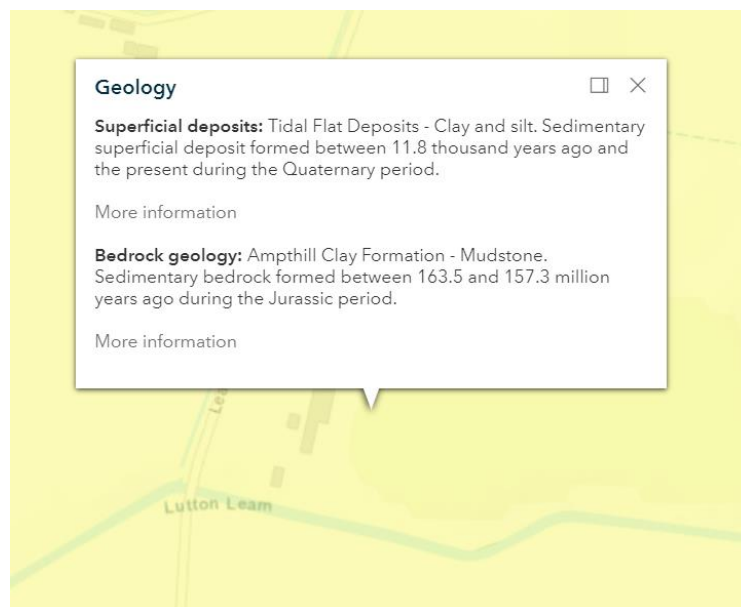
Publicly available British Geological Society maps and borehole records indicate the site to be underlain with Tidal flat deposits of Clay and Silt tidal flat deposits over the Clay Formations.
