**PRELIMINARY STRUCTURAL REPORT**

**AGRICULTURAL BARN 1**

**LEAMLANDS FARM, LEAMLANDS LANE**

**PROJECT No: SW 22-167**

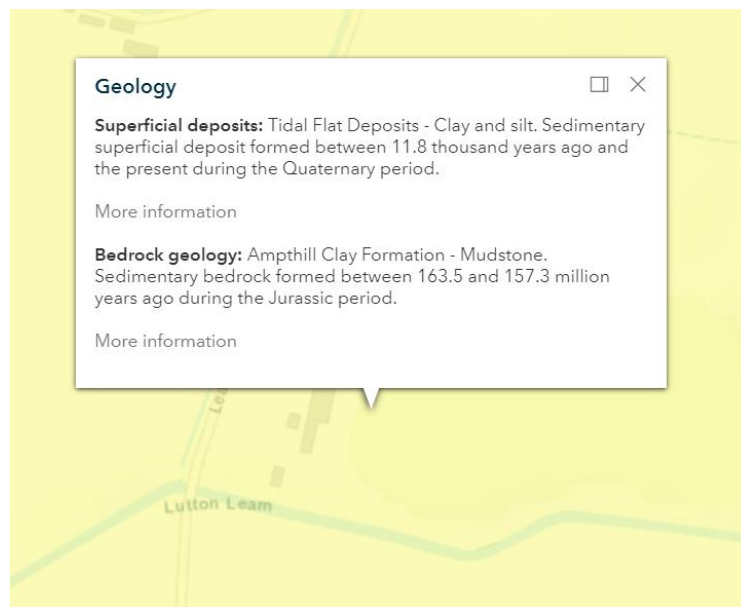
Publicly available British Geological Society maps and borehole records indicate the site to be underlain with Tidal flat deposits of Clay and Silt tidal flat deposits over the Clay Formations.
