Drawing for Planning condition No 6

| Project: | Barn Conversion | Date: | January 2021 |
| Drawing Title: | Existing + Proposed Plans and Sections Through Barn 1 showing structure being retained + replaced | Job No: | 18156 |

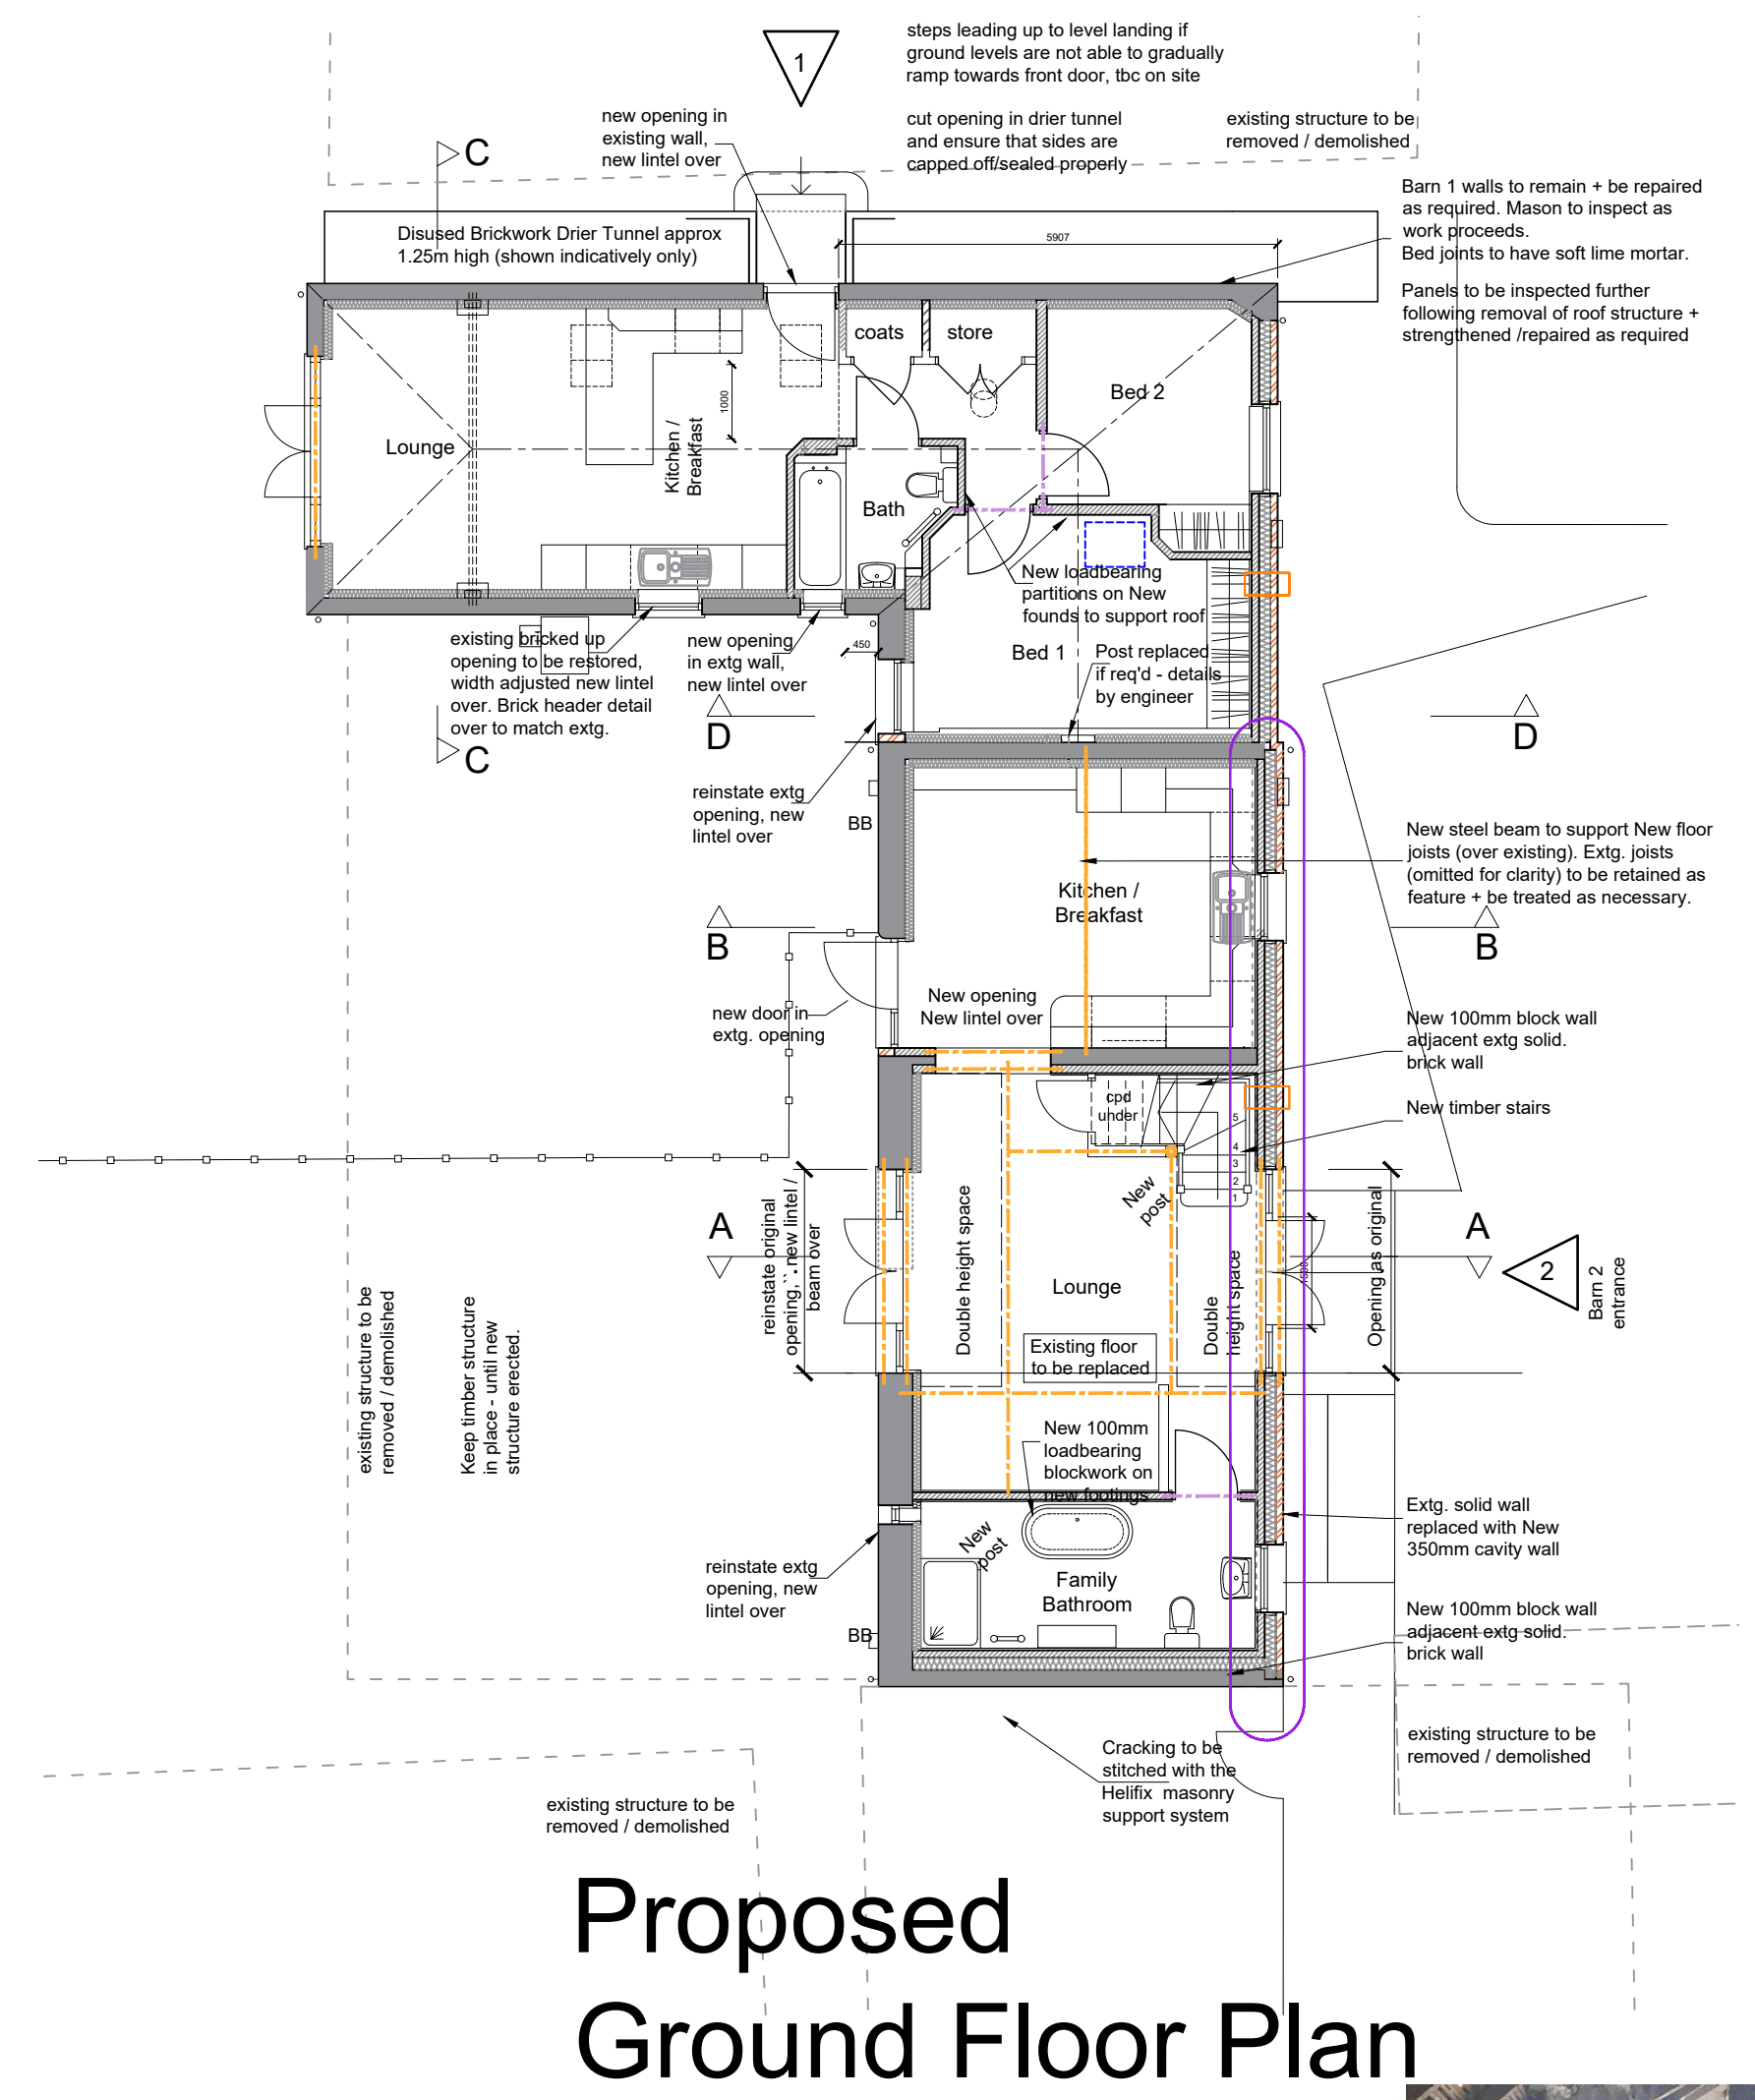
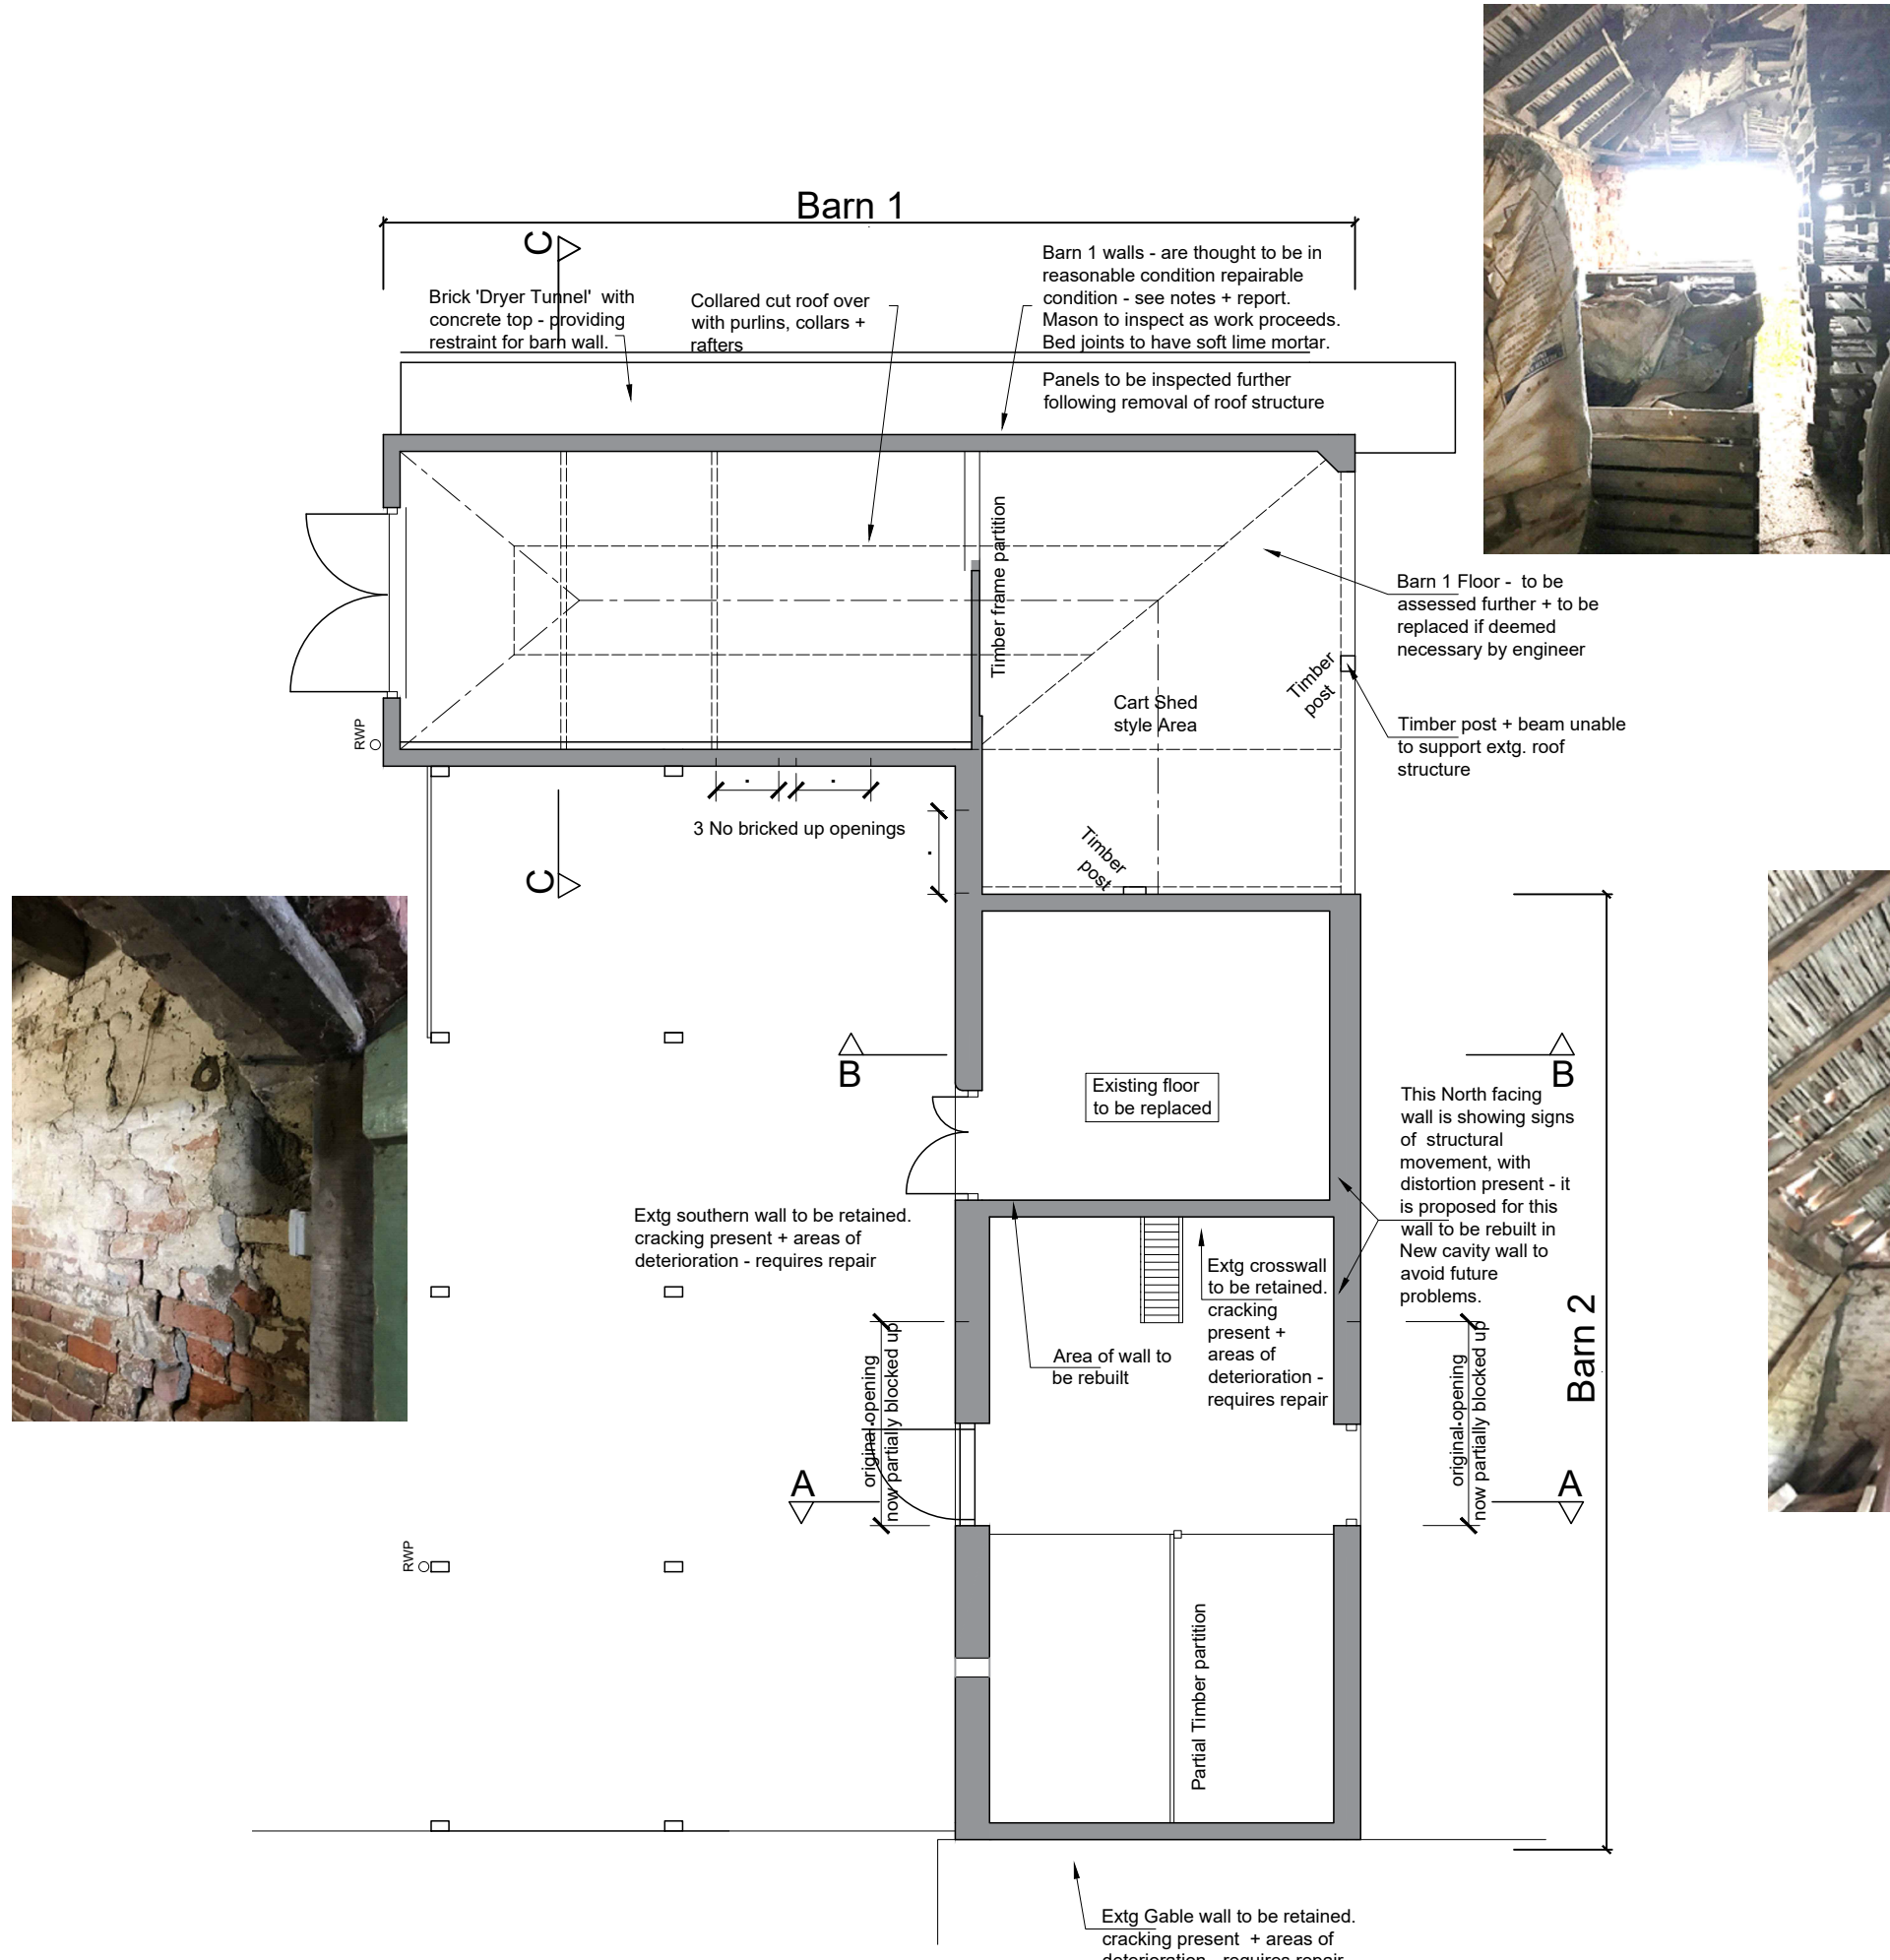
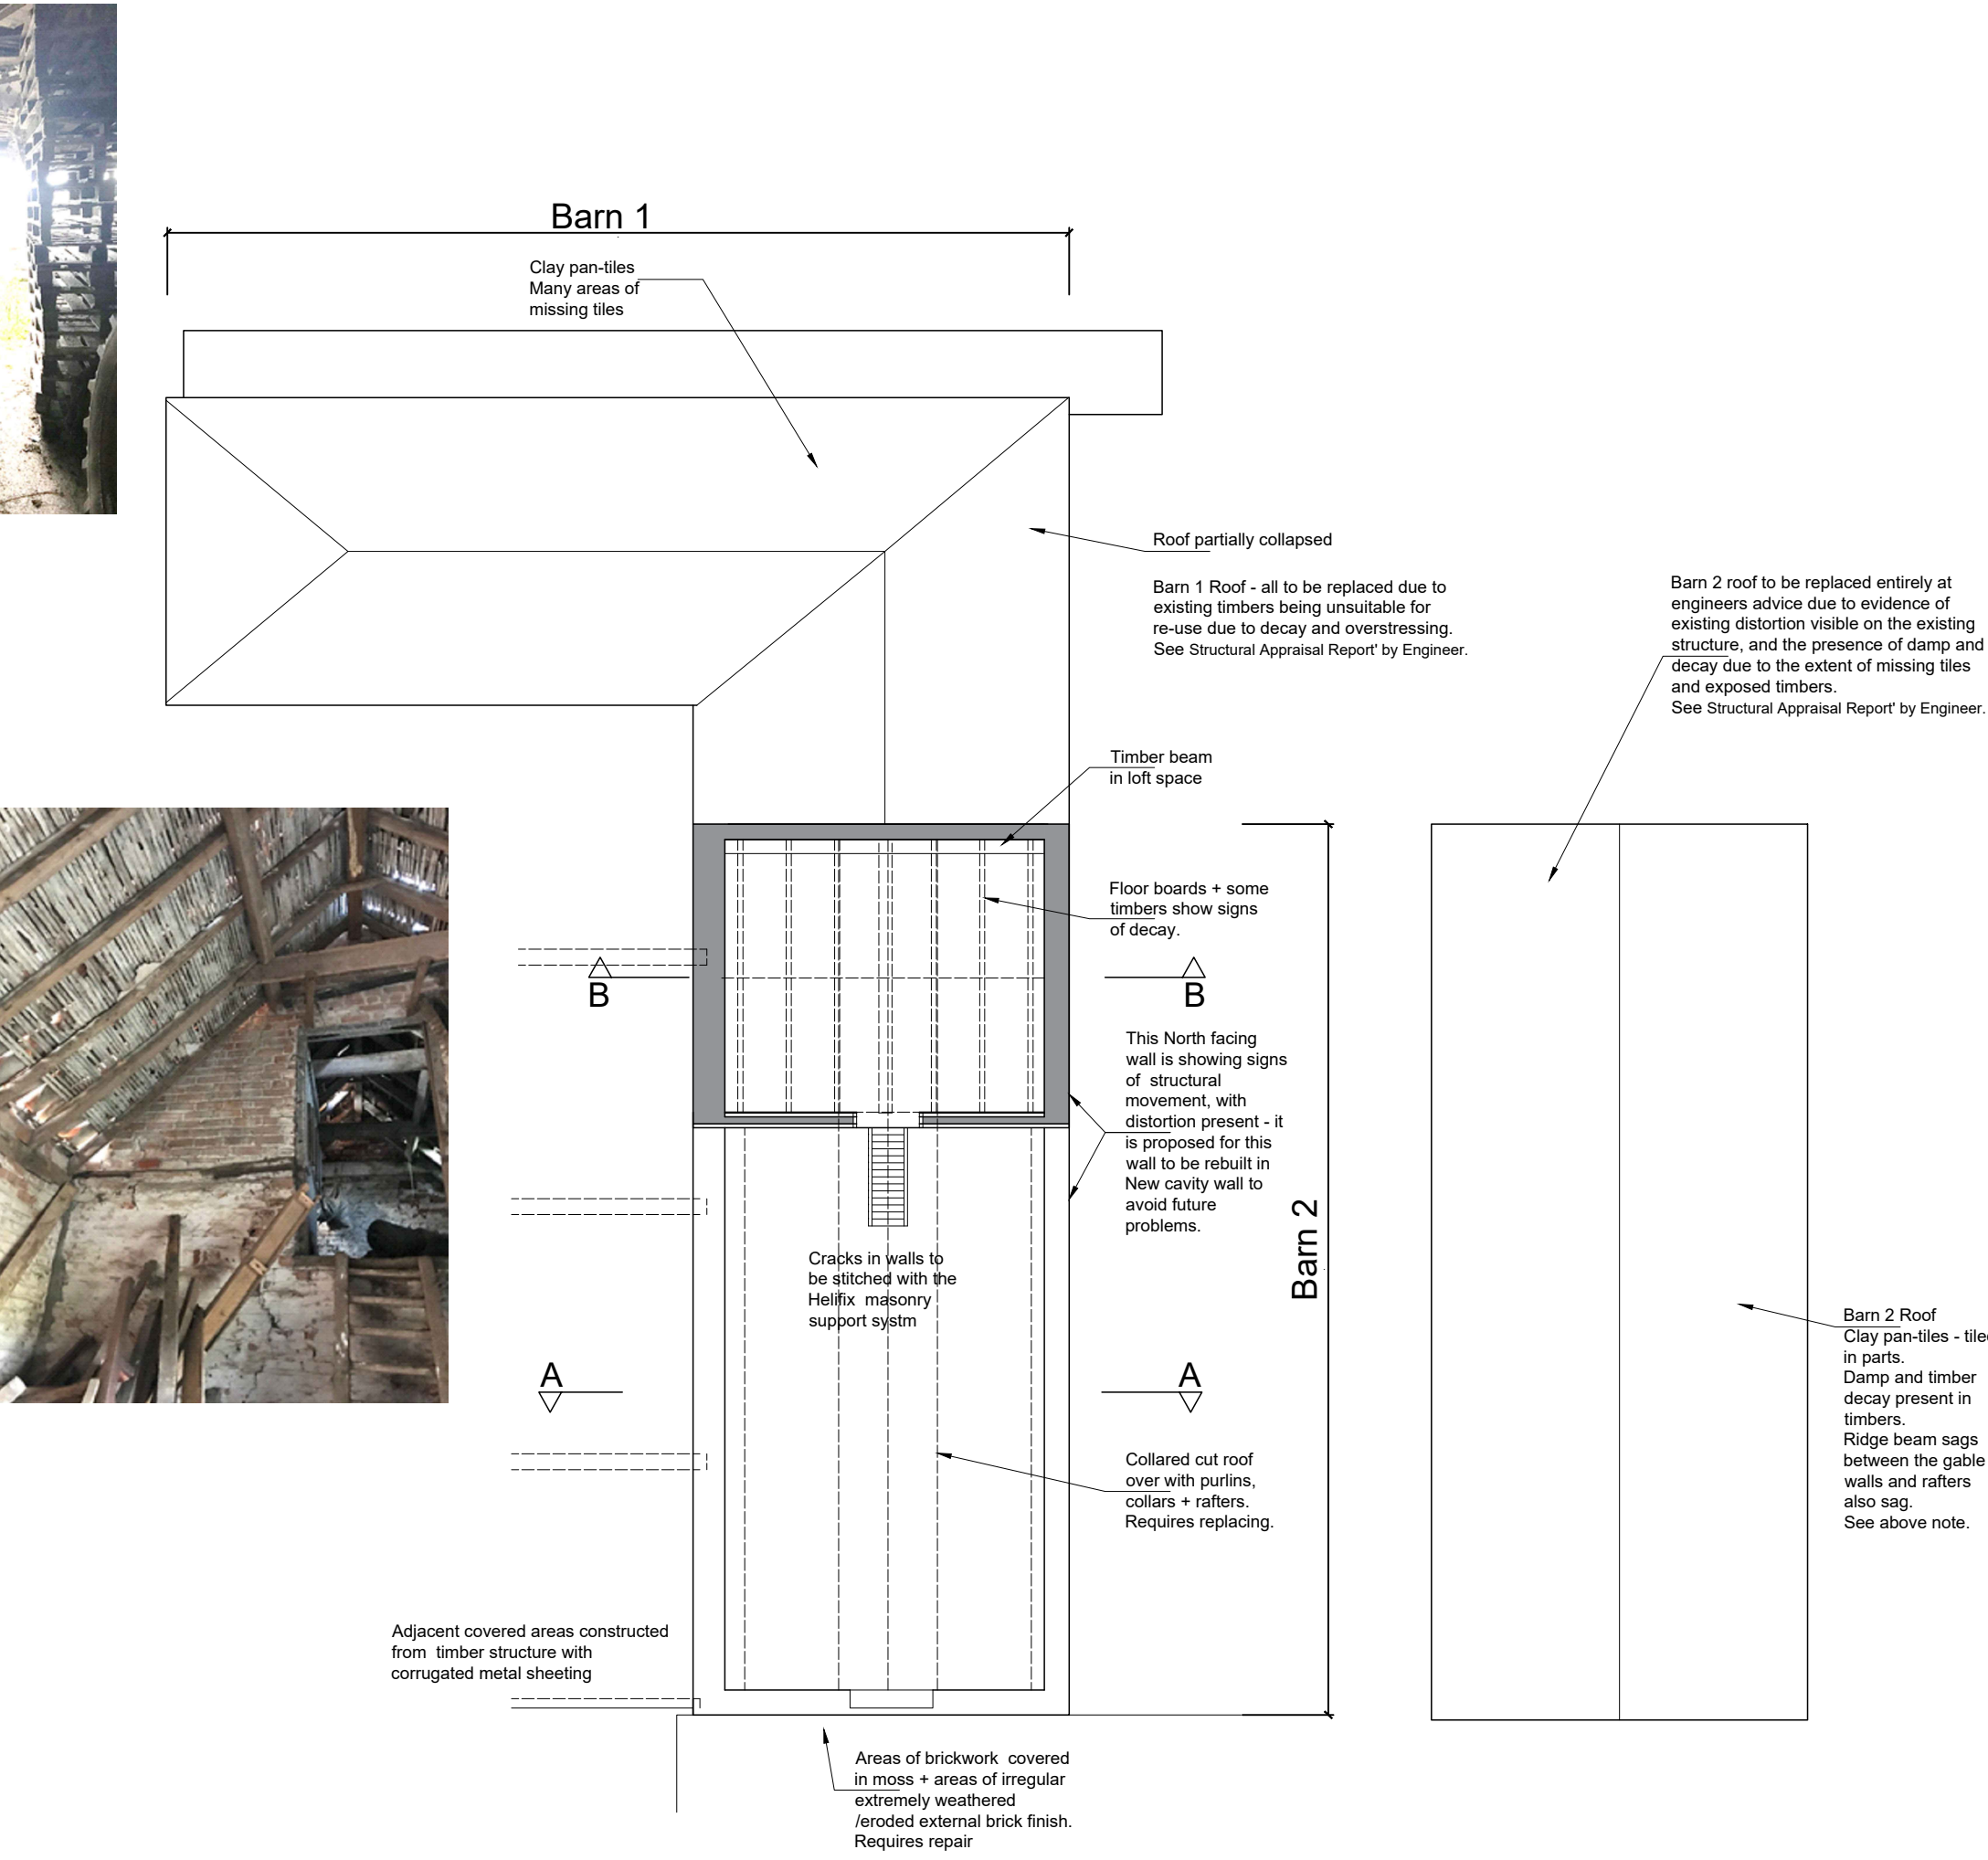
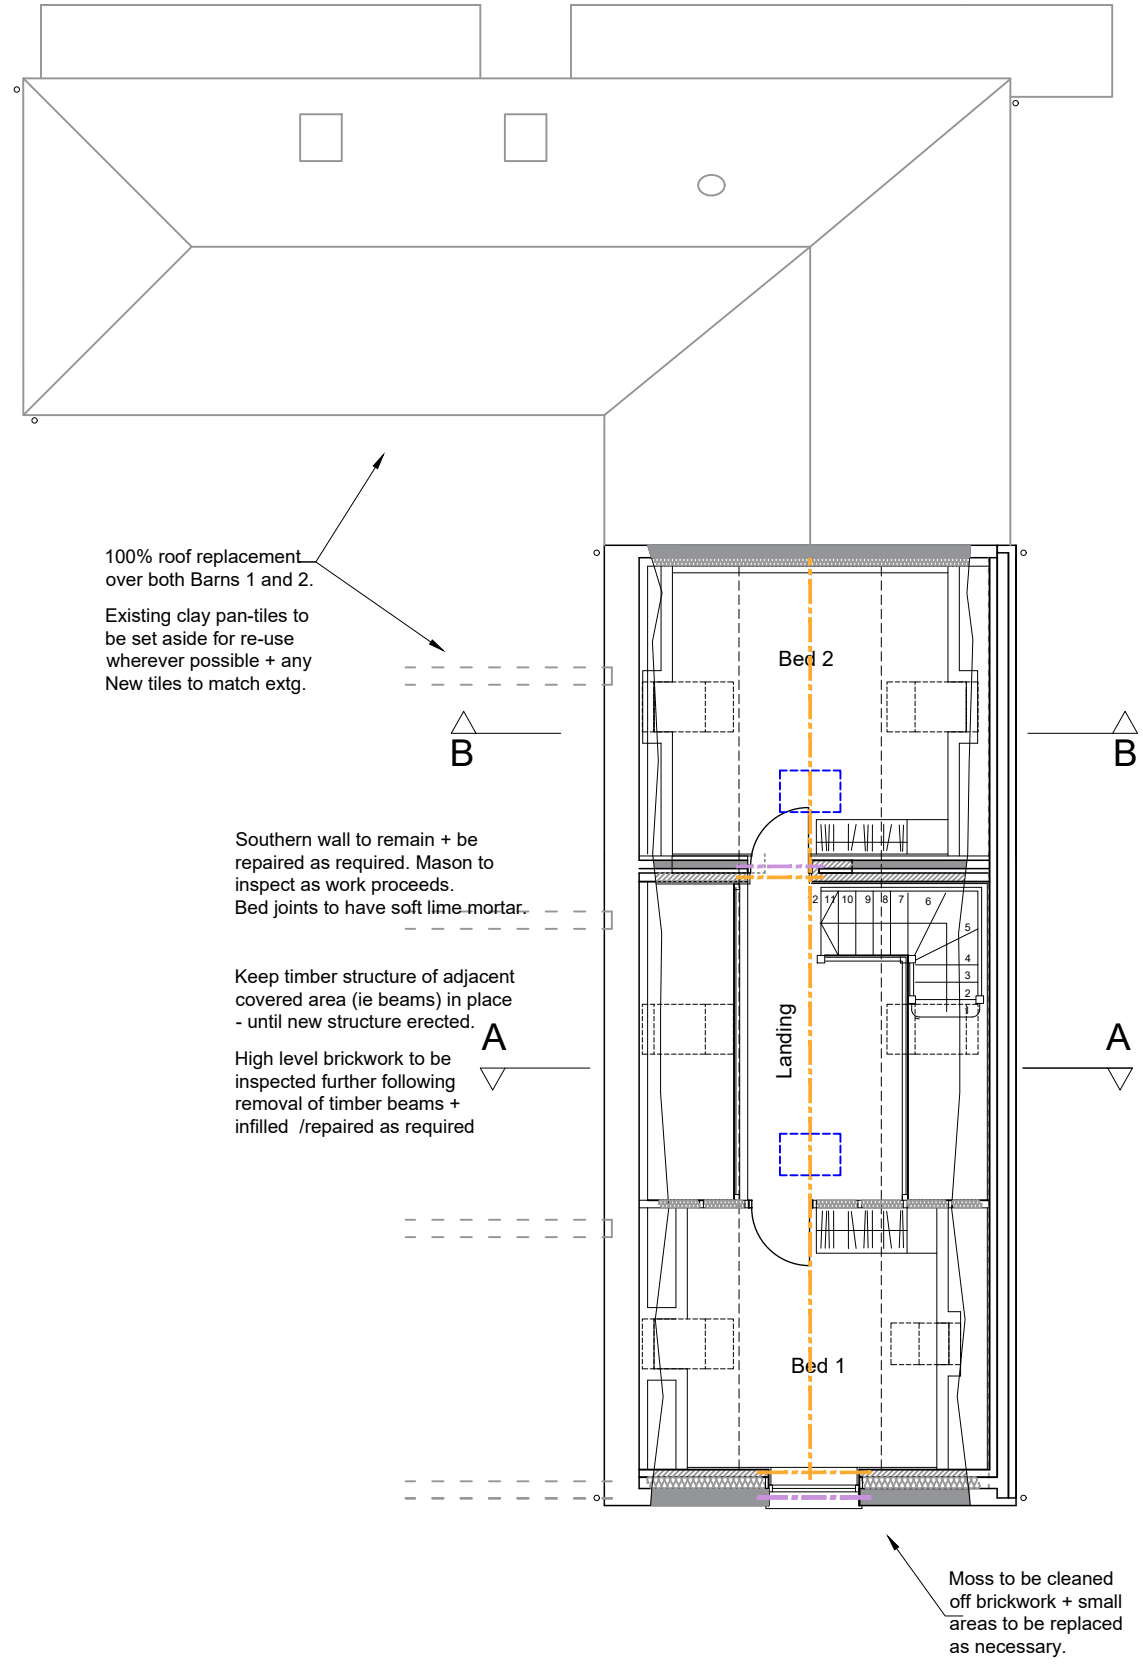
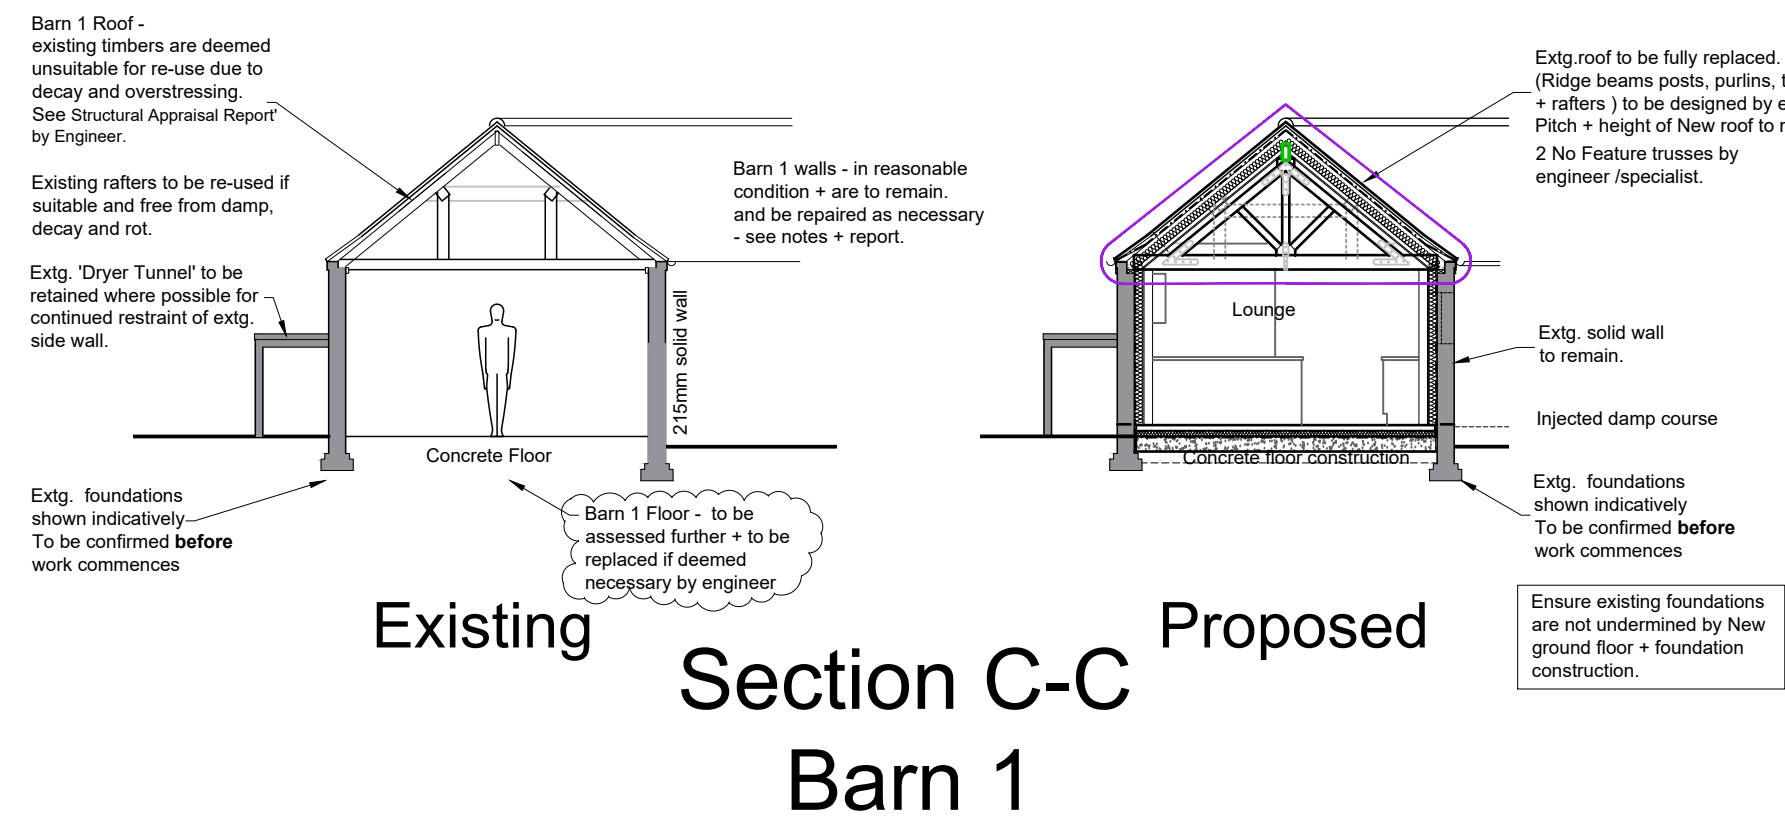
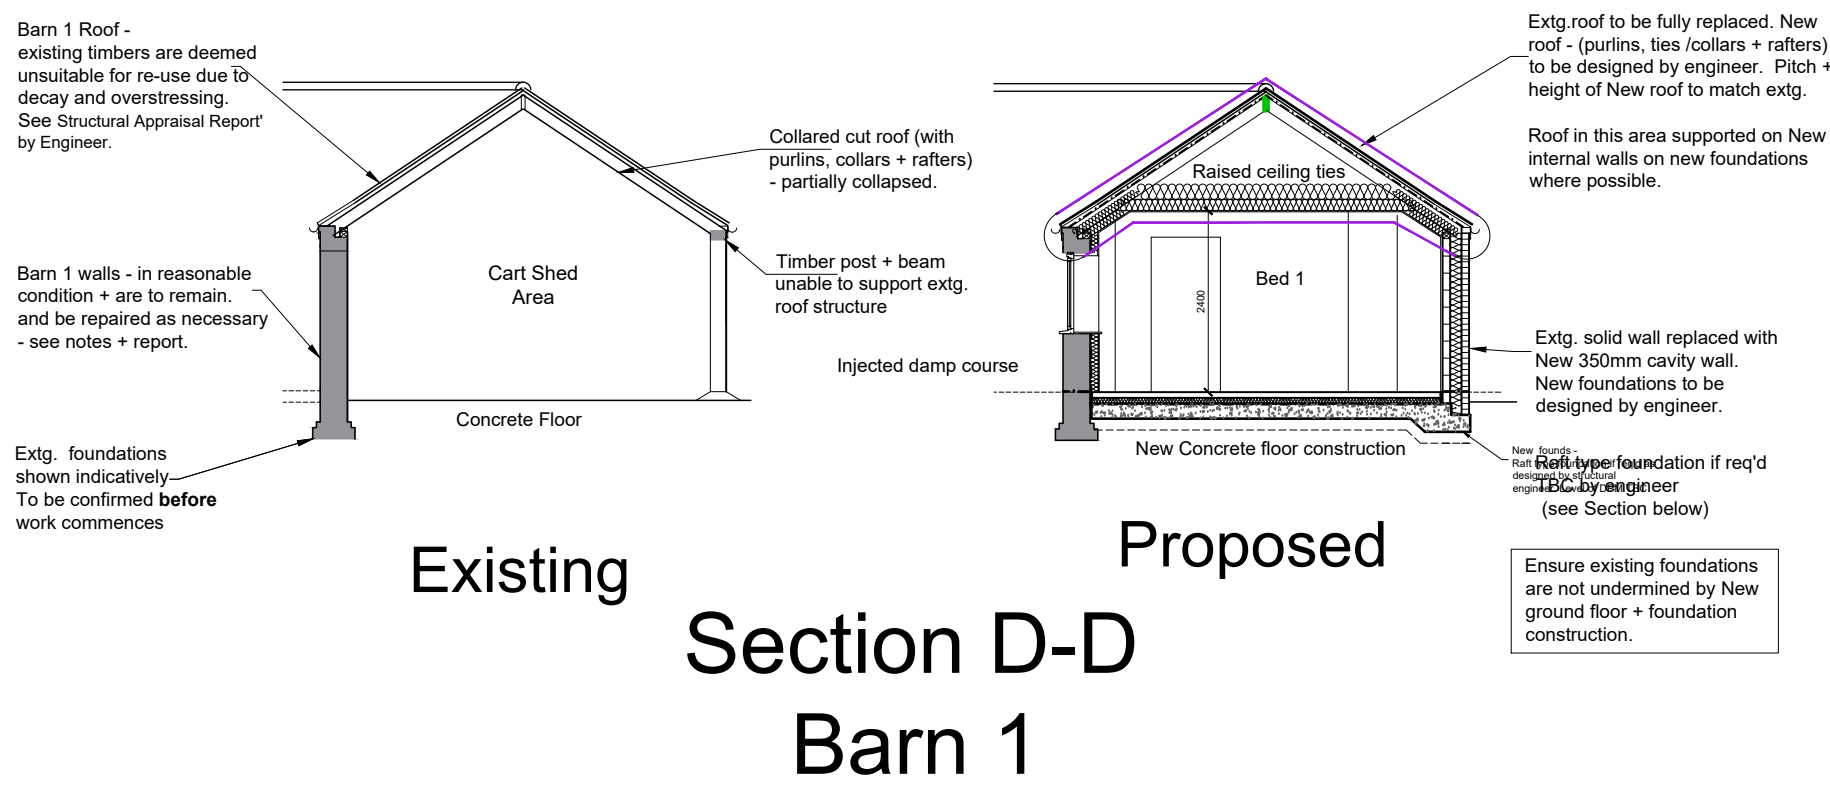
Plans + Sections C-C + D-D  
@ 1:100 scale

Structure being rebuilt.

Barn 1  
The existing roof structure is to be carefully removed + the remaining brickwork walls to be assessed as work progresses and supported temporarily as required. Panels to be inspected further following removal of roof structure. New roof to be designed by engineer.  
Existing walls that are to remain are to be strengthened and repaired as described in the engineers 'Structural Appraisal Report' and also strengthened as necessary to support the proposed refurbishment (as specified by engineer).  
Small areas of bricks to be replaced where necessary (type + colour to match extg.). Any minor fractures can be improved by low key stitching using the 'Helifix' masonry repair system as described in S.A. report.  
Extg. hard mortar should be replaced with sympathetic soft lime based mortar, and also any repointing - see report.  
Timber lintels, wallplates and any other existing timbers to be replaced as described in S.A. report.

Barn 2  
The existing roof structure is to be carefully removed + the remaining brickwork walls to be assessed as work progresses and supported temporarily as required.  
The adjacent timber structures to be kept in place - until new roof is installed.  
New roof to be designed by engineer.  
Existing North wall to be replaced due to poor condition.  
Existing East, South and cross walls are to remain + be strengthened and repaired as described in the engineers 'Structural Appraisal Report' and also strengthened as necessary to support the proposed refurbishment (to be designed by engineer).  
Small areas of bricks to be replaced where necessary and very small parts to be rebuilt. (type + colour to match extg.). Any minor fractures (including that within the East wall) can be improved by low key stitching using the 'Helifix' masonry repair system as described in report.  
Extg. hard mortar should be replaced with sympathetic soft lime based mortar, and also any repointing - see report.

Timber lintels, wallplates and any other existing timbers to be replaced as described in report.
