Project: Conservation Roof Lights & Structural Remedial Works  
Bresby House, Quadding Eaudike  
Client: Mr & Mrs Barrell  
Drawing Title: Attic (bedroom 6) As Proposed  
Date: November 2008  
Scale: 1: 25 on A1 1:50 on A3  
Project No: 07099  
Drawing No: JM CL  
Rev: 05/2 D  
Contractors are to check all dimensions on site and to report any discrepancy to the Architect. Do not scale from the drawings. © 2005

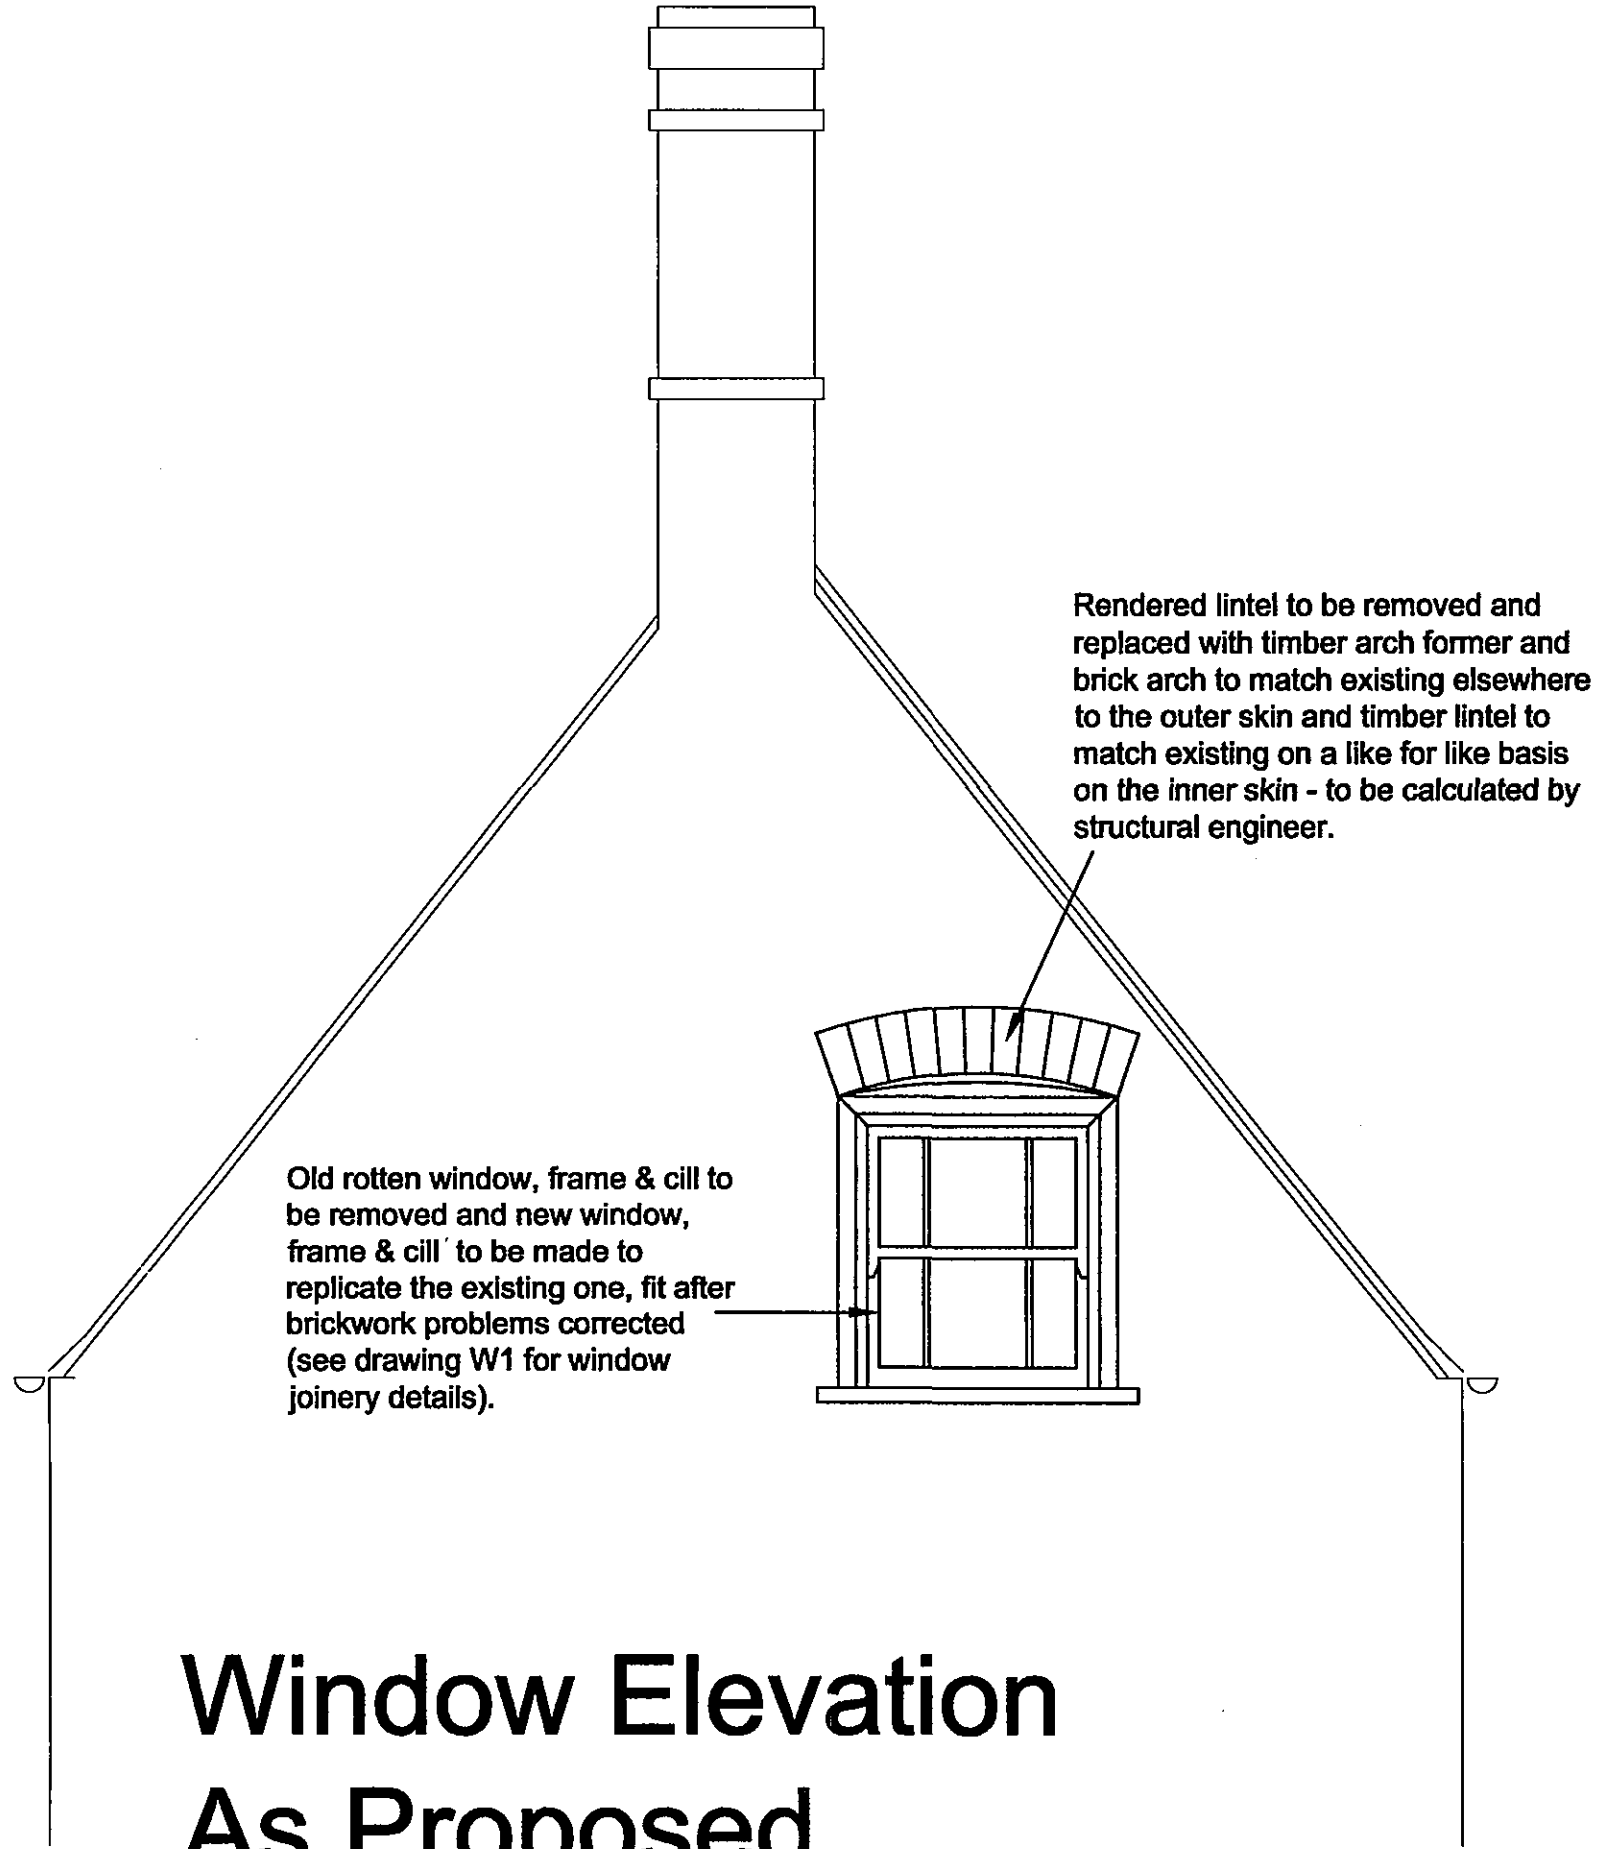
Window Elevation As Proposed

Provide access scaffold and temporary support as necessary. Carefully remove existing timber window and frame, providing support to any loose brickwork above. Insert steel or timber needle beams through gable wall at 1 metre spacings above timber collars and provide internal and external Acrow propping for support. Cut out damaged brickwork to wall and outer face of chimney flue down to approximately window cill level. Rebuild wall in sound brickwork to match existing to the correct line, using a 1:3 hydraulic lime and sand mix mortar, feathering into surrounding brickwork. Install new lintel above window and fit new window and frame to match original. Remove loose internal lime plaster, cut out and make good cracks on internal chimney breast, make good cracked brickwork and re-plaster with a haired sand/lime render (see structural engineers report for details). Structural Engineer is to confirm the exact extent of the works and provide a detailed elevation drawing highlighting the areas of brickwork on the gable wall to be reinstated in red, measurements of these areas are to be undertaken and recorded on the elevation drawing, details of support to the structure and its exact position are to be fully detailed, measurements of existing mortar depths are to be recorded, any repointing is to be recorded (only to be undertaken if absolutely necessary, a slaked lime putty and sand mix for the mortar is to be used), and bricks are to be numbered and mapped so they are put back in the correct position, this does not include the modern London common bricks, which are to be replaced with reclaimed bricks to match existing.

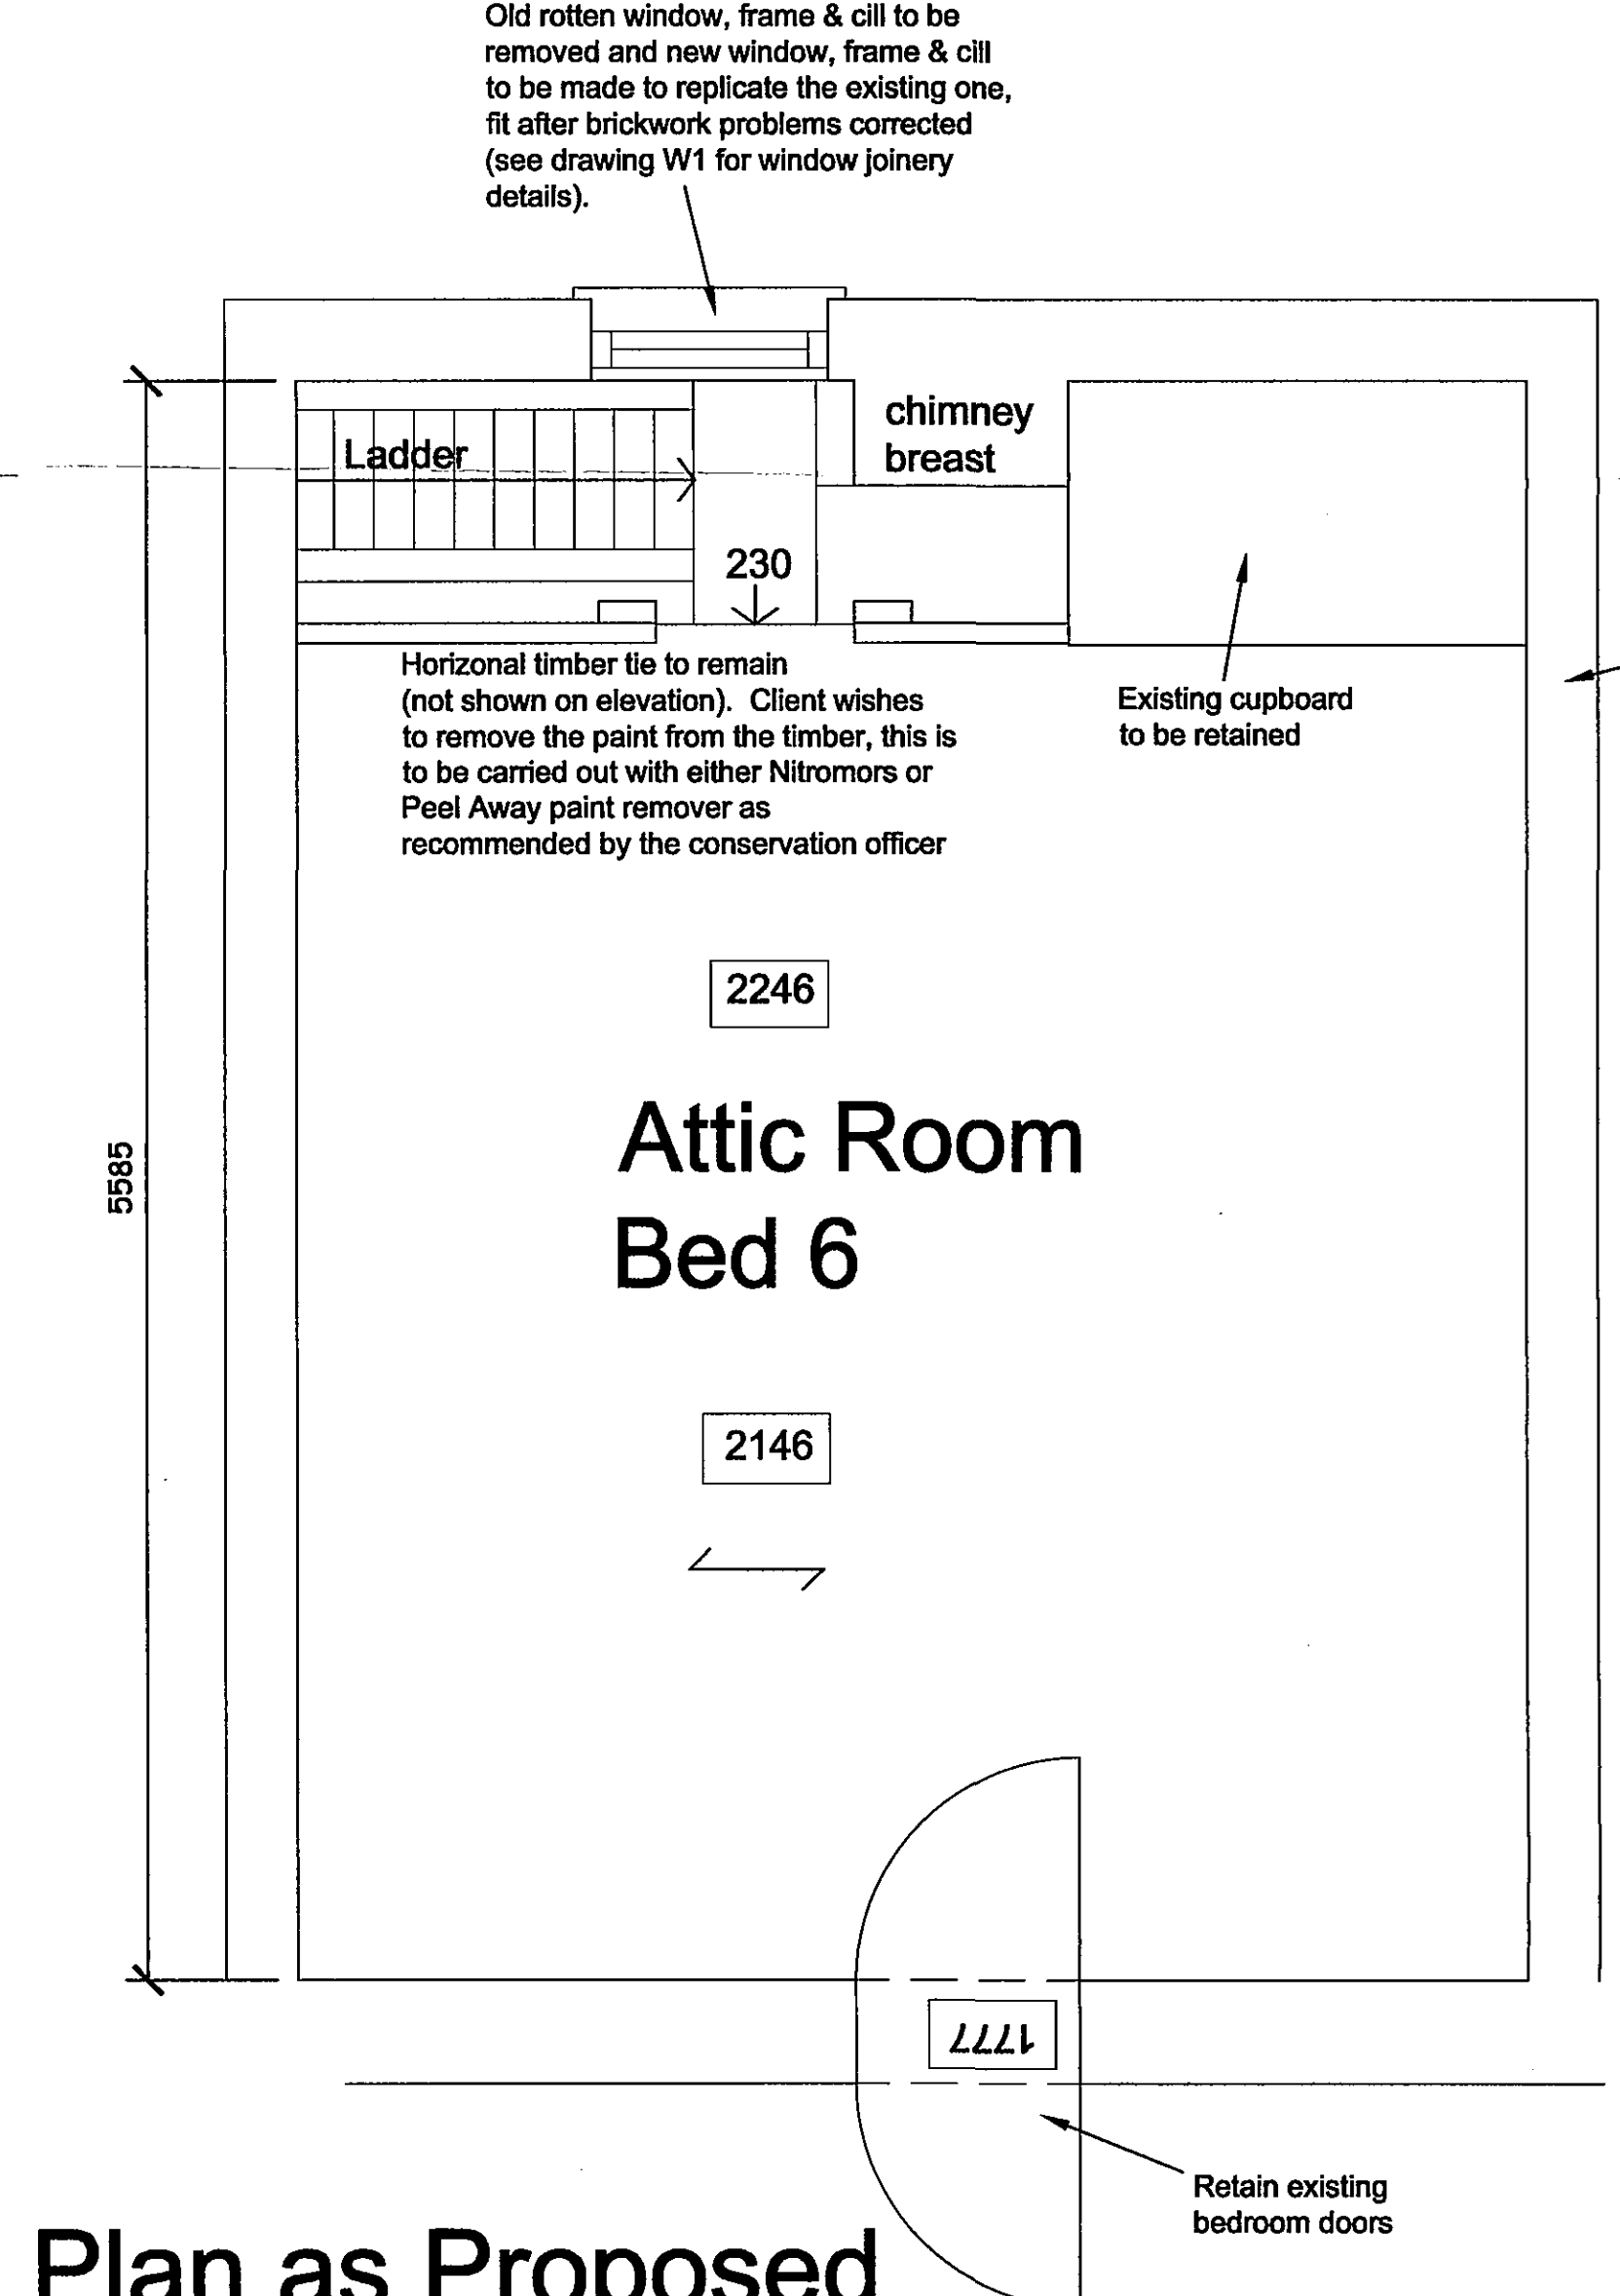
Plan as Proposed Floor Level

Remove plaster from crack lines to expose cracked brickwork. Make good internal cracks by brick-stitching across crack lines, building in stainless steel bed-joint reinforcement as necessary. Remove plaster and loose brickwork to cracked area at inner corner between South side-wall and inner wall. Cut out loose and damaged brickwork and re-bond around corner, building in bed-joint reinforcement. If cracking is found to be severe, consult structural engineer and if necessary provide steel restraint straps around corner, bolted into wall at side. Existing lime render to walls is to be retained as far as is practically possible, all repairs to the lime render are to be done with a haired sand/lime render (see structural engineers report for details). Structural Engineer is to confirm the areas of cracking which are absolutely necessary to brick stitch, any areas which are not absolutely necessary are to be left as existing. The structural engineer is to provide detailed plans and internal elevations highlighting the areas which require repair in red.

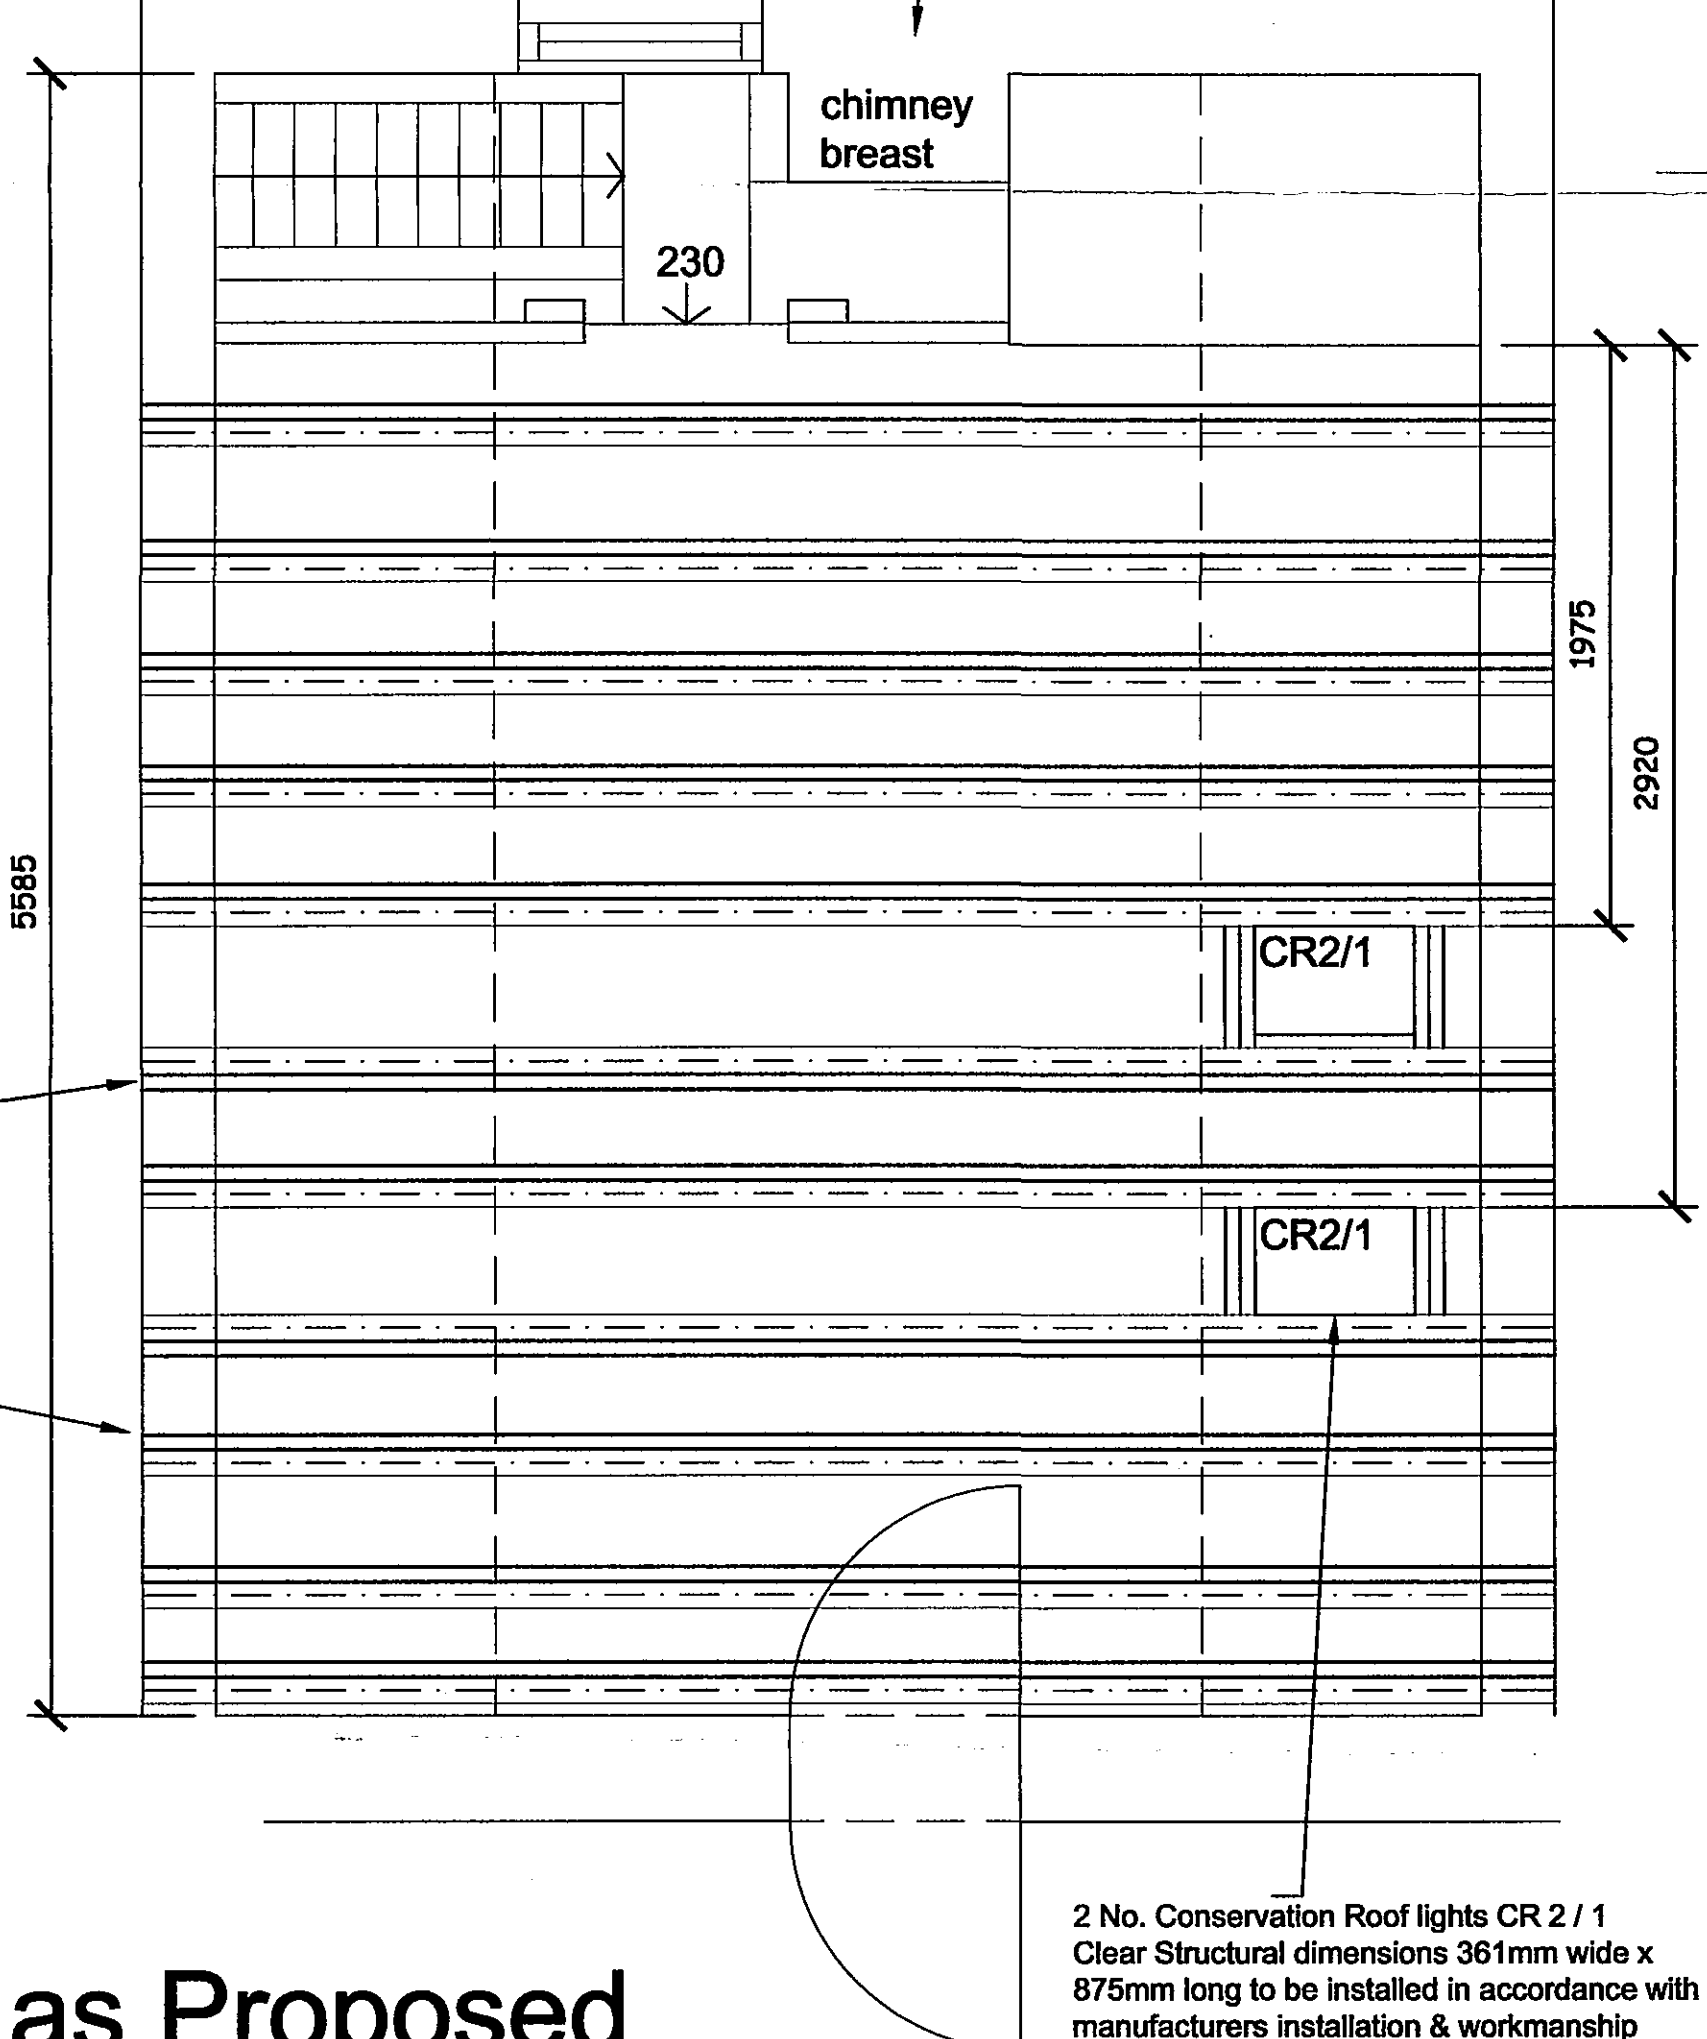
Plan as Proposed Rafter Level

Additional rafters and ceiling joists are to be fixed to the sides of the existing rafters and ceiling joists to strengthen them as discussed with and recommended by the conservation officer, this is a more justified approach to providing some resolution to the failing roof structure. Although it will not be as effective as using the originally proposed steel channels it will have minimum intervention on the existing historic building. The additional rafters and ceiling joists are to be installed when the roof covering has been overhauled and before the proposed lath and plaster ceiling is to be installed. The layout shown is indicative, the structural engineer is to calculate and fully detail the exact size, position of each rafter and ceiling joist and the method of fixing them to the existing, the rafters must not exceed the depth of the existing rafters, as discussed with the conservation officer it is acceptable to fix the new ceiling joists so that the ceiling height is lower than the existing, as she fully appreciates that the lower the ceiling joist, the less spread it will have, and it is proposed to remove the existing ceiling finish and replace it with a traditional lath and plaster method, structural engineer is to calculate the feasibility of doing this.
