Our Ref: E22108/SSJ/UL1

**E22108: UPDATE AND SUMMARY OF ENVIRONMENTAL WORKS AT SITE OFF CHAPELGATE, SUTTON ST. JAMES**

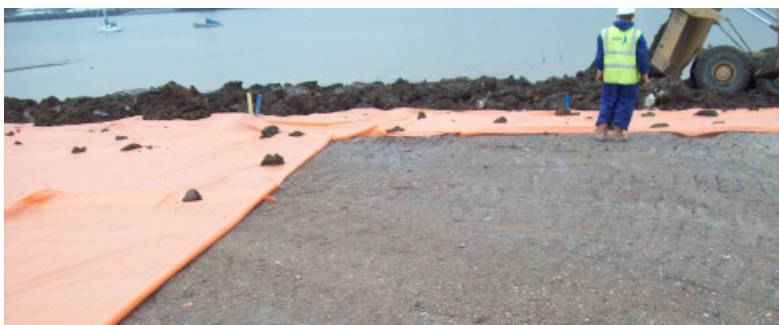
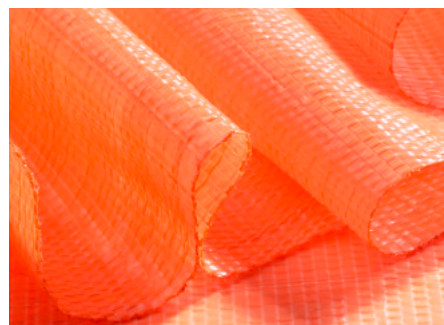
**Alert™ Woven Polypropylene Geotextile and Contamination Indicator**

**Alert™** was developed by Geosynthetics Limited to provide a cost effective and practical way to indicate the break between potentially contaminated ground and imported or site won clean fill. The large roll size combined with industrial leading technical specifications and strength have lead to the vivid orange **Alert™** woven geotextile being the product of choice in the UK.
